Diamond Head Consulting Ltd. Arborist Report

5616 Westport Place
West Vancouver, BC

December 3, 2014

To be submitted with Tree Protection Plan
Dated: December 3, 2014

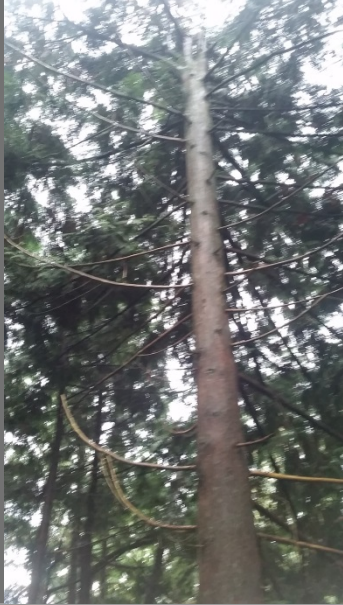
Photo 1. The majority of trees located within the proposed development area have been previously topped for views..

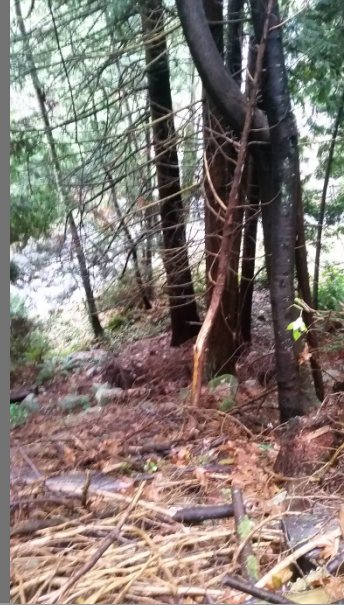
Photo 2. View from within the development area.

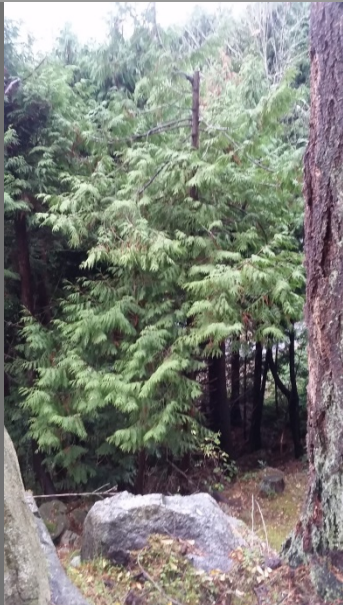
Photo 3. The majority of trees located within the proposed development area have been previously topped for views.

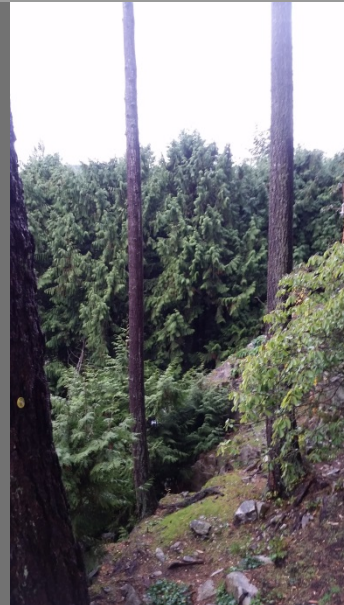
Photo 4. The majority of trees located within the proposed development area have been previously topped for views.
