# Diamond Head Consulting Ltd. Arborist Report

4719 Pilot House Road  
West Vancouver, BC

March 24, 2014

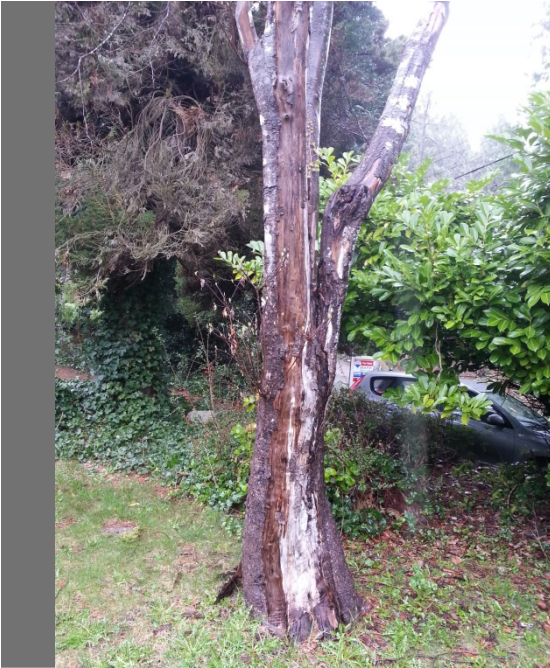
Photo 1. Tree # 7058, this dogwood tree is severe health and structural decline.

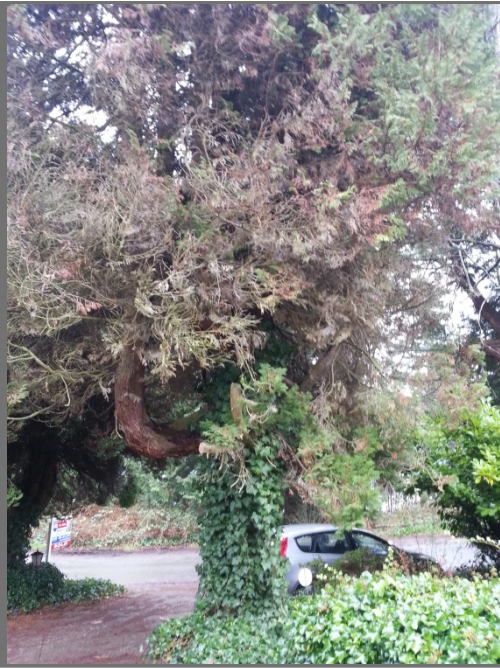
Photo 2. Tree # 7059, previously topped, displaying large patches of crown dieback.

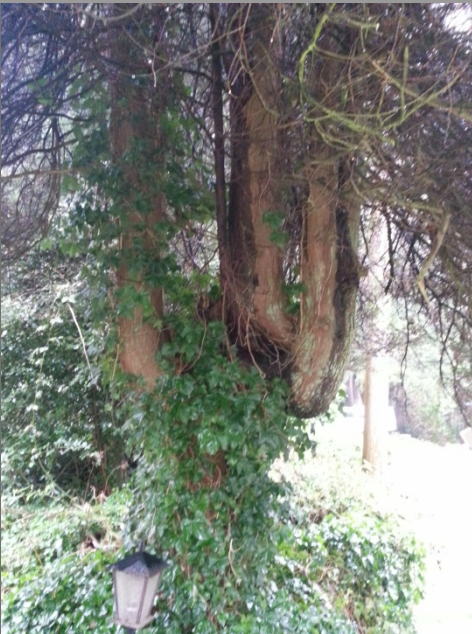
Photo 3. Tree # 7056, previously topped with decay visible at the stem union.

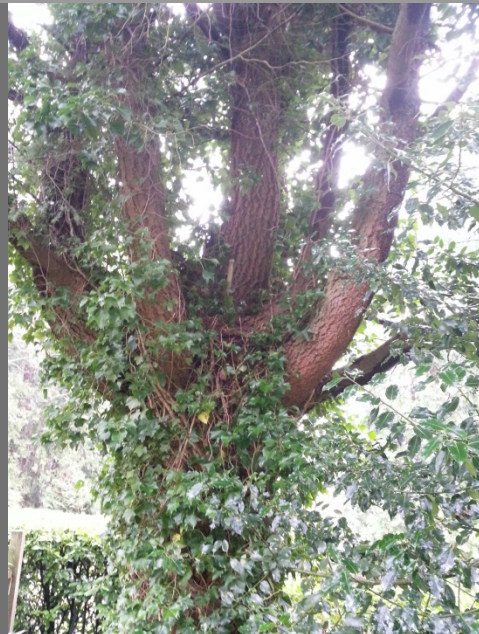
Photo 4. Tree # 5988 previously topped that resulted in the large replacement leaders.

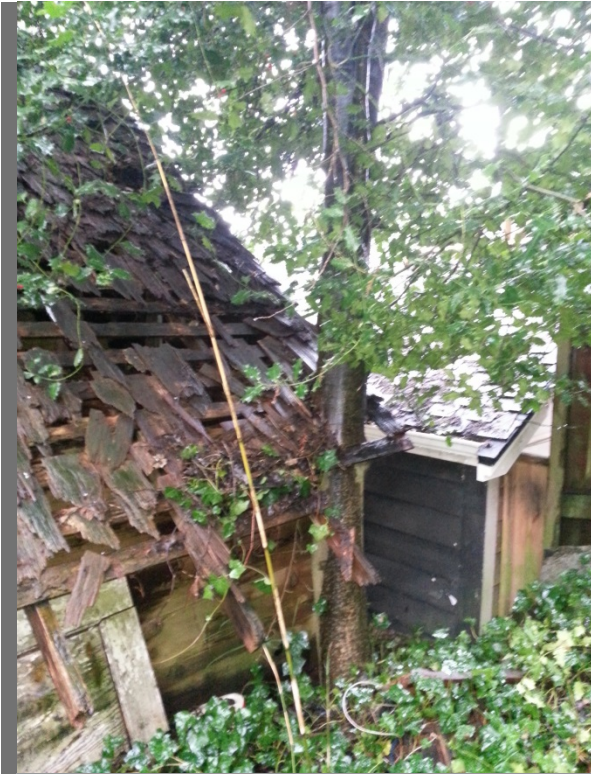
Photo 5. Tree # 5985 is growing through the existing carport roof.

5985	English Holly	<i>Ilex aquifolium</i>	28	5	Very poor	Unsuitable	This tree is growing through the existing carport roof, and there several boards embedded in the tree's trunk. In addition the tree has been topped to approximately 5m above grade.	Remove	Due to pre-existing very poor health and structural condition. This tree will not survive demolition of the adjacent carport.
5986	Western redcedar	<i>Thuja plicata</i>	80	8	Very poor	Unsuitable	This tree has been previously topped at approximately 5m above grade, resulting in the formation of several replacement leaders. These replacement leaders have been topped as well. This tree is growing adjacent the concrete deck and the deck is embedded into the trunk. The tree's crown is infested with ivy.	Remove	Due to pre-existing very poor health and structural condition. This tree will not survive demolition of the adjacent wood and concrete deck.

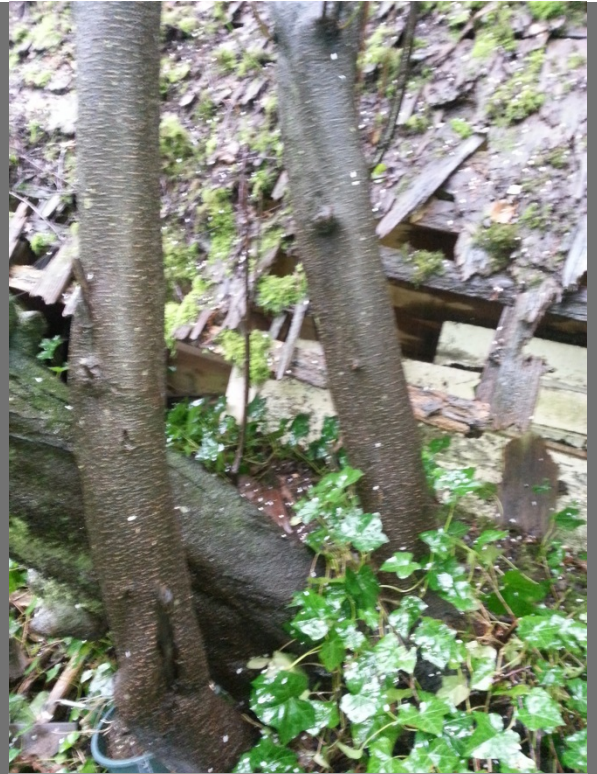
Photo 6. Tree # 5984, is growing in close proximity to the existing carport.

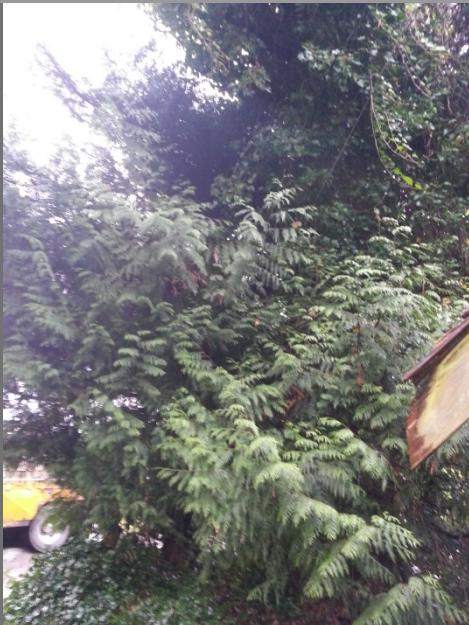
Photo 7. Showing topped tree # 5982.

Tag #	Common Name	Botanical Name	DBH (cm)	Ht (m)	Overall Condition	Retention Suitability	Comments	Retain/Remove	Tree Retention Comments
5982	Western redcedar	<i>Thuja plicata</i>	54	7	Very poor	Unsuitable	This tree has been previously topped to the height of 7m for overhead Hydro line clearance. Decay is visible at the historic topping wounds. The tree is growing in an above grade rock walled planter.	Remove	Due to pre-existing very poor health and structural condition.
5983	Western hemlock	<i>Tsuga heterophylla</i>	93	10	Very poor	Unsuitable	This tree has been previously topped and there is decay visible at the historic topping site. There is a fruiting body of decay (conk - <i>Ganoderma applanatum</i> ) located approximately 1.5m above grade. This conk is an indicator of severe internal decay.	Remove	Due to pre-existing very poor health and structural condition.
5984	Purpleleaf plum	<i>Prunus cerasifera</i>	Multi	5	Very poor	Unsuitable	This tree has been previously topped with the limbs having been headed. The crown is comprised mostly of shoot growth. There are significant decay cavities throughout the main stems. This tree is growing adjacent a retaining wall for the adjacent carport.	Remove	Due to pre-existing very poor health and structural condition.

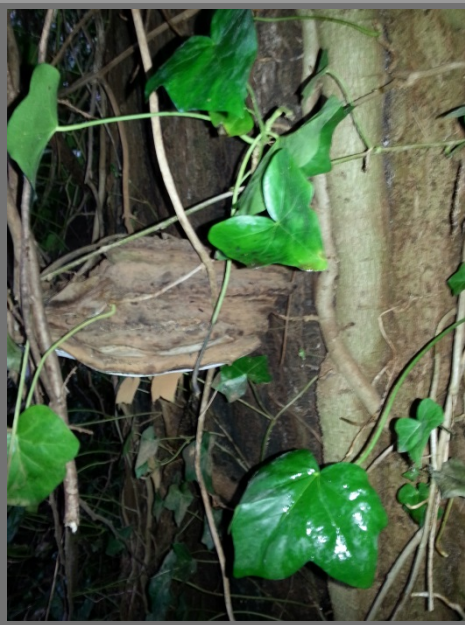
Photo 8. Showing the decay conk growing on Tree # 5983.

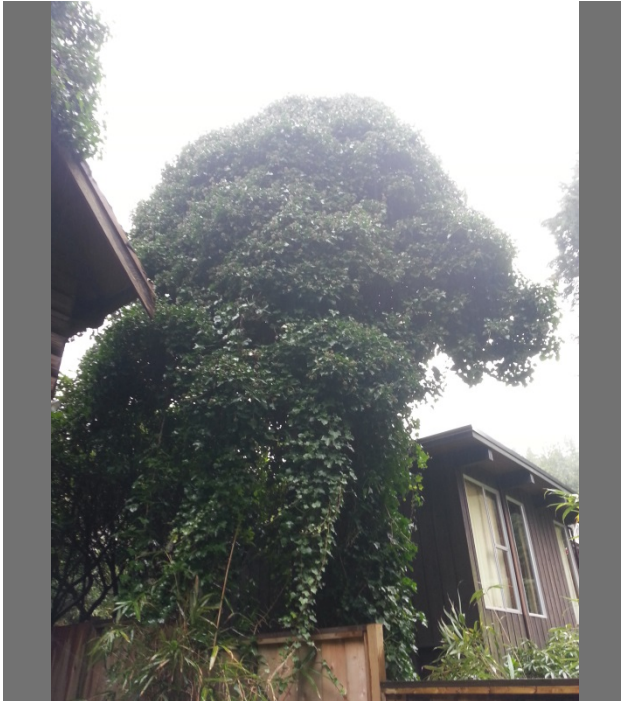
Photo 1. Off-site 5m tall (approximate) ivy covered stump located on north adjacent property.

There is a 5m high stump located on the adjacent north property; the neighbours should be consulted about removing this stump prior to construction on the subject site. There are no other off-site trees that are within the zone of influence to the subject site.
