Arborist Report

Date:	26 July 17
File #:	17-123
Client:	Donna Begg
Telephone:	604-202-9201
Email:	perennialdesigns@shaw.ca
Site Address:	4730 the Hwy West Vancouver, BC

Burley Boys Tree Service Ltd. has been contracted to provide tree inventory and tree removal/tree retention outline for the property at 4730 the Highway, West Vancouver, BC. Plans include the development of the property, including the construction of a new laneway home on the property.

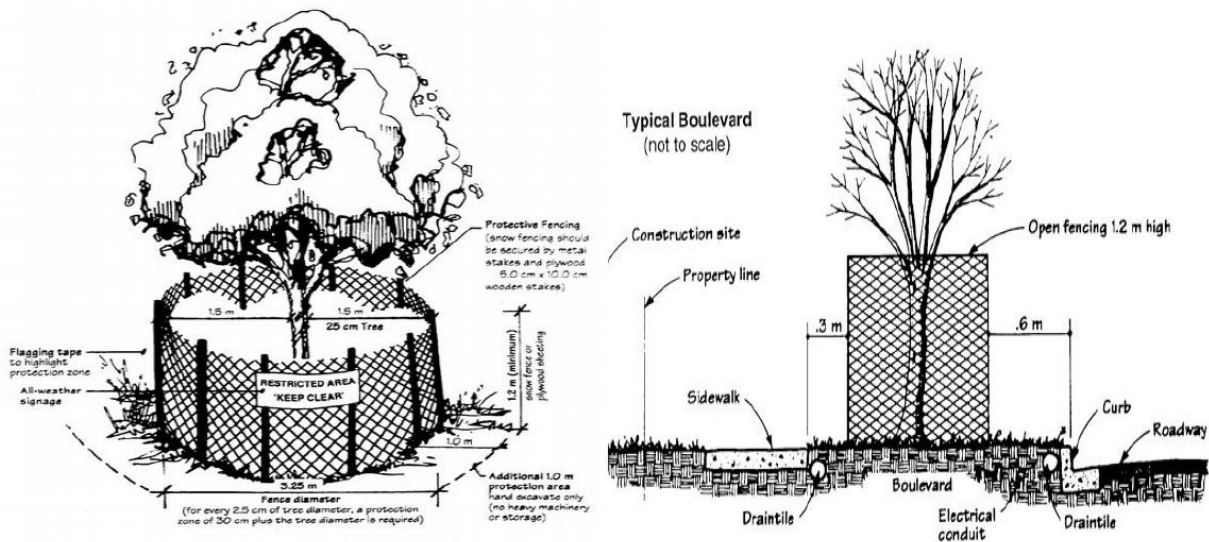
Standard and Boulevard Tree Protection Barrier (TPB) guide/outline (Fig 3)
 TPB is to be erected in accordance with municipal bylaw. Traditionally it is composed of wooden 2x4 construction and orange snow fencing material. It is to be erected in a suitable geometrical form or shape to encompass the outlined areas in the above mentioned report, or as described by development services. It is to be a permanent structure that can be maintained for the entire development process. It is to be adhered to and the inside area is not to be used for storage of supplies or rubbish. Any reduction in TPB should be supervised and Arborist consultation is mandatory.
