SUTHERLAND HOUSE

1768 INGLEWOOD AVENUE, WEST VANCOUVER, BC

CONSERVATION PLAN

JUNE 2017

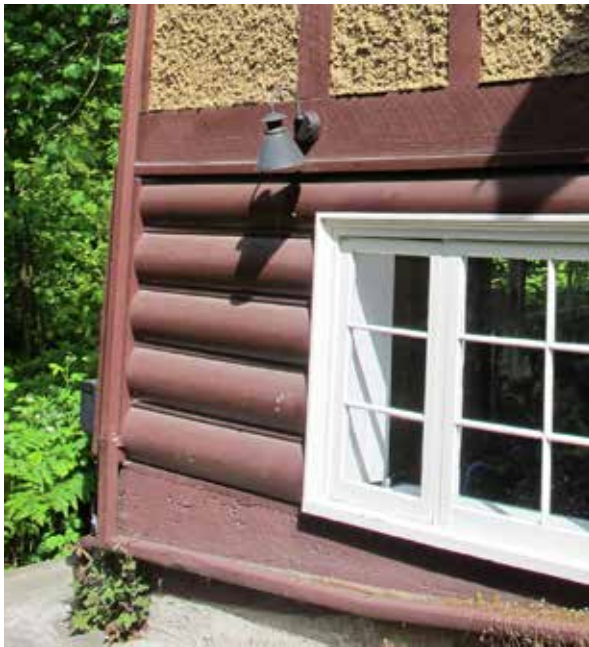
The Sutherland House features a poured-in-place concrete foundation, with a full basement clad in log-cabin siding below water table on all elevations. Along the west and the rear elevation to the south, the foundation wall is almost entirely exposed above grade; the log-cabin siding terminates into exposed concrete foundation, which is aligned to the existing window sills. Directly below the log-cabin siding, the concrete foundation is finished with paint of the same colour as the siding and the rainwater leader. In general, the foundation appears to be in good condition.

Typical condition of foundation, as seen from the southwest corner of the historic house.

- Existing foundations should be preserved, if possible.
- If new foundations are proposed, concrete is a suitable material. New material should match original in appearance, as viewed from the exterior.

- Foundations should be reviewed by a Structural Engineer. Once condition is assessed, conservation recommendations can be finalized.
- To ensure the prolonged preservation of the new foundations, all landscaping should be separated from the foundations at grade by a course of gravel or decorative stones, which help prevent splash back and assist drainage. New vegetation may assist in concealing the newly exposed foundations, if desired.

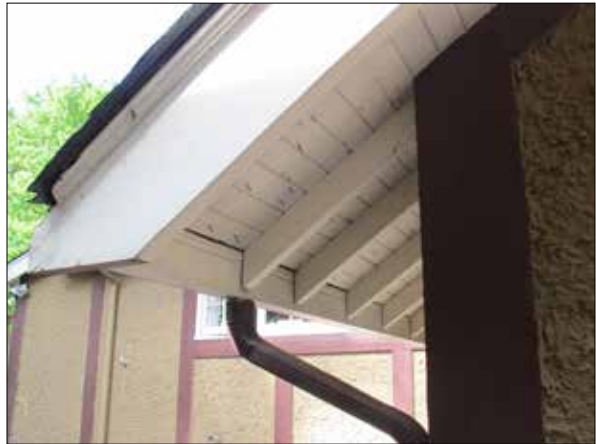
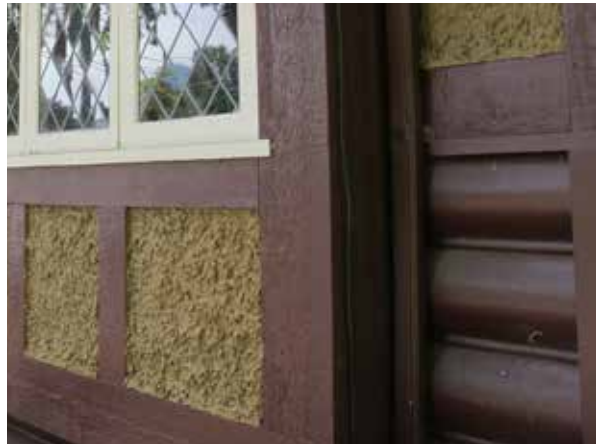
Based on visual inspection from the ground, the wood trim work are finished with paint; they are generally in good condition, with minor evidences of deterioration in localized areas, and should be retained in-place. In locations where new exterior walls are proposed to be constructed, salvage all original wood trim and reinstate following rehabilitation work.

Photos showing typical condition of extant original wood trim work of the historic house, as seen from the ground.

- Any existing trim should be preserved. Any character-defining elements that are missing or heavily deteriorated beyond repair should be restored using new materials that are visually and physically compatible with the original.
- Salvage and reinstate original wood trim work where new exterior walls are proposed. If new trim work is required, it should be installed on the rear elevation and original material should be relocated to the front, as necessary.

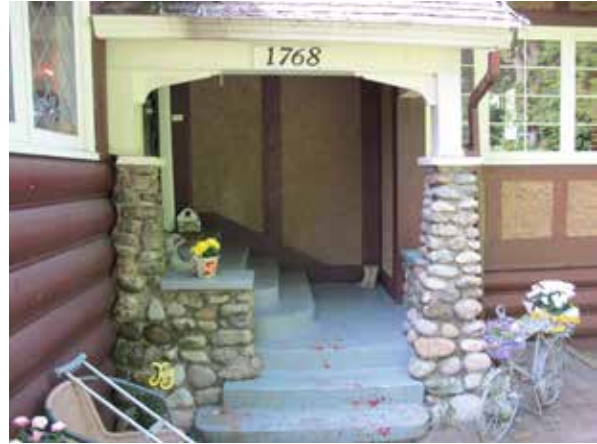
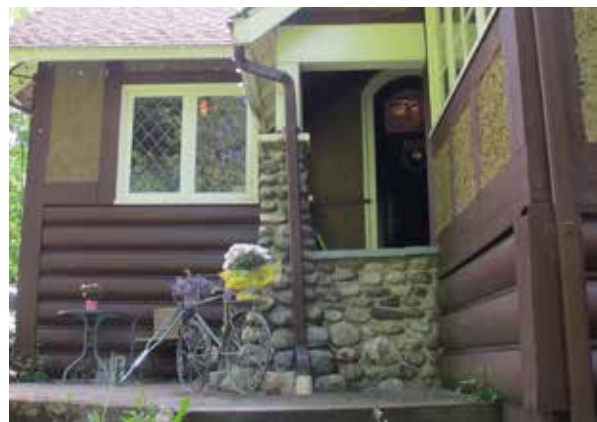
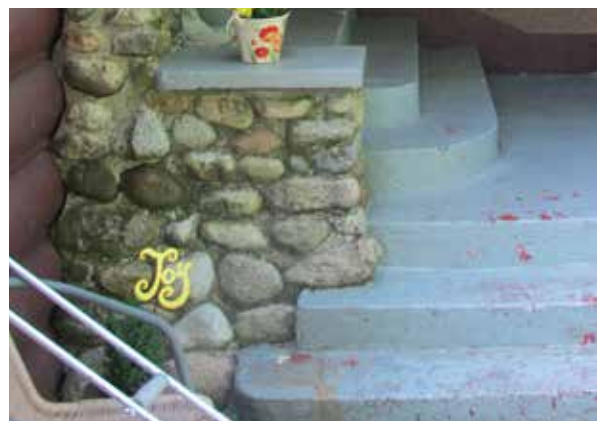
Photos showing typical condition of extant original side-entry porch and stairs of the historic house. Note the crack along the mortar, which also shows biological growth.

In general, the entry porch and stairs appears to be in good condition, although the stone piers and low balustrades show signs of weathering and minor deterioration in the form of stepped cracking and biological growth. The entry porch and associated detailing are character-defining elements of the historic house, and should be preserved.

- Preserve original details of the entry porch and stairs.
- Extant original stone piers and low balustrades should be retained and preserved. Exterior surface of stone can be cleaned, as necessary. No abrasive cleaning methods should be used.
- Mortar condition should be assessed, and localized repointing may be required. Any new mortar repair work should be visually and physically consistent with historic original. Heritage Consultant should review specifications prior to commencement of work.
- Wood elements should be cleaned, and

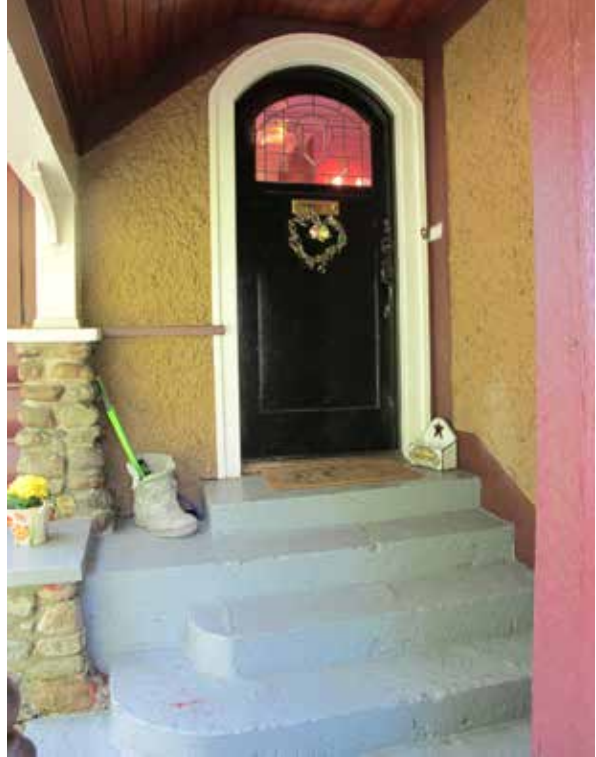
Existing entrance door above concrete stairs of entry porch. Note low stone balustrade and stained soffit beneath porch canopy.

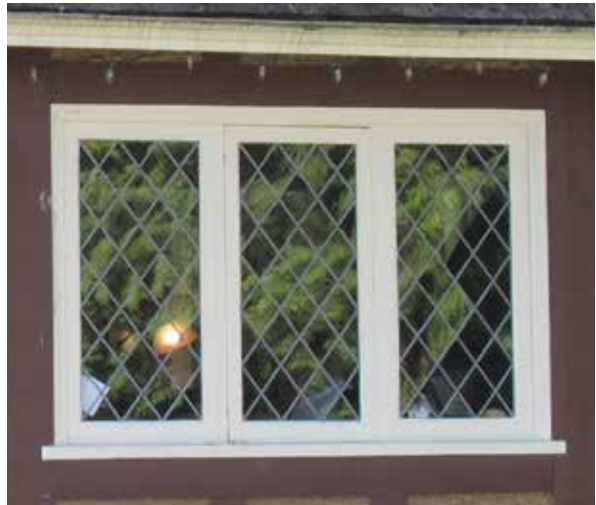
Typical condition of existing tripartite windows on the front facade to the north.

- Inspect for condition and complete detailed inventory to determine extent of recommended repair as required.
- Retain existing window sashes; repair as required; install replacement matching sashes where missing or beyond repair.
- Preserve and repair as required, using in kind repair techniques where feasible.
- Overhaul, tighten/reinforce joints. Repair frame, trim and counterbalances.
- Each window should be made weather tight by re-puttying and weather-stripping as necessary.

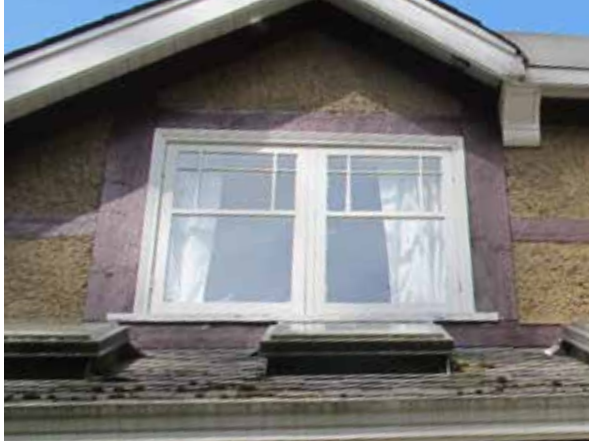
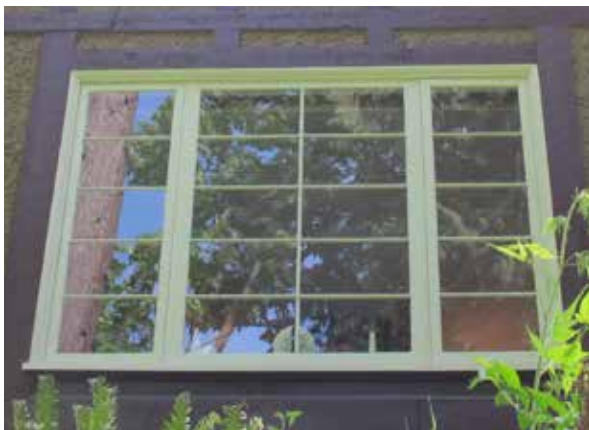
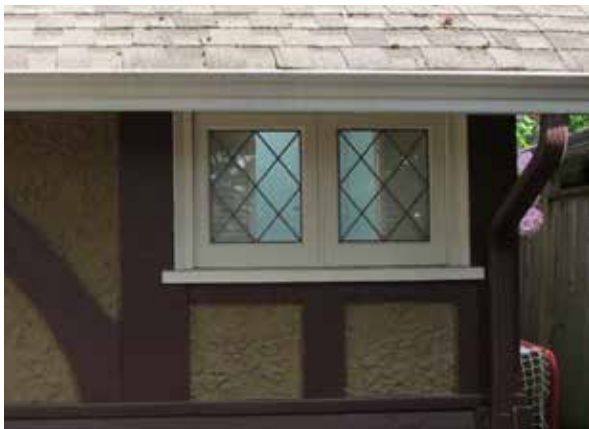
Photos showing typical condition of extant exterior wood windows in different configurations.

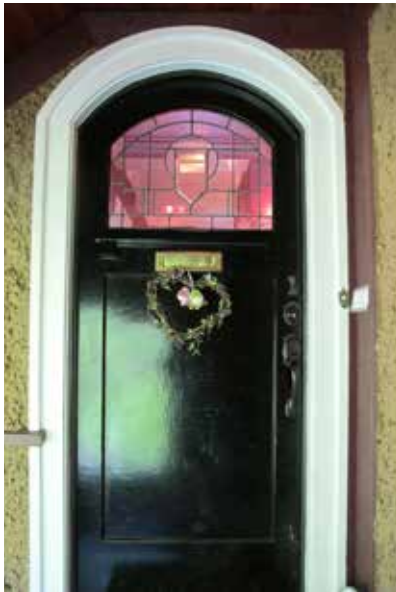
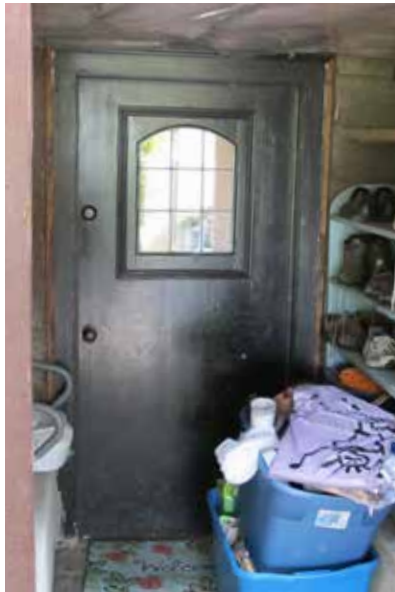
Generally, the exterior condition of the existing doors appear to be in good condition. The original arched wooden front door and associated features is a significant character-defining element, and should be preserved. The extant secondary wooden panelled doors are sympathetic to the historic character of the house, and should be retained in their original locations and restored as necessary.

Photos showing existing exterior wood doors in different configurations and locations: the original wooden front door at the west return of the front facade to the north (left); and south elevation (right). Note that all doors feature multi-pane leaded glass windows and true-divided lights.

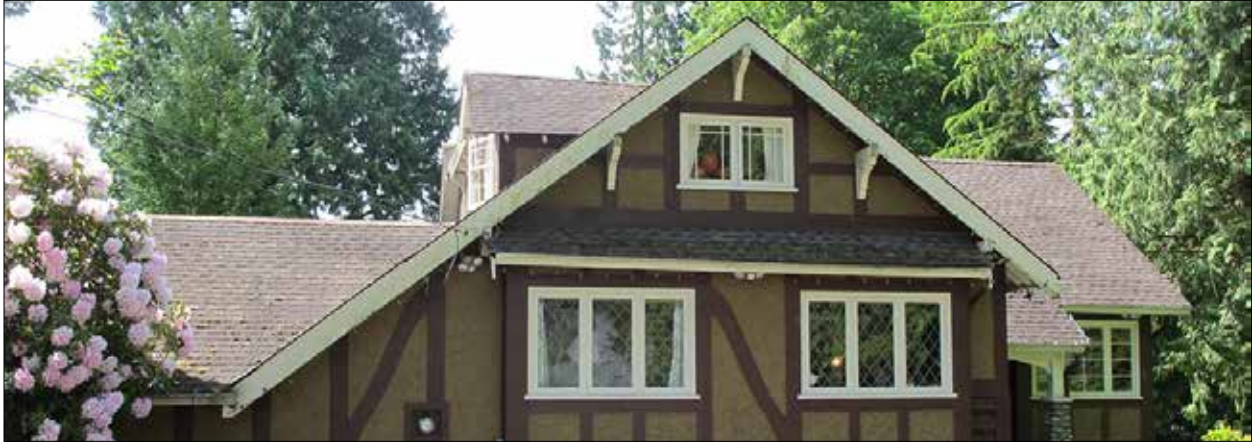
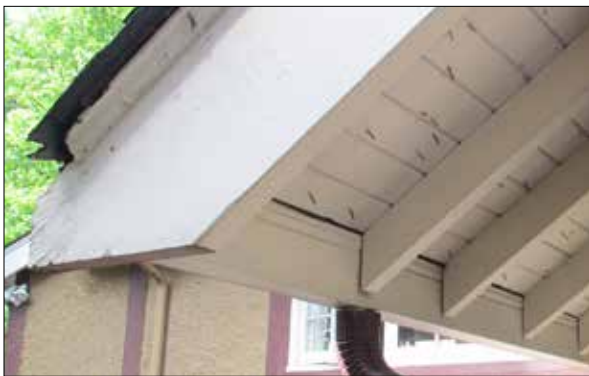
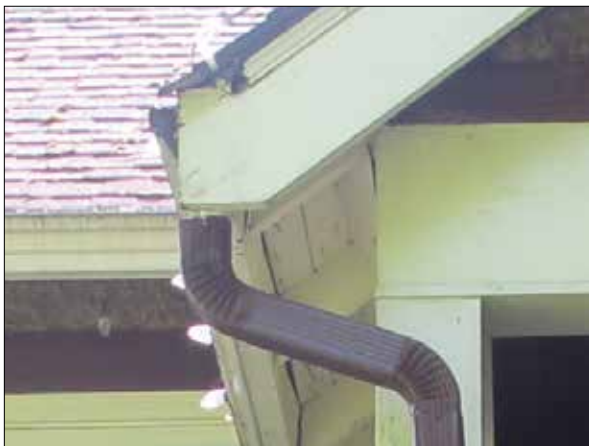
Cross-gabled roof structure of the Sutherland House (top); exposed roof rafters and nailing boards (middle); and typical condition of roof drainage (bottom)

- If required, roofing membrane and cladding system may be rehabilitated.
- Retain the original bargeboards and fascia boards, as well as the soffit any exposed roof elements.
- Design and install adequate rainwater disposal system and ensure proper drainage from the site is maintained. Wood gutters with galvanized steel downspouts are recommended.
- Paint all drainage system elements according to colour schedule devised by Heritage Consultant.

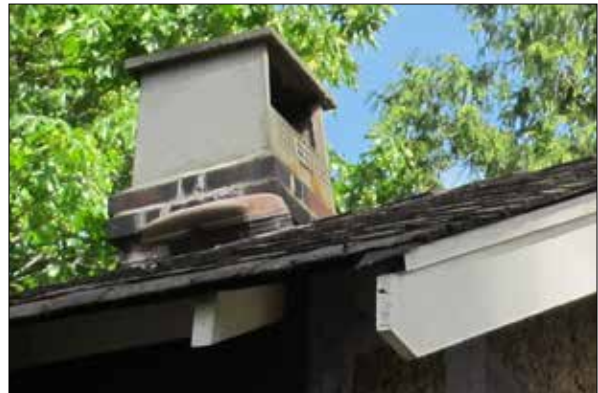
Existing rectangular chimneys: chimney with metal flashing above roof ridge of side-gable (top); and brick chimney with metal chimney cap above roof line to the south.

- Preserve the chimneys in their original configuration, if possible.
- Chimney may require structural stabilization.
- Investigate condition of brickwork. If required, brickwork may be repointed and cleaned using a natural bristle brush and mild rinse detergent.

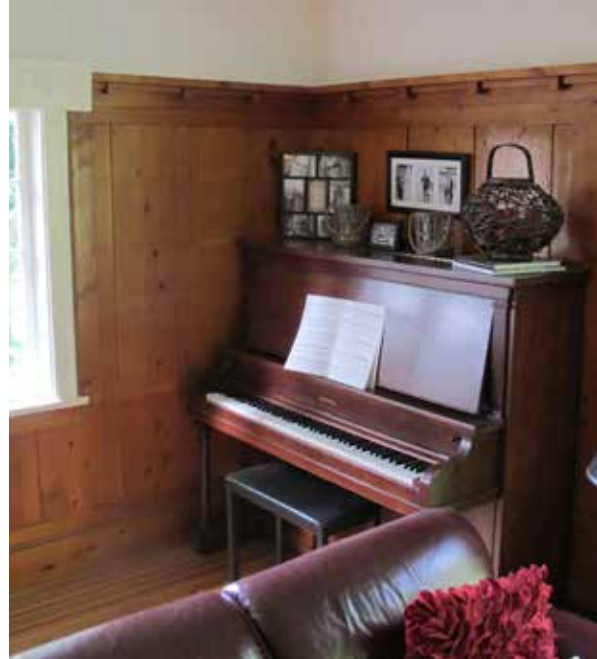
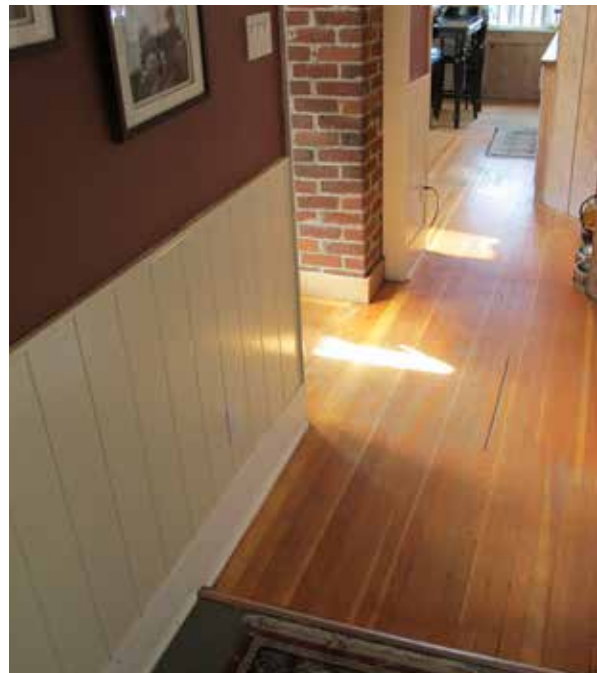
Photos showing typical condition of original interior wall finishes.

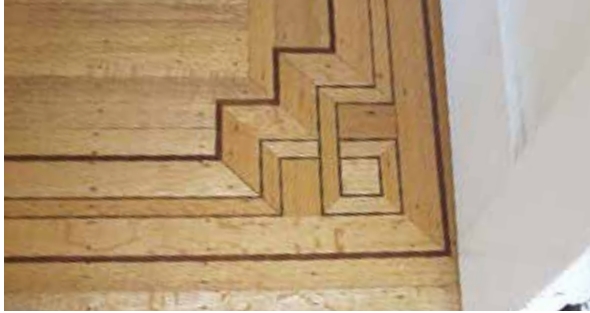
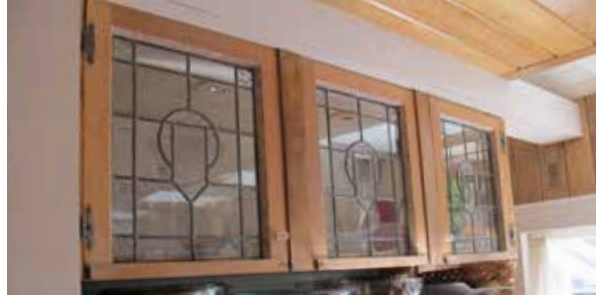
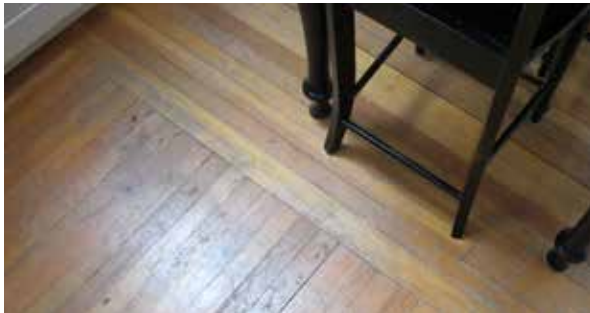
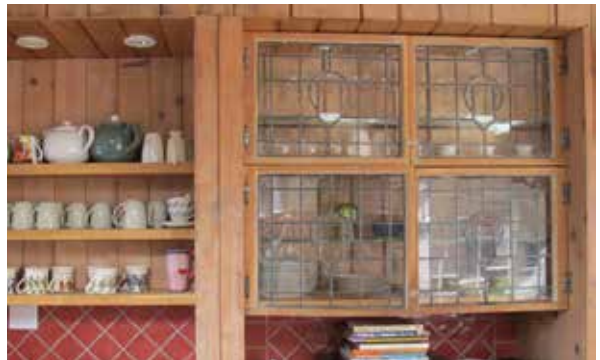
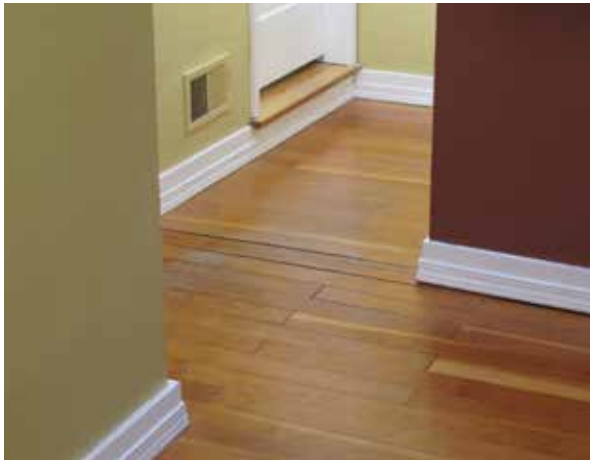
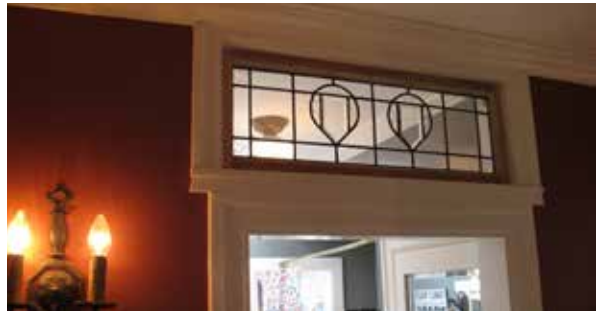
The Sutherland House features extant, original hardwood oak floors, with some areas elaborately detailed with corner and trim inlay. They appear to be in good condition. These are character-defining elements of the historic house, and should be preserved, as possible.

Photos showing typical condition of original hardwood floor in different areas of the historic house.

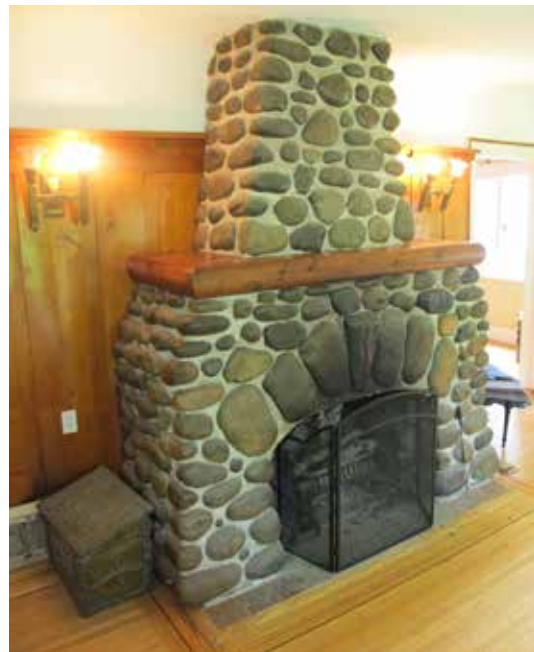
Photos showing existing original stone fireplace in the living room (top).

- Preserve the stone fireplace, and repair as necessary.
- If cleaning is necessary, do not use any abrasive methods that may damage the fireskin surfaces. Only approved chemical restoration cleaners may be used. Sandblasting or any other abrasive cleaning method of any kind is not permitted.
