## ARBORIST REPORT

DATE: 2021-09-01

PROJECT:	<b>Inglewood Campus of Care</b>
MUNICIPAL PROJECT#	N/A
VDZ PROJECT#	DP2020-43
SITE ADDRESS:	725 Inglewood Avenue; 721-735 Burley Drive West Vancouver
PREPARED FOR:	<b>ZGF Architects</b> #350 - 355 Burrard Street, Vancouver, BC V6C 2G8
SITE REVIEW DATE(S):	October 2020 - January 2021
PROJECT ARBORIST:	Kyle MacGregor  ISA Certified Arborist PN9111-A, TRAQ Wildlife Dangerous Tree Assessor P2769

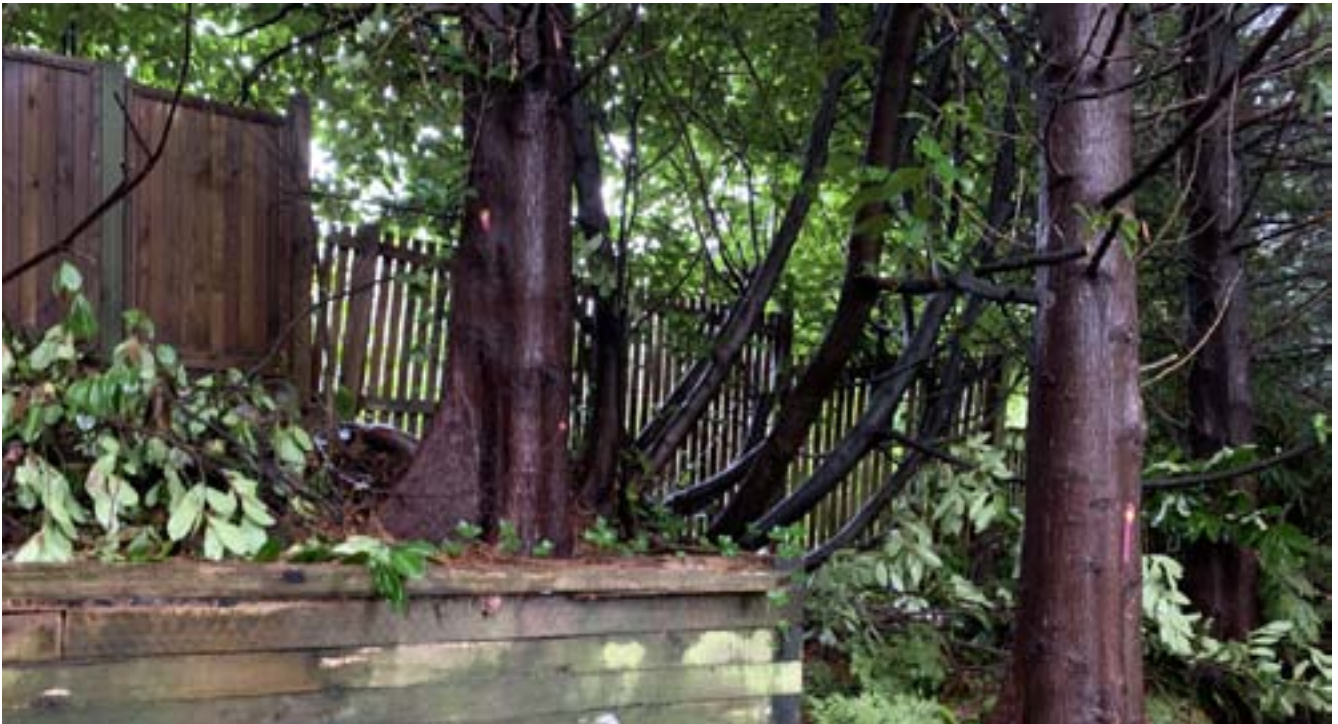
**FIG 31** - Tree retention area NW Corner - subject to review of final grading plan.

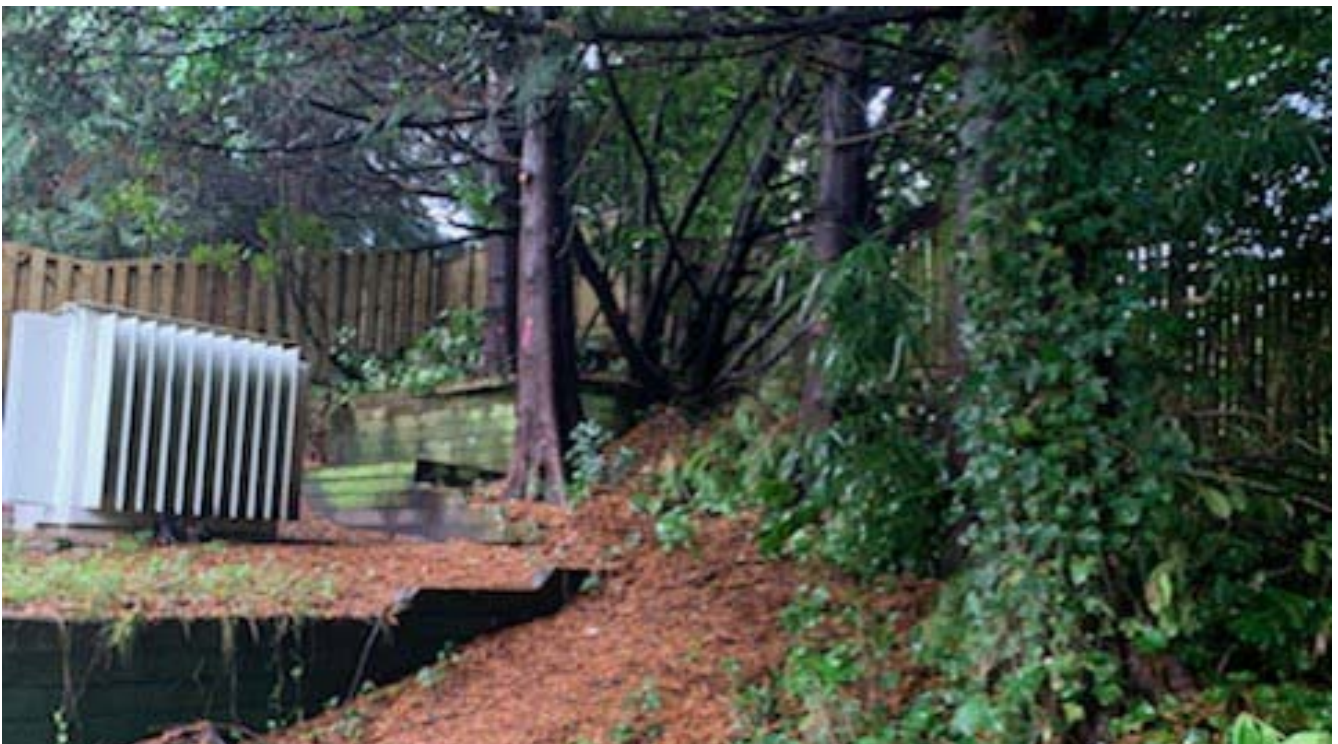
**FIG 32** - Tree retention area, NW Corner. Subject to review of final grading plan.

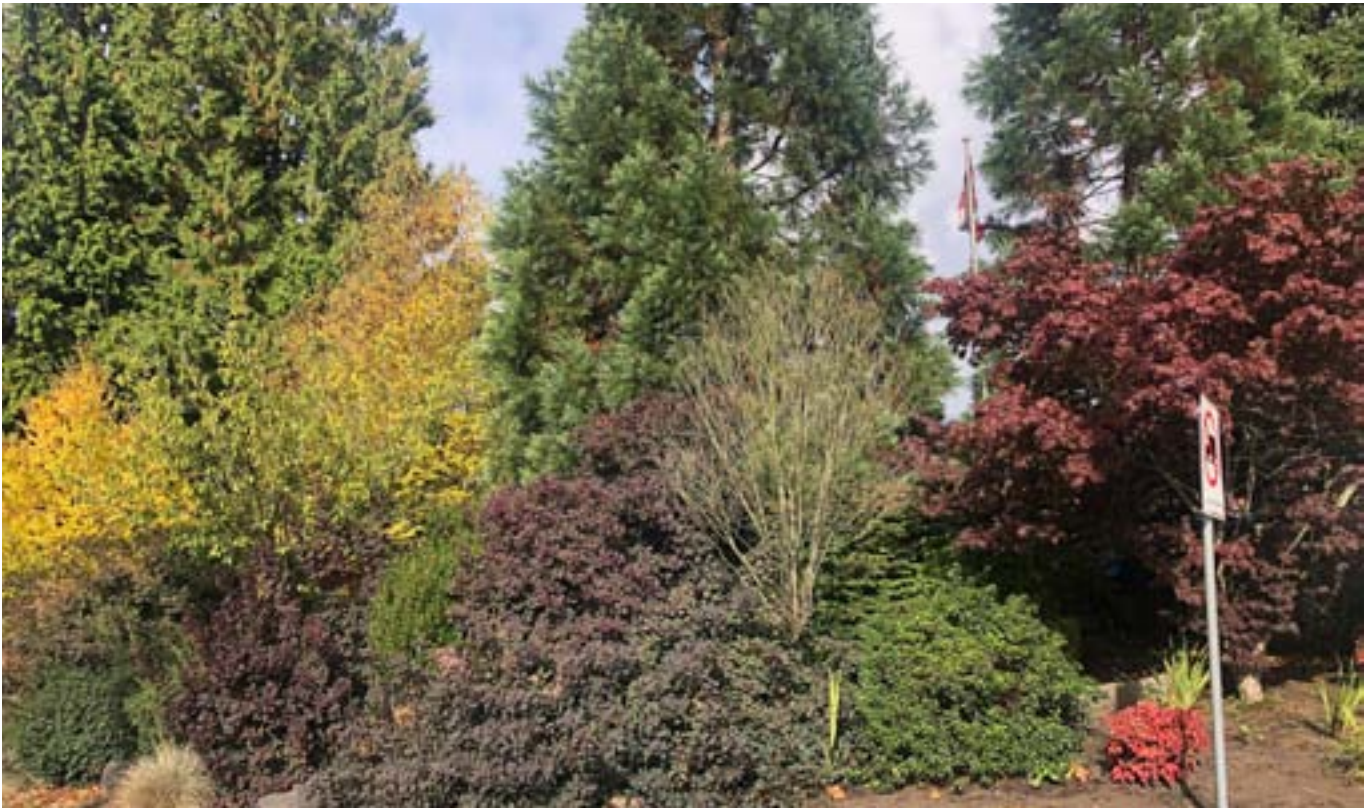
**FIG 33** - C1-C4, #1-4 C4 to be transplanted to accomodate future road alignment Location TBC with Landscape.

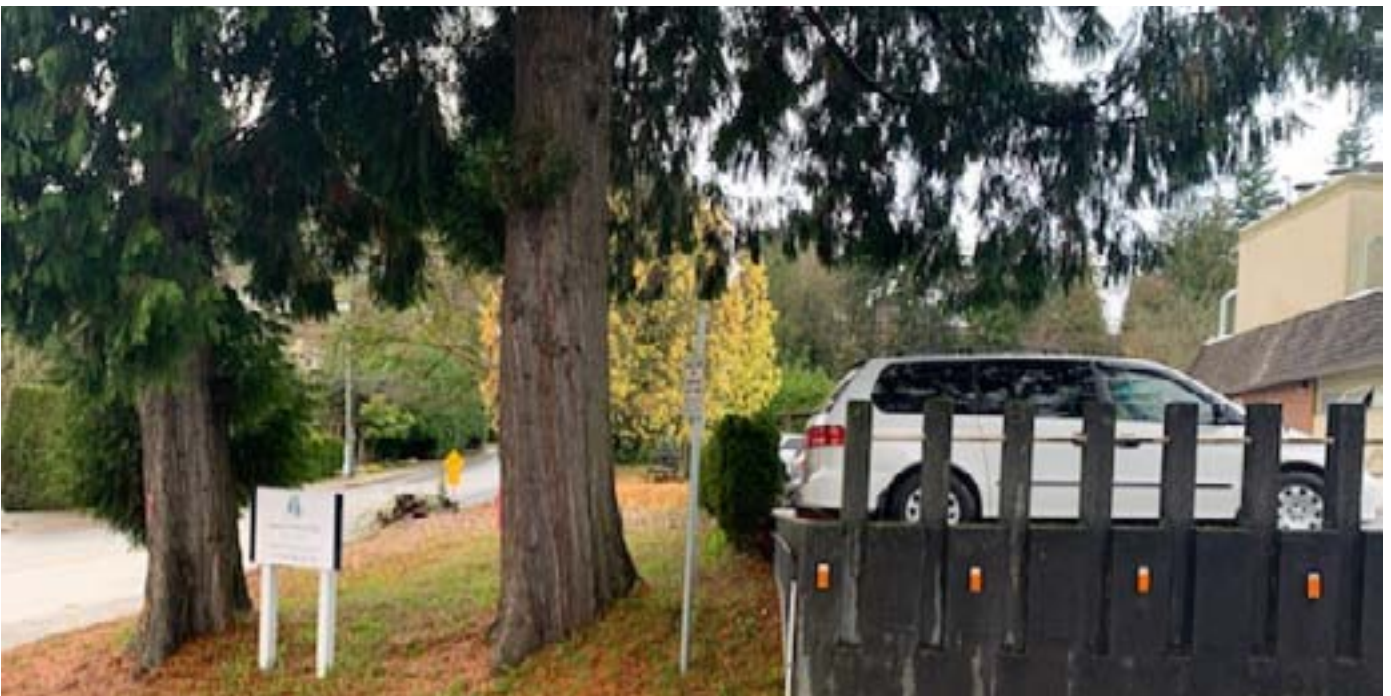
005	Western redcedar <i>Thuja plicata</i>	75	5.8	70	<p>FAIR</p> <p>TRUNK – Flat on the southeast side. Pockets of resin surrounding trunk.</p> <p>ROOTS - Probably that roots have developed under the asphalt is low.</p>	<p>Retain</p> <p><b>Subject to:</b></p> <p><b>Retention of existing retaining wall, or partial removal (cut to grade).</b></p> <p><b>Minimal clearance pruning is required.</b></p>	Yes - See TMP
006	Western redcedar <i>Thuja plicata</i>	93	5.8	70	<p>FAIR</p> <p>TRUNK – Pockets of resin surrounding trunk. Previously tagged 31. Requires Parkade Adjustments and above grade pruning from building conflicts.</p> <p>ROOTS - Probably that roots have developed under the asphalt is low.</p>	<p>Retain</p> <p><b>Subject to:</b></p> <p><b>Retention of existing retaining wall, or partial removal (cut to grade).</b></p> <p><b>Minimal clearance pruning is required.</b></p>	Yes - See TMP
007	Sweetgum <i>Liquidambar styraciflua</i>	21	3.1	80	<p>GOOD</p> <p>TRUNK – Superficial frost cracking.</p>	Retain	Yes - See TMP

**FIG 34** - Western Red Cedars 005 + 006 to be retained.

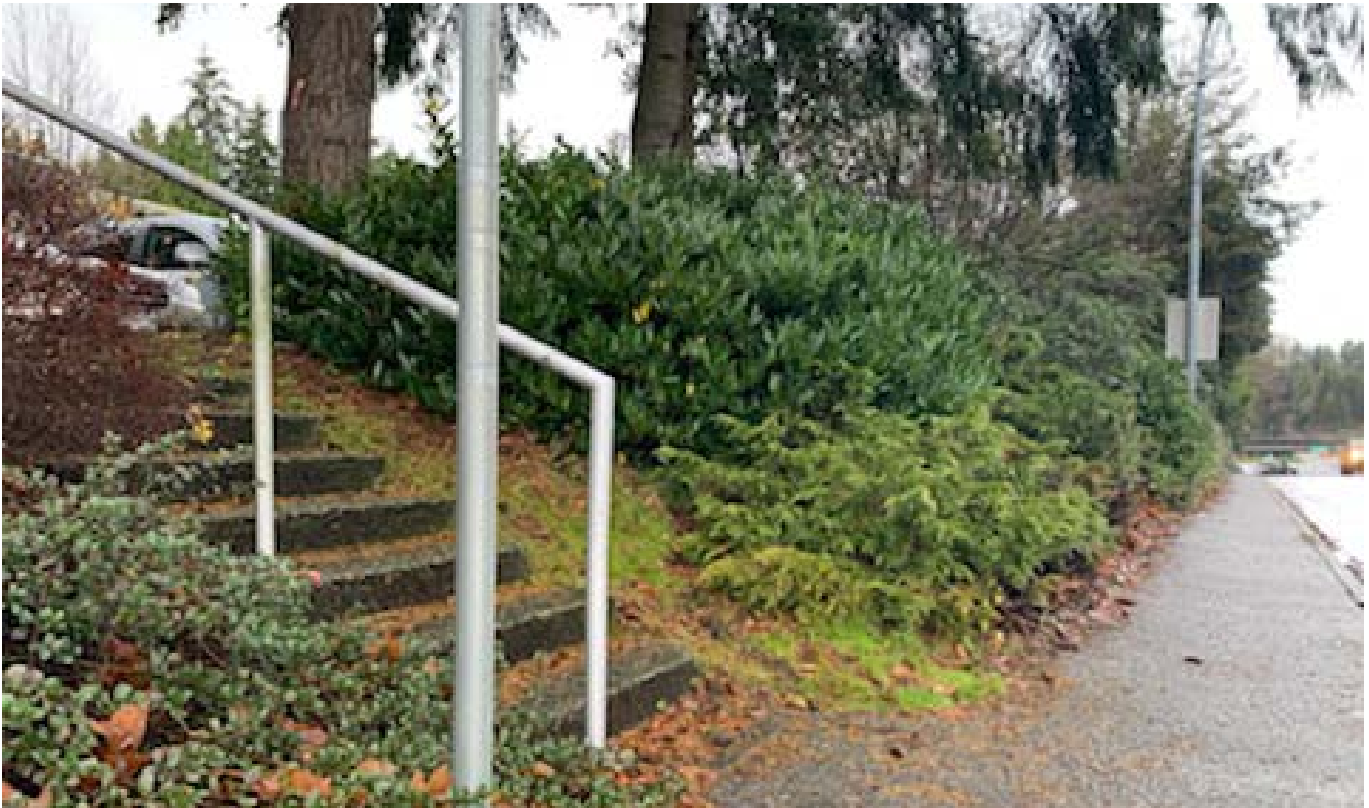
015	Douglas fir <i>Pseudotsuga menziesii</i>	52	5.4	70	<p>GOOD</p> <p>CROWN – Pruning for parking clearance.</p> <p>ROOTS - Structural roots reaching north into the CRZ of 16, and south under the asphalt pathway and staircase.</p> <p>TRUNK - Resonosis around trunk, likely due to previous improper pruning cuts.</p>	<p>Remove</p> <p>Conflicts with parkade and future grading.</p> <p>Root zone is predominately located beneath existing asphalt and bordered by concrete staircase.</p>
016	Douglas fir <i>Pseudotsuga menziesii</i>	65	6.9	70	<p>POOR</p> <p>TRUNK – Co-dominant at 5 m, equally weighted. Crotch union with included bark from 0.5 m to union.</p> <p><b>HAZARD TREE RATING BEFORE CONSTRUCTION RISK IS CALCULATED - If failure was to occur, the tree would split and likely cause severe damage.</b></p>	<p>Remove</p>
017	Common sourwood <i>Oxydendrum arboreum</i>	24 25	4.1	80	<p>FAIR</p> <p>TRUNK – Co-dominant at 0.5 m. English ivy at base.</p> <p>Previously tagged 030</p>	<p>Remove</p>

FIG 33 - Tree #15 to be removed to accomodate future parkade excavation and grading changes.

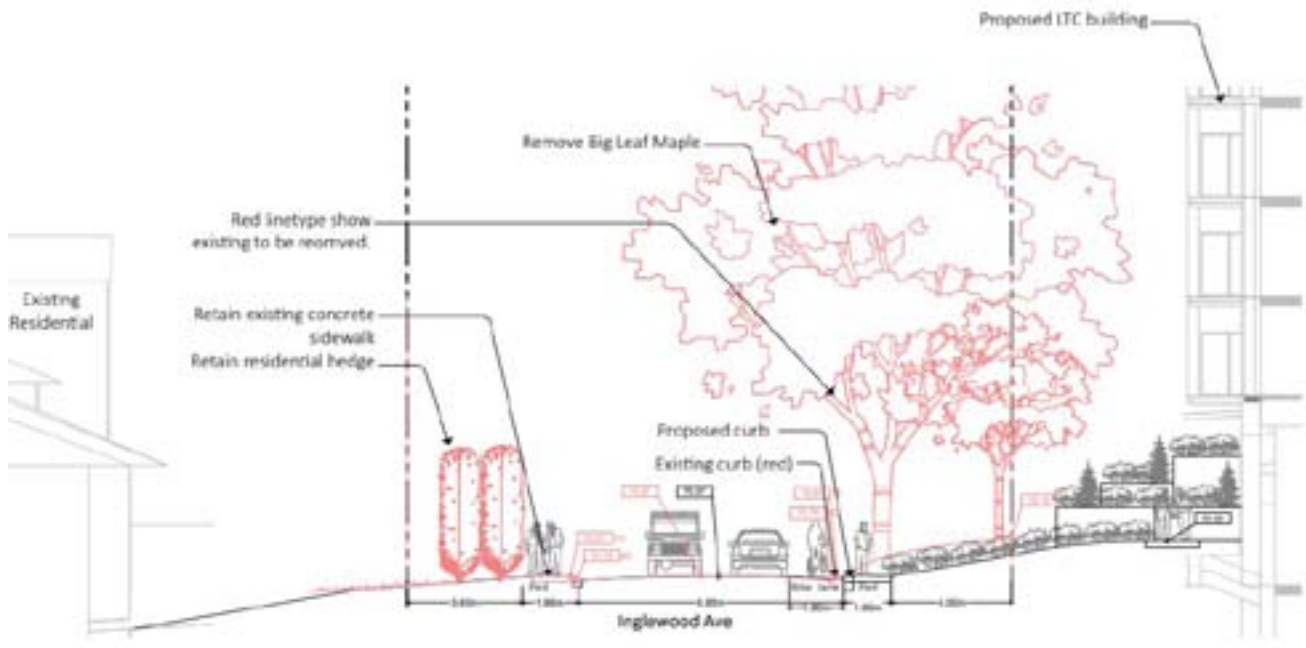
The retention of tree C5, a mature Big Leaf Maple was subject to supporting plans from civil, landscape and architecture which would consider future road and sidewalk alignment as well the long term health of this tree. Several designs were proposed and reviewed extensively in meetings and onsite. Unfortunately due to various constraints, particularly grading and the location of the tree - we concluded that it is not possible to retain. The tree developed next to existing curb and so does not allow for sidewalk routing to the South of the tree. Alternatively, the steep grades to the North prevents sidewalk routing behind. (Fig.34)

FIG 34 - Landscape section illustrating constraints influencing removal of Big Leaf Maple C5
