RUSH HOUSE

1195 12TH STREET, WEST VANCOUVER, BC

CONSERVATION PLAN

APRIL 2017

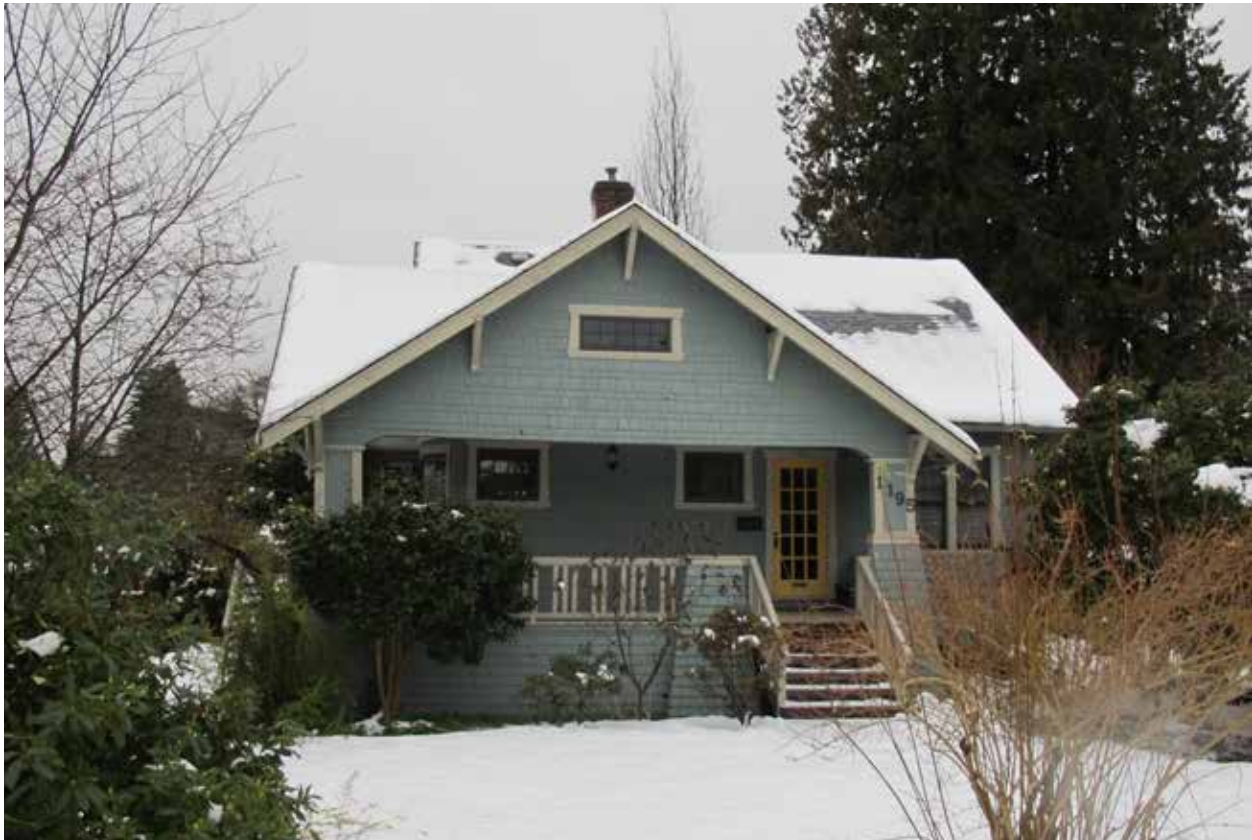
Historic front facade of the Rush House along 12th Street.

- Preserve the overall form, scale and massing of the building.
- The historic street façades along Jefferson Avenue & 12th Street should be retained.

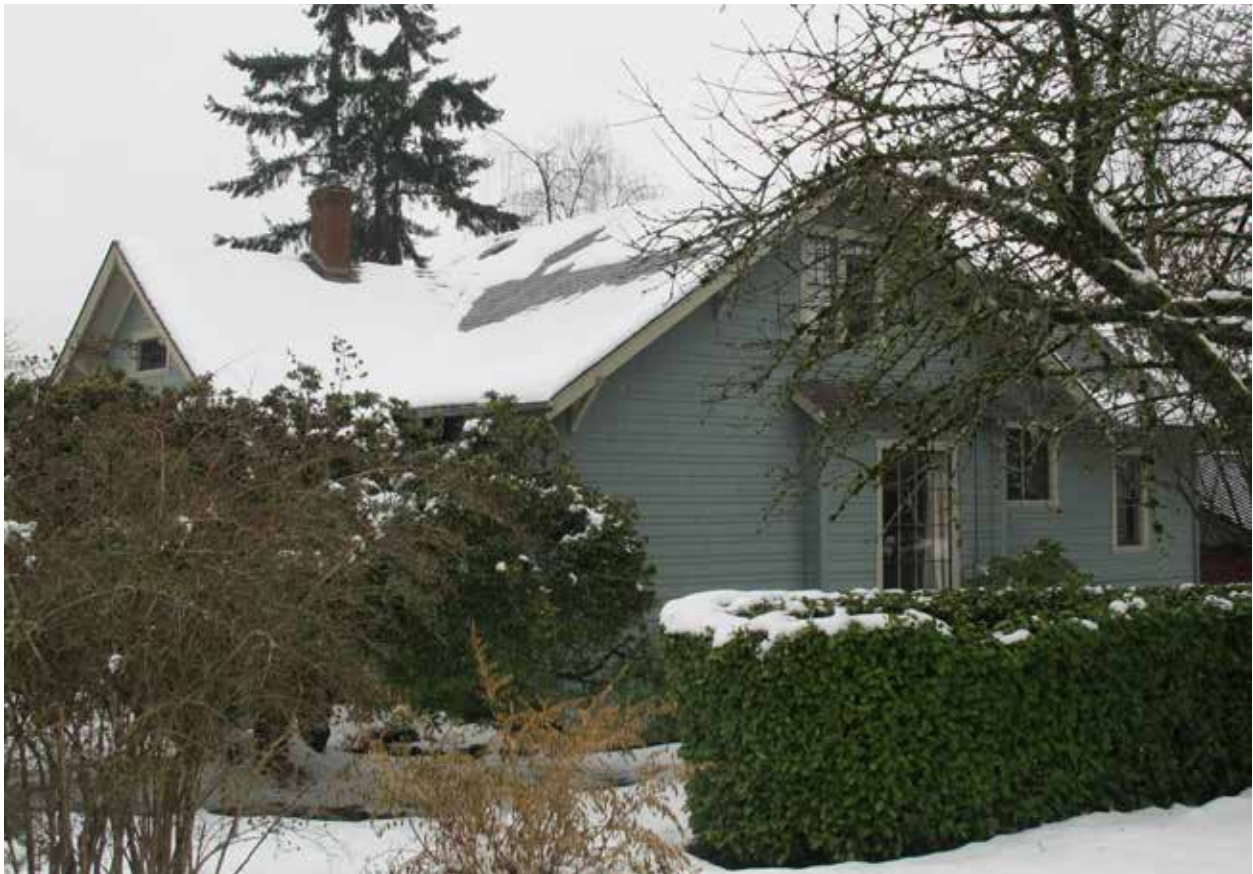
side elevation of the Rush House, at corner of 12th Street and Jefferson Avenue.

- As new foundations are proposed, concrete is a suitable material. New material should match original in appearance, as viewed from the exterior.
- Foundations should be reviewed by a Structural Engineer. Once condition is assessed, conservation recommendations can be finalized.
- To ensure the prolonged preservation of the new foundations, all landscaping should be separated from the foundations at grade by a course of gravel or decorative stones, which help prevent splash back and assist drainage. New vegetation may assist in concealing the newly exposed foundations, if desired.

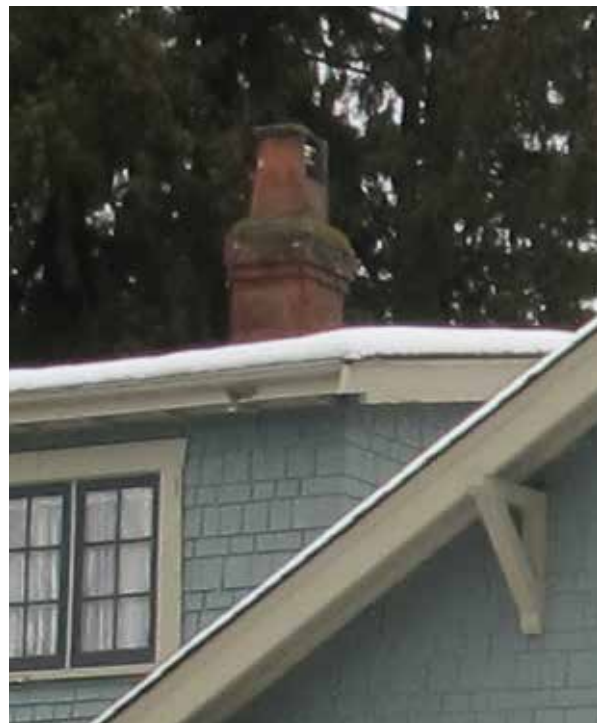
The Rush House features two, original, interior brick chimneys that appear to be in fair condition based on visual review from the ground level. The brick masonry units of both chimneys above the roofline show varying degrees of deterioration, as evident by discolouration, bird deposit staining, biological growth, and deteriorated or missing mortar joints. The surviving, original brick masonry chimneys are character-defining elements of the heritage asset, and should be preserved, and repaired as necessary.

Interior brick chimneys of the Rush House.

- Preserve the chimneys in their original configuration, if possible.
- Chimneys may require structural stabilization.
- Investigate condition of brickwork. If required, brickwork may be repointed and cleaned using a natural bristle brush and mild rinse detergent.

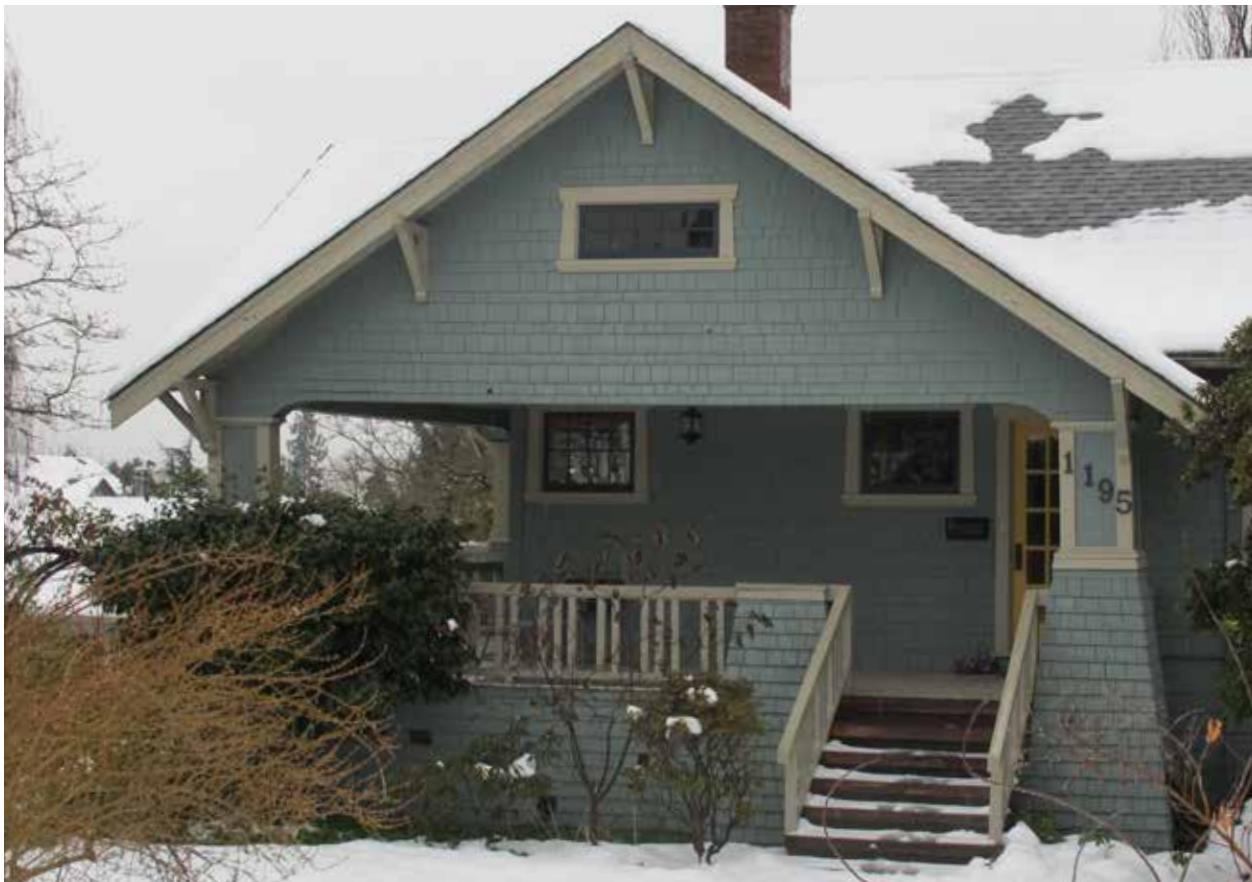
Wrap-around verandah of the Rush House, facing 12th Street.

- Original lower height of the balustrade should be restored, with alternate compliance methods utilized to achieve the required 42" height.
- Top of restored wood balustrade should be 24".
- New possible alternative materials may be glass panels, metal pipe rails or a combination of both.

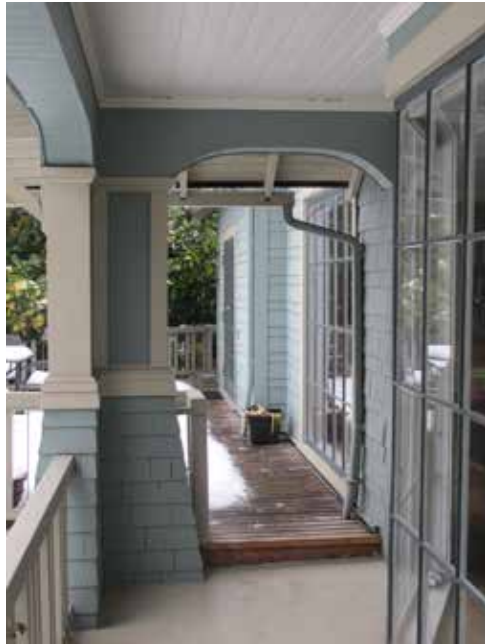
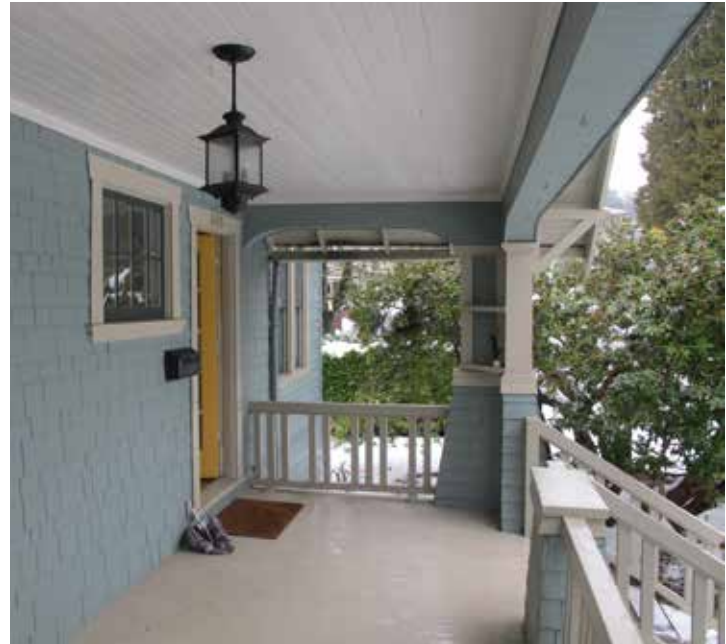
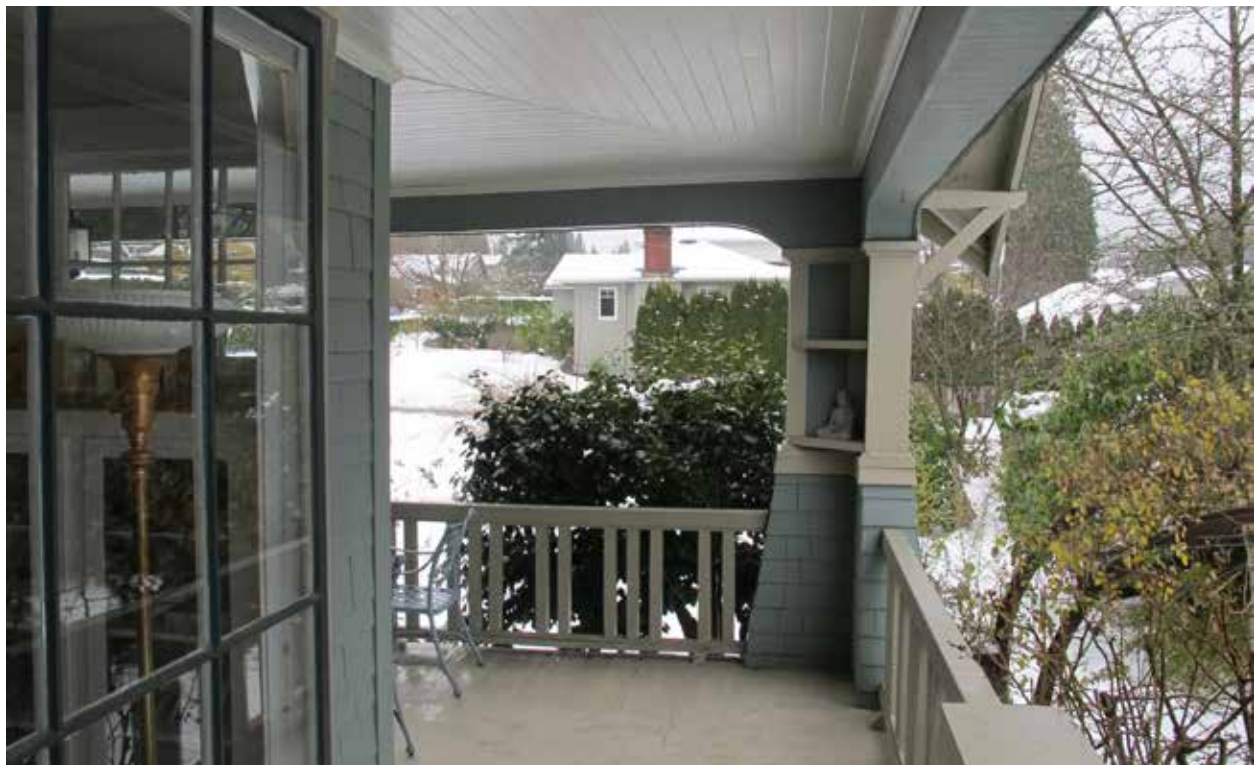
Photos showing existing condition of wrap-around verandah. Note the later porch-deck extension to the verandah (top, left)

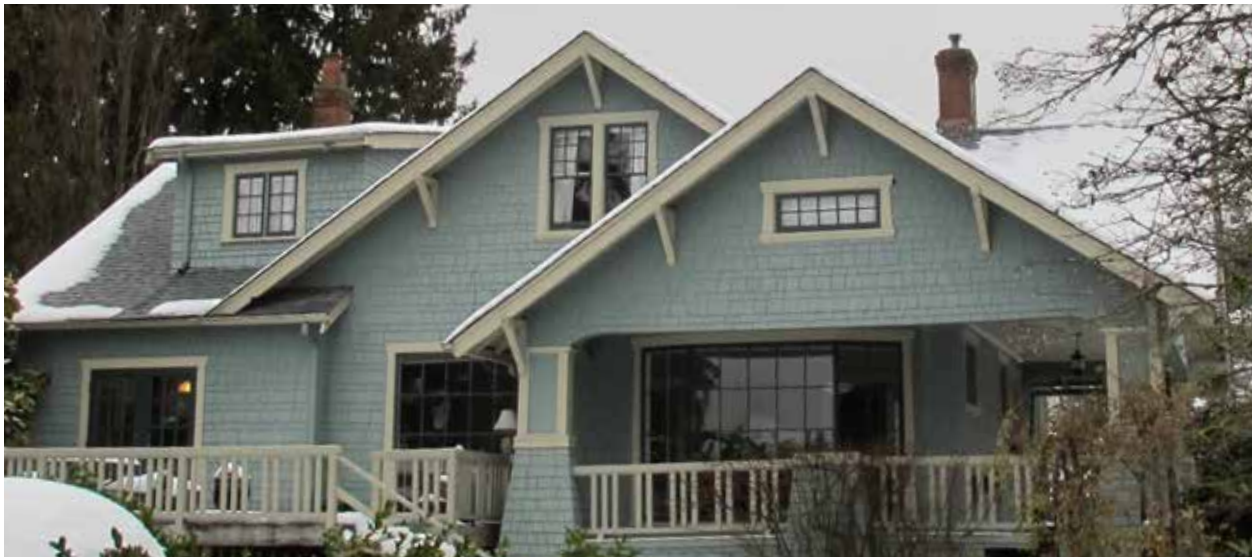
The Rush House features surviving, original wood windows, including a number of multi-pane casement and multi-pane double-hung assemblies with true-divided lights. Based on initial visual review of the original wood window assemblies, the window sashes appear to be operable and in good, repairable condition.

Photos showing original windows of the Rush House.

All surviving original wood window assemblies should be preserved, and repaired in place as possible, while any unsympathetic replacement window assemblies should be removed as necessary, and restored with historically accurate window assemblies.

- Inspect for condition and complete detailed inventory to determine extent of recommended repair or replacement.
- Retain existing window sashes; repair as required; install replacement matching sashes where missing or beyond repair.

- Preserve and repair as required, using in kind repair techniques where feasible.
- Overhaul, tighten/reinforce joints. Repair frame, trim and counterbalances.

- Each window should be made weather tight by re-puttying and weather-stripping as necessary.
- Retain historic glass, where possible. Where broken glass exists in historic wood-sash windows, the broken glass should be replaced. When removing broken glass, the exterior putty should be carefully chipped off with a chisel and the glazier's points should be removed. The wood where the new glass will be rested on should be scraped and cleaned well, and given a coat of linseed oil to prevent the wood from absorbing the oil from the new putty. The new glass should be cut 1/16-1/8th smaller than the opening to allow for expansion and irregularities in the opening, to ensure the glazing does not crack due to natural forces. Window repairs should be undertaken by a contractor skilled in heritage restoration.

- Replacement glass to be single glazing, and visually and physically compatible with existing.
- Prime and repaint as required in appropriate colour, based on colour schedule devised by Heritage Consultant.

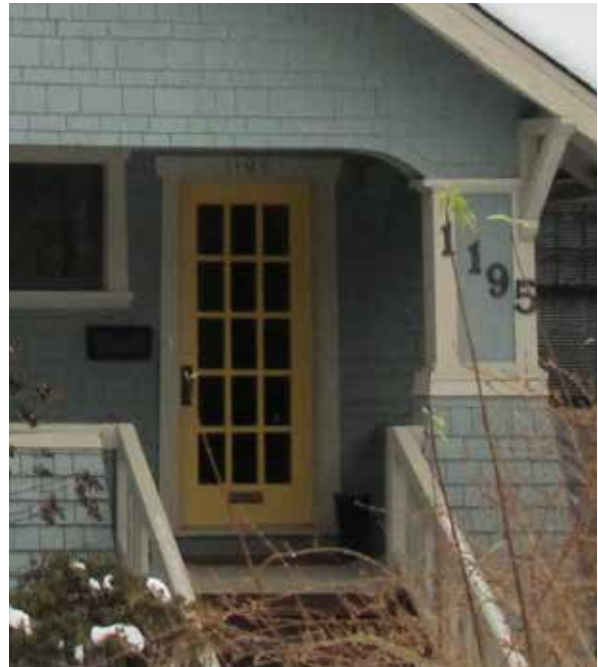
The Rush House features original door openings, and surviving, original wood door assemblies that are finished with paint in unsympathetic colour, and also includes wood surround trim. The original doors and trims are important character-defining elements of the heritage asset. In general, the existing doors appear to be in good condition, with minor evidences of deterioration.

Main entrance door of the Rush House.

All surviving original doors should be preserved and repaired, as required, while all unsympathetic replacement doors should be removed and restored with historically accurate wood doors.

- Retain the door openings in their original locations, and preserve and repair all original door.
- New doors should be visually compatible with the historic character of the building.
