ROOT MAPPING REPORT

Date: **November 20, 2019** Rev 0: **ACL File: 19214**
 Attn: **Katie Hlynsky** Prepared by: **Norman Hol**
Hlynsky Architects Principal and Senior Consultant
 2439 Bellevue Avenue
 West Vancouver, BC V7V 1E1
 Project: **BP Application for a Single-Family Home**
4358 Ross Crescent
 Re: **Aerial inspection and Detailed Decay Testing**

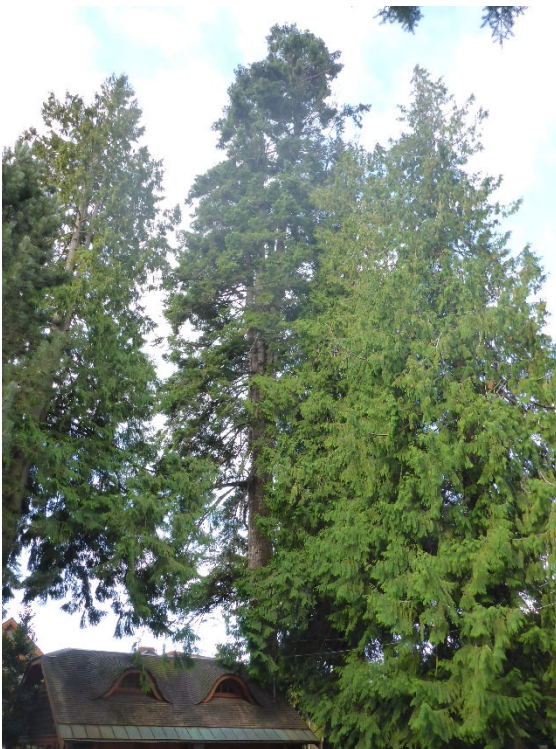
Photo 1. Subject tree is the central one in this photo.

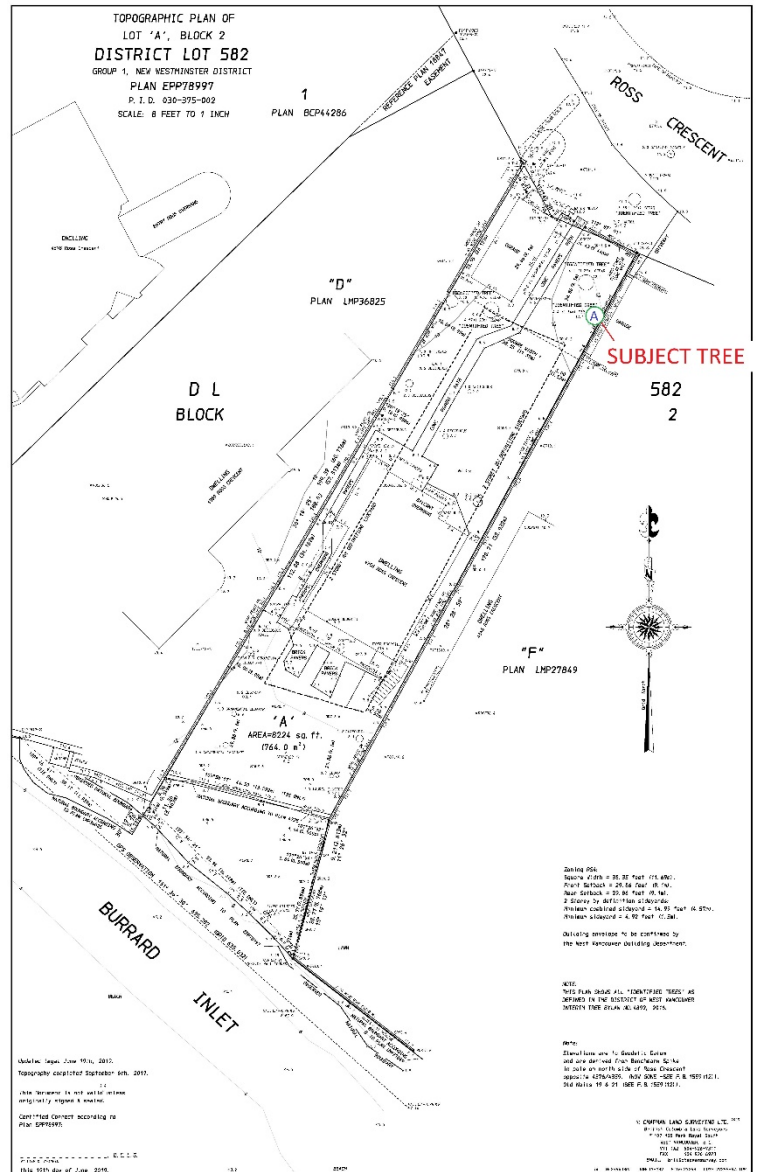
Figure 1. Location of the subject tree and the current topographic conditions.

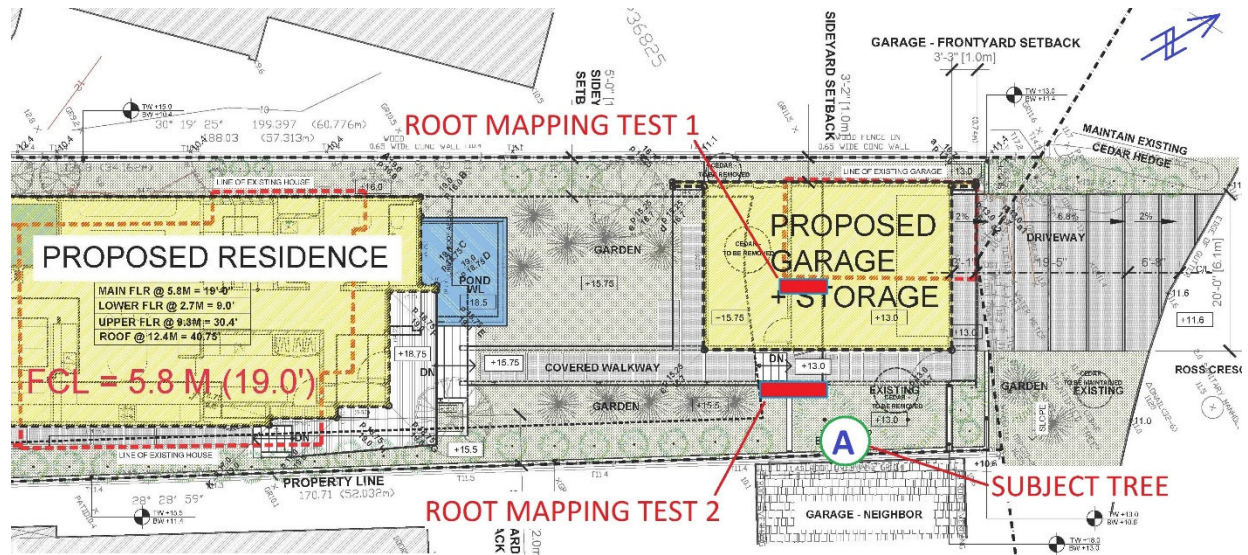
Figure 2. Root mapping locations relative to the tree and the proposed garage design.

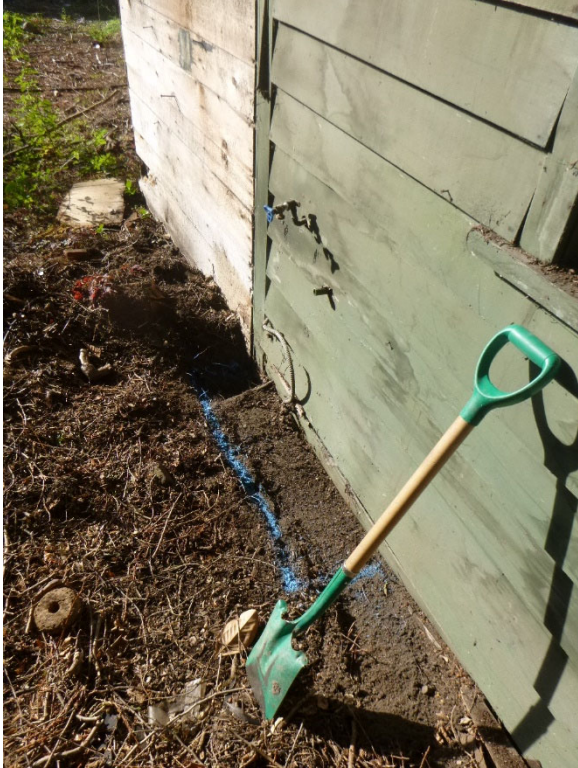
Test 1	Adjacent to SE Corner of Existing Garage
<p>Photo 2. Location of test before excavating to 70 cm depth.</p>

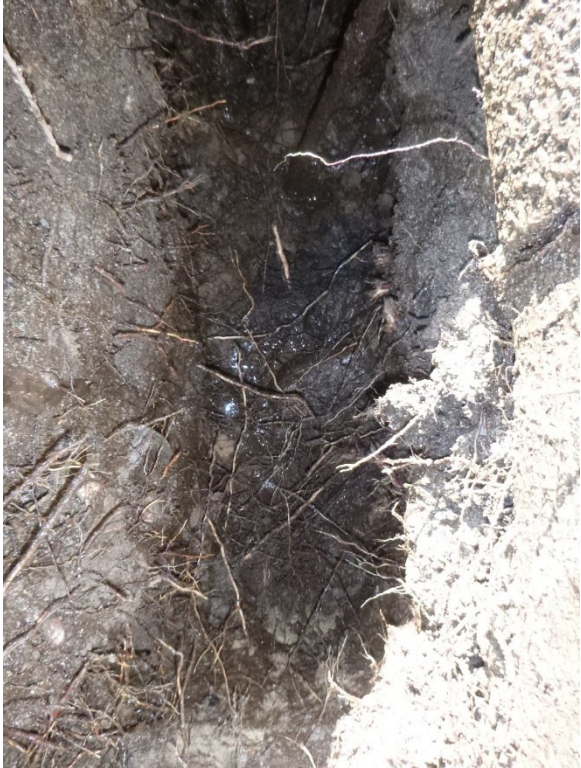
<p>Photo 3. Observed minimal fine cedar roots only.</p>

<p>Test 1 Findings:</p> <ul style="list-style-type: none"> • This area of the site is populated only by sparse cedar roots. • No grand fir roots were observed in this test location. • Soil conditions were highly compacted at the 70 cm depth and unlikely to be sufficiently fertile and aerable to allow tree roots to have developed within that soil strata.

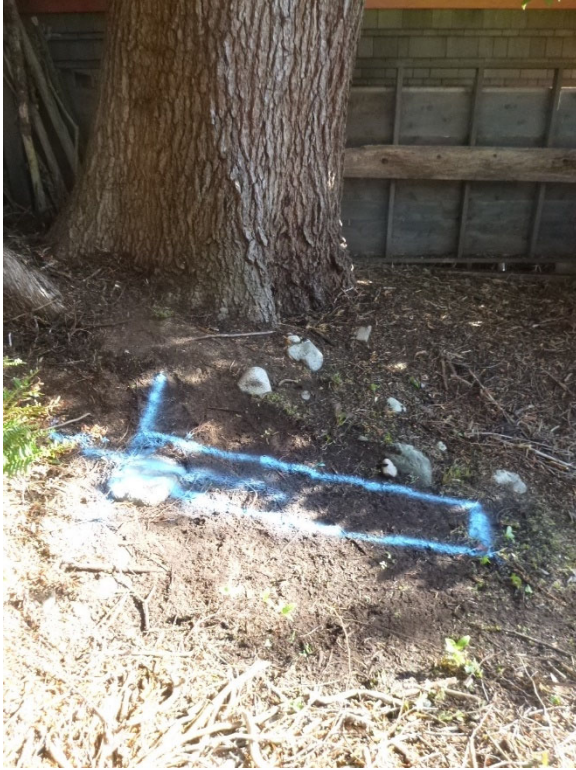
Photo 4. Location of test before excavating to 35 cm depth.

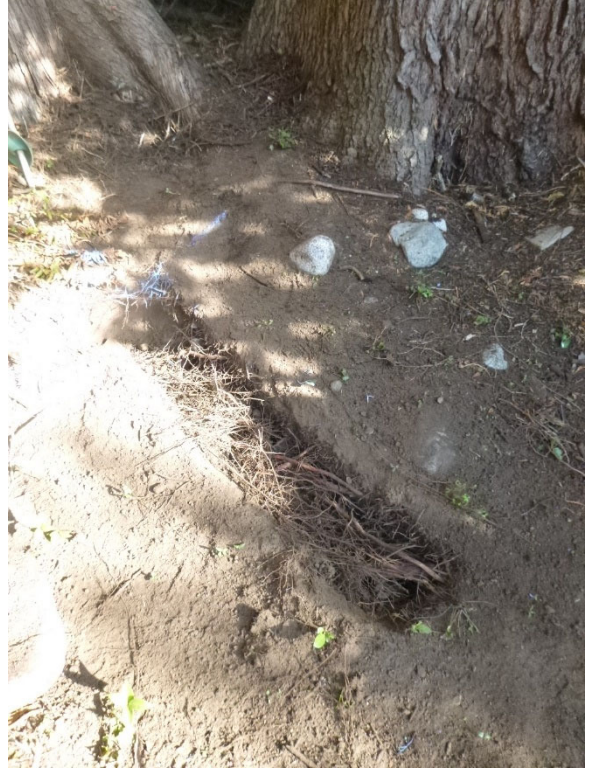
Photo 5. Observed dense fine cedar roots and sparse fir roots.

- This area of the site is populated only by fine cedar roots and sparse small diameter woody roots from the grand fir.
- No significant woody roots and no buttress roots from the grand fir were observed in this test location, despite the close proximity to the tree. Also, indicators at the root crown (see photos 5 and 7) lead us to expect buttress roots to be present in the test pit, but no grand fir buttress roots were found.

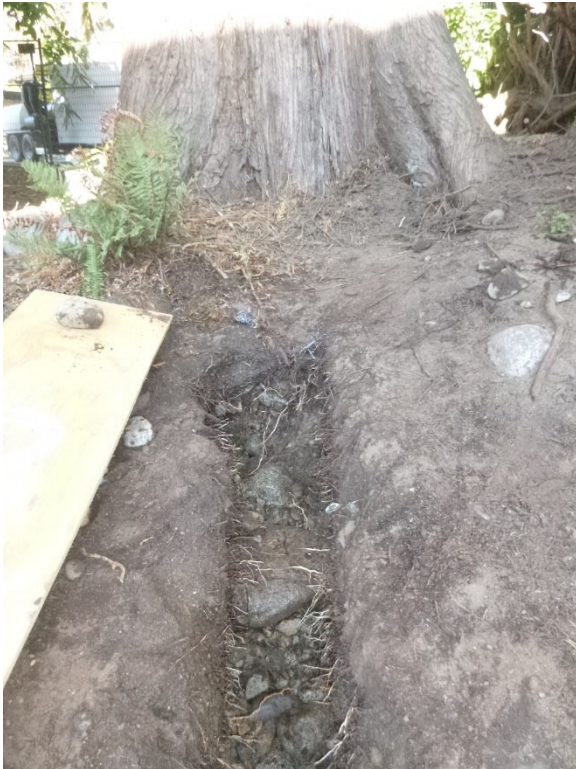
Photo 6. Test pit with cedar tree in background.

- Soil conditions in the upper 30 cm depth of this test pit consisted of organic overburden. Below that depth we encountered boulders and rocks with a distinct absence of organic soil. We expect that this condition extends below this depth but we are not able to excavate any lower with the method and machinery used for this root mapping investigation. We can only conclude that the root system of this grand fir tree has developed in a deeper soil strata at an unknown depth.

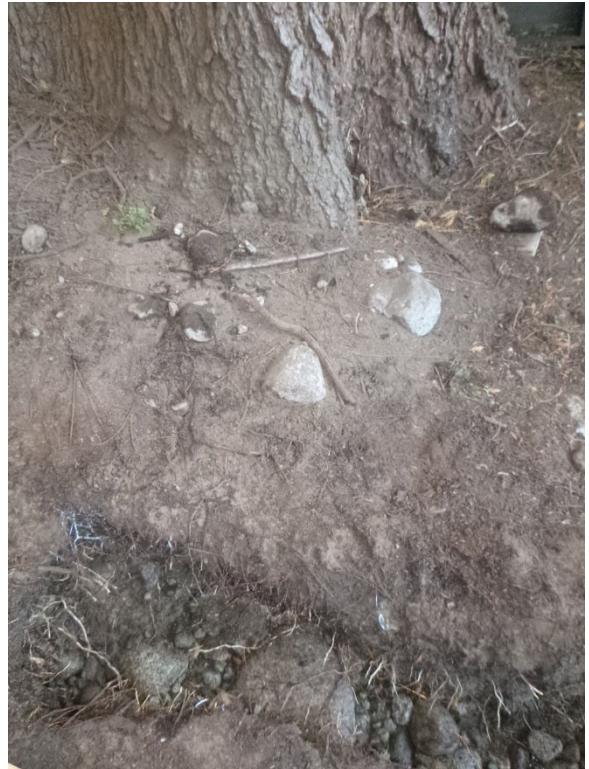
Photo 7. Test pit with grand fir tree in background.
