RADIX TREE & LANDSCAPE CONSULTING

TREE ASSESSMENT REPORT

825 Taylor Way & 707 Keith Rd, WV

RE: Arborist Report for trees at 825 Taylor Way & 707 Keith Road, WV

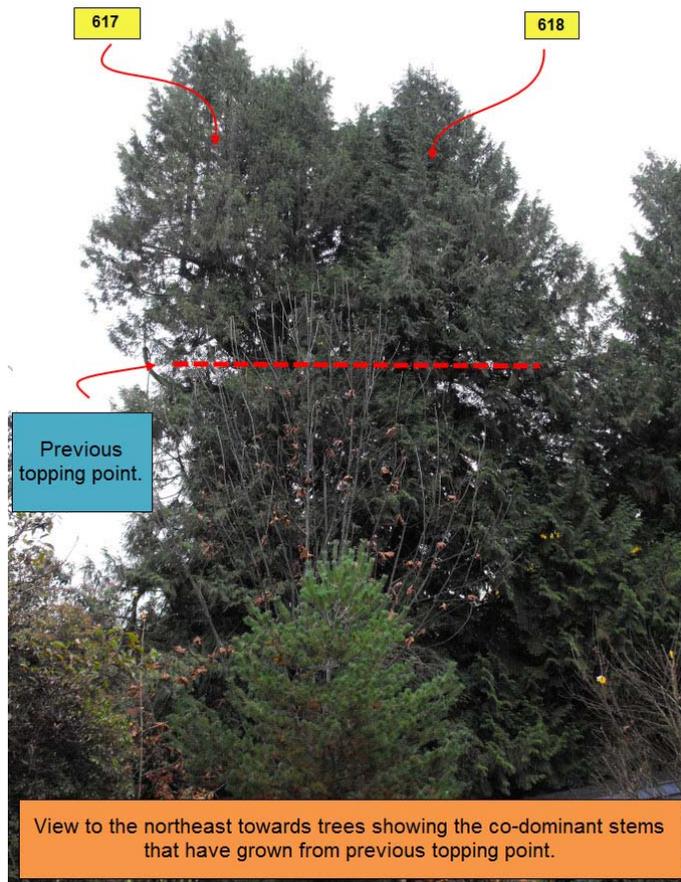
The majority of these trees are located with the property boundaries of 825 Taylor Way and almost all of them have been previously topped at some point in past. This can occur by natural means (breakage by snow load or a bird sitting on a terminal branch) or by mechanical means (cutting the top off which is an antiquated practice) which is more likely the case on this site. The multiple stems that result from the topping generally have weak attachments and are more susceptible to failure at these attachment points. Consequently, trees that are previously topped generally have a high probability of decay within the tree. This also contributes to the high probability of stem failure if the canopy or top of the tree far outweighs what the lower decayed stems can bear. As the trees grow and the shoots increase in weight, the branches of a topped tree become susceptible to breaking off during storms, heavy winds, snow or precipitation loads.

Picture 2. Previous topping

12. Conducting pruning to remove any dead or damaged scaffold branches, to re-top and shape any previously topped trees, and to remove any dead tree tops is recommended. This or any safety pruning is recommended to be completed prior to the construction activities commencing. Conducting an aerial inspection to visually assess and inspect the crowns and the previous topping points, noting or reporting any defects or concerns is recommended to be conducted at the same time. This work is to be conducted by or under the direct supervision/instruction of a qualified Certified Arborist.

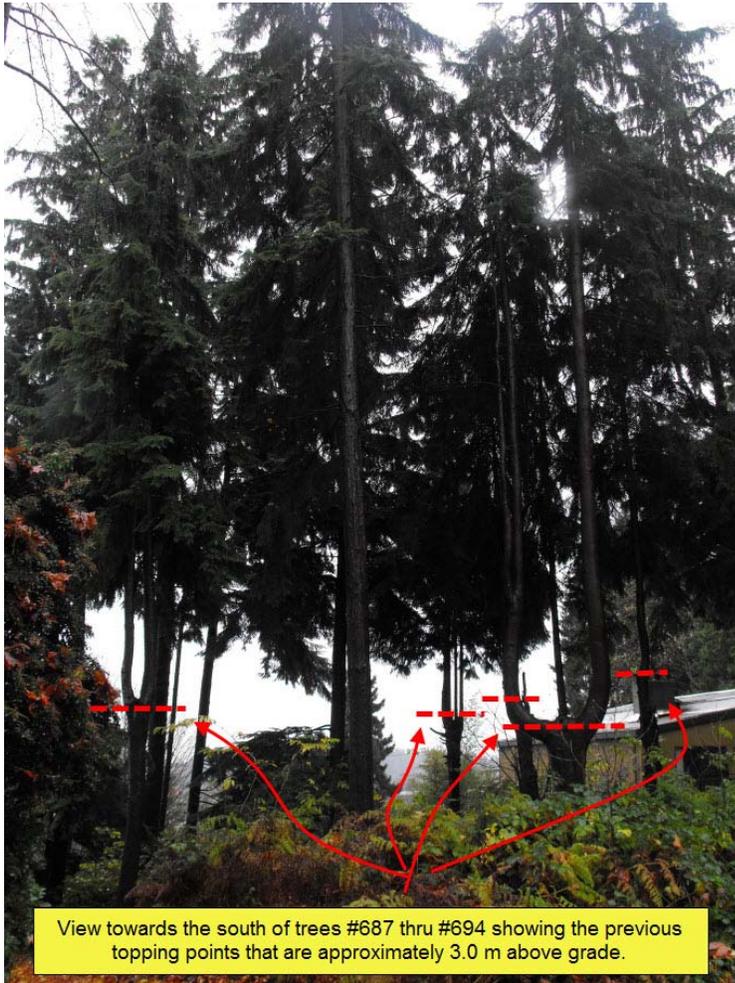
Picture 3. Previous topping

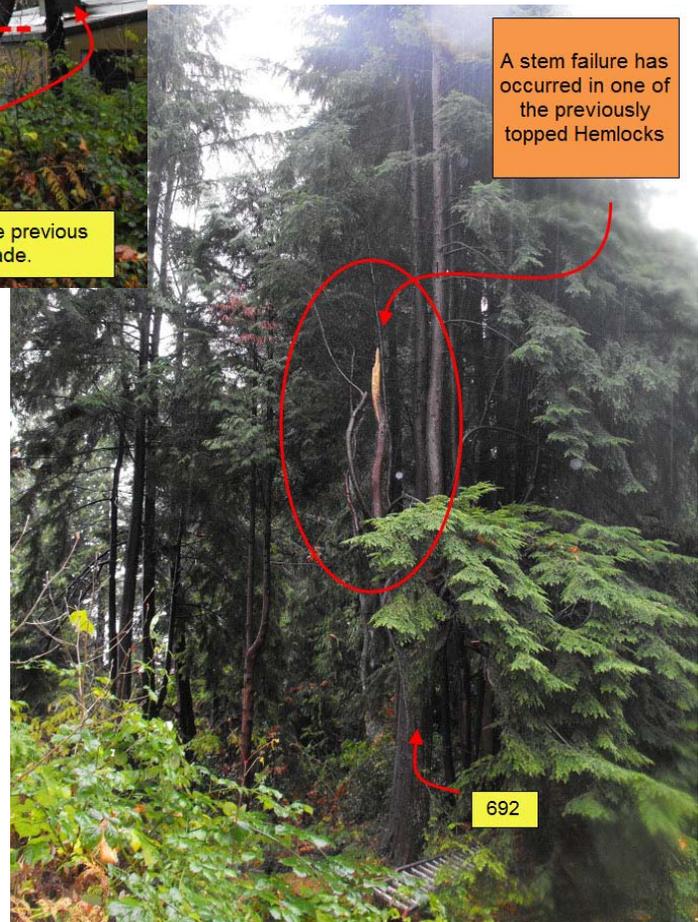
Picture 4. Stem failure in previously topped tree

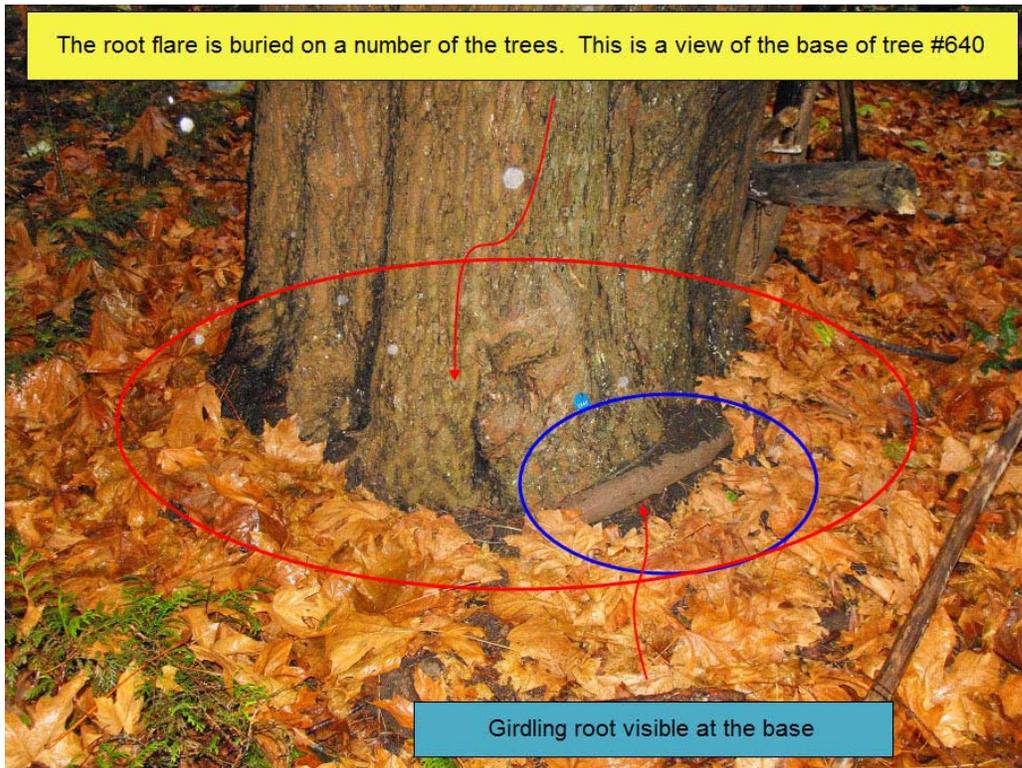
It was also observed that the root flares are either buried or partially buried on most of these trees. This is likely the result of the natural accumulation on the forest floor over time. There were also many of the trees that had structural roots visible at the surface and a few of them exhibited girdling roots near their bases. Girdling roots grow across or perpendicular to the radial placement of roots. This can pose problems for some trees the more mature they get. They can survive for many years with girdled roots but eventually the girdling will cause 'choking off' of a buttress or structural root causing decline and possible death for the tree. For the most part their buttress roots appear to have developed to compensate for the growing conditions on this site and the varying terrain. Therefore they are considered to have an atypical placement of their roots however the vast majorities appear to have adapted well. There was one tree noted as having experienced a partial root failure as a result of growing on a rock or nurse log where either there was insufficient soil for root anchorage or natural decay of the nurse log caused the tree to go over. It does not pose a high risk at this time as it remains a juvenile however it is not likely to be a long term landscape investment on this site the more mature it gets.

Picture 5. Buried root flares and girdling roots

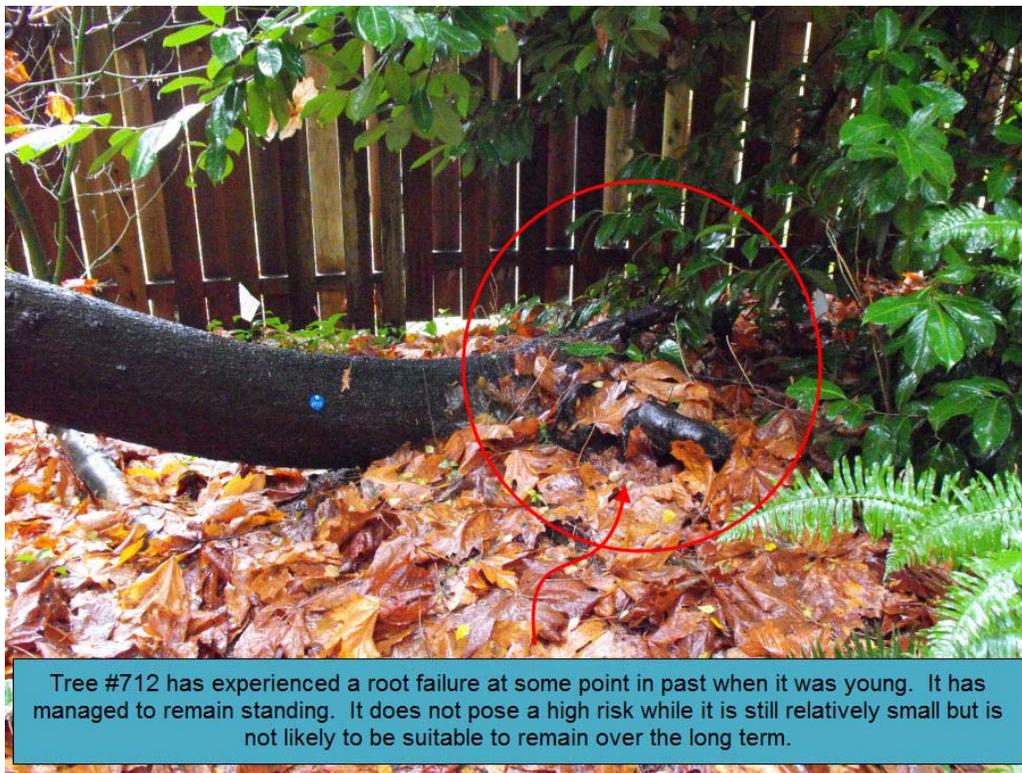
Picture 6. One tree experienced a root failure

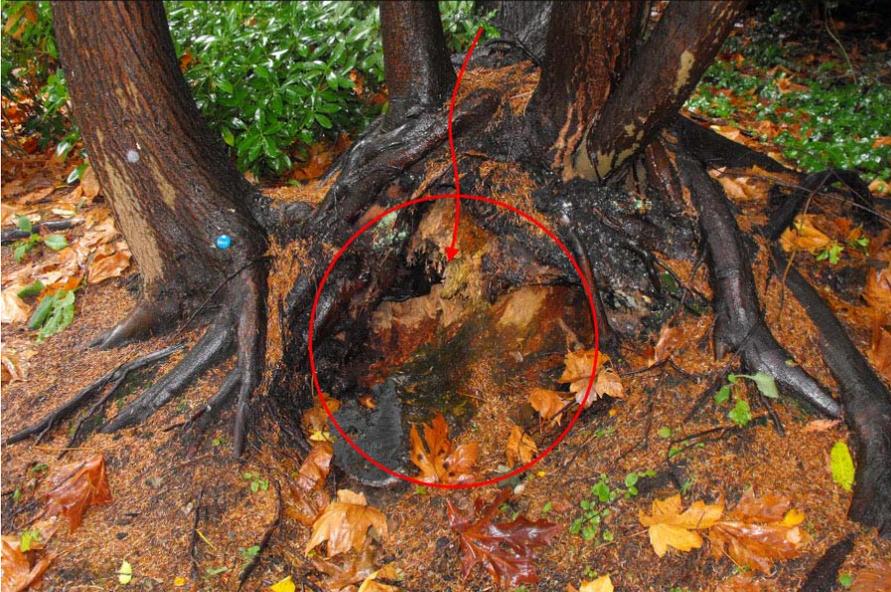
View of the base of the grouping of trees #695 thru #697 growing on a nurse log which is showing advanced decomposition. A void is starting to form at the east side. Also, lots of large structural roots are visible at the surface & visibly intertwined.

Picture 7. Lots of nurse logs/stumps on site

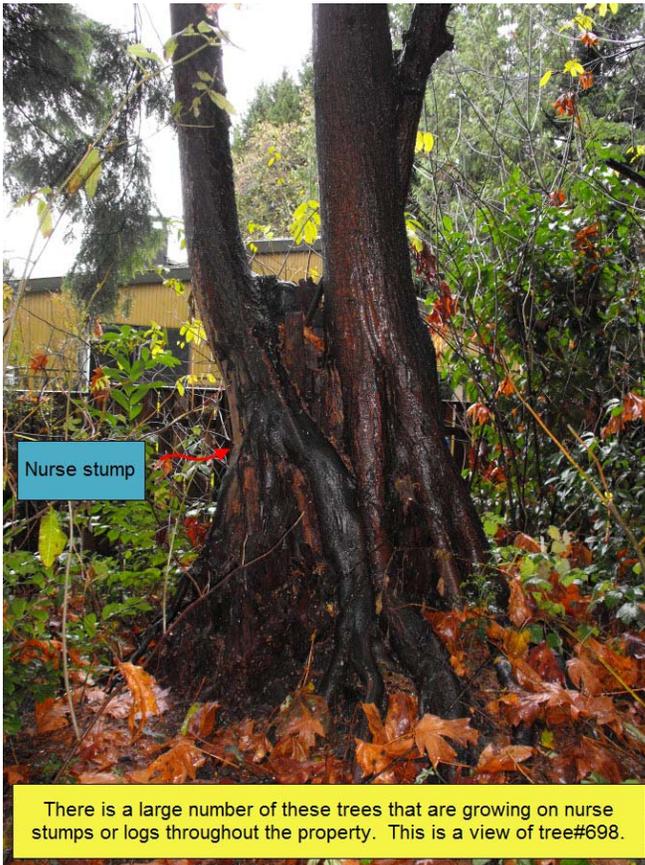
Picture 8. Lots of nurse logs/stumps on site

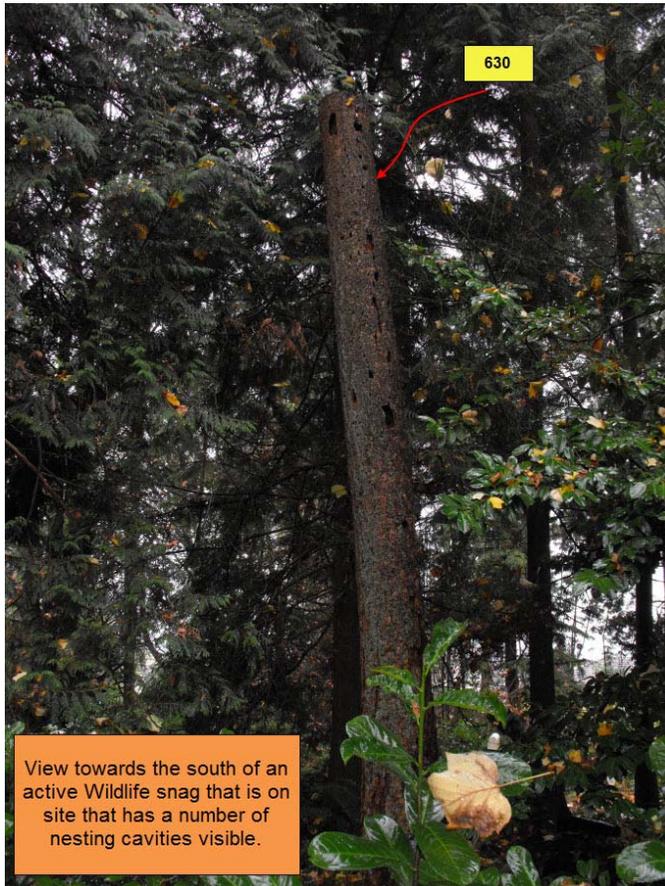
A few of these trees have been left as living stumps or wildlife snags allowing nature to take its course. *Wildlife trees* are defined as any standing dead or living tree with special characteristics that provide habitat for wildlife. They are an invaluable component in the forest ecosystem. According to the Ministry of Forests, Lands and Natural Resource Operations, there are found to be over 70 species of vertebrates and invertebrates that are dependent of the wildlife trees, for example birds, bats, insects, fungi, mycorrhizae etc.

Picture 9. Active Wildlife snag
