**Heritage Designation Bylaw No. 4942, 2017  
(1768 Inglewood Avenue)**

# SUTHERLAND HOUSE

1768 INGLEWOOD AVENUE, WEST VANCOUVER, BC

# 5.0 CONSERVATION RECOMMENDATIONS

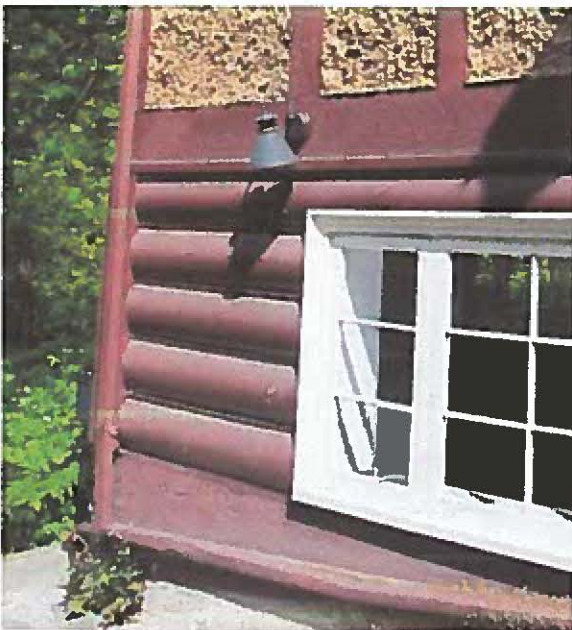
The Sutherland House features a poured-in-place concrete foundation, with a full basement clad in log-cabin siding below water table on all elevations. Along the west and the rear elevation to the south, the foundation wall is almost entirely exposed above grade; the log-cabin siding terminates into exposed concrete foundation, which is aligned to the existing window sills. Directly below the log-cabin siding, the concrete foundation is finished with paint of the same colour as the siding and the rainwater leader. In general, the foundation appears to be in good condition.

*Typical condition of foundation, as seen from the southwest corner of the historic house.*

- Existing foundations should be preserved, if possible.
- If new foundations are proposed, concrete is a suitable material. New material should match original in appearance, as viewed from the exterior.

- Foundations should be reviewed by a Structural Engineer. Once condition is assessed, conservation recommendations can be finalized.
- To ensure the prolonged preservation of the new foundations, all landscaping should be separated from the foundations at grade by a course of gravel or decorative stones, which help prevent splash back and assist drainage. New vegetation may assist in concealing the newly exposed foundations, if desired.

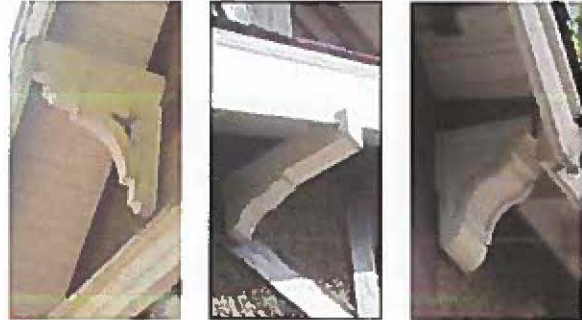
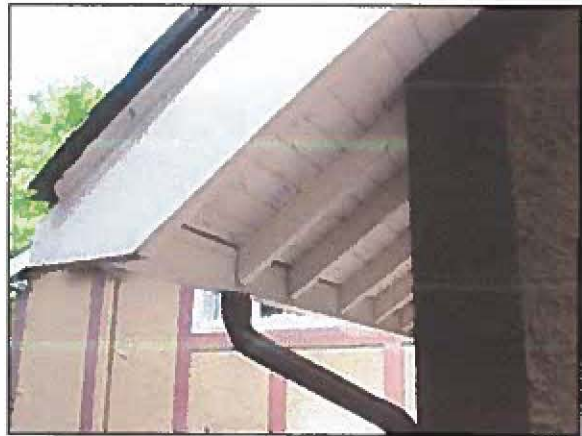
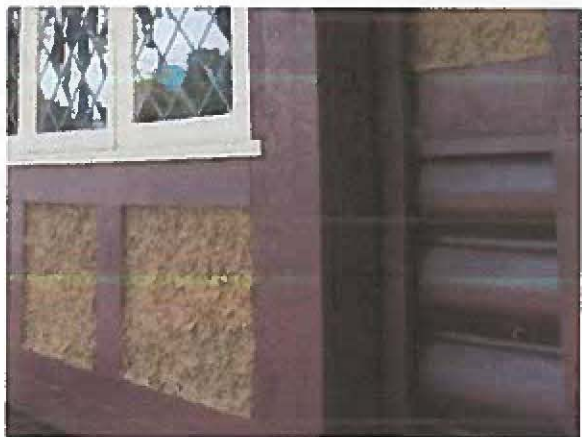
Based on visual inspection from the ground, the wood trim work are finished with paint; they are generally in good condition, with minor evidences of deterioration in localized areas, and should be retained in-place. In locations where new exterior walls are proposed to be constructed, salvage all original wood trim and reinstate following rehabilitation work.

*Photos showing typical condition of extant original wood trim work of the historic house, as seen from the ground.*

- Any existing trim should be preserved. Any character-defining elements that are missing or heavily deteriorated beyond repair should be restored using new materials that are visually and physically compatible with the original.
- Salvage and reinstate original wood trim work where new exterior walls are proposed. If new trim work is required, it should be installed on the rear elevation and original material should be relocated to the front, as necessary.

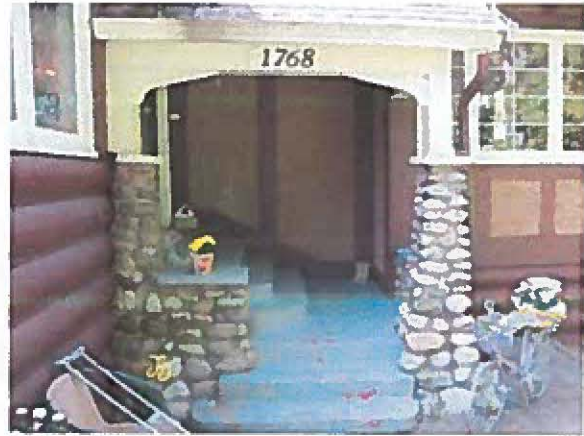
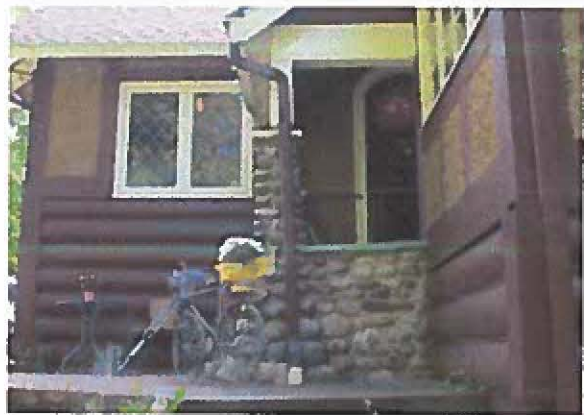
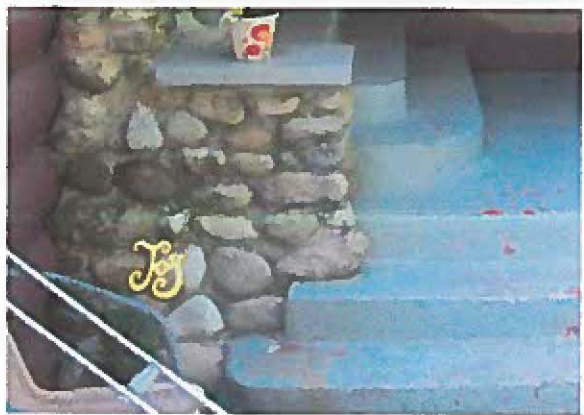
*Photos showing typical condition of extant original side-entry porch and stairs of the historic house. Note the crack along the mortar, which also shows biological growth.*

- Preserve original details of the entry porch and stairs.
- Extant original stone piers and low balustrades should be retained and preserved. Exterior surface of stone can be cleaned, as necessary. No abrasive cleaning methods should be used.
- Mortar condition should be assessed, and localized repointing may be required. Any new mortar repair work should be visually and physically consistent with historic original. Heritage Consultant should review specifications prior to commencement of work.
- Wood elements should be cleaned, and

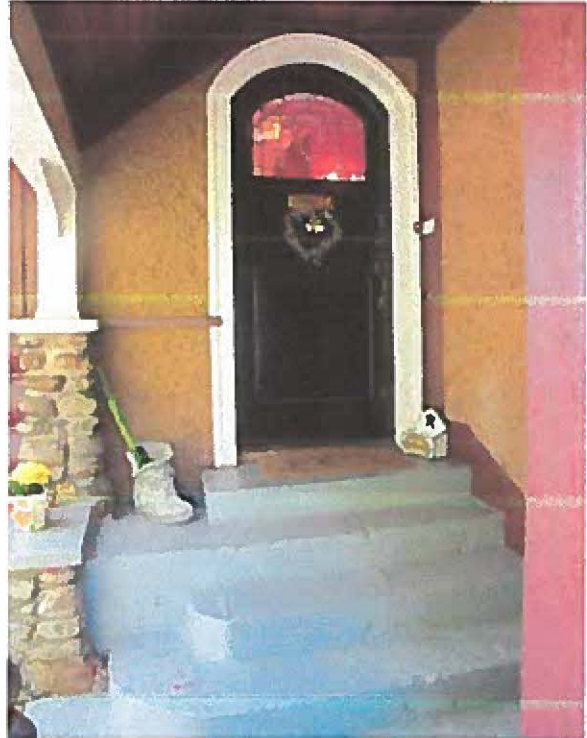
*Existing entrance door above concrete stairs of entry porch. Note low stone balustrade and stained soffit beneath porch canopy.*

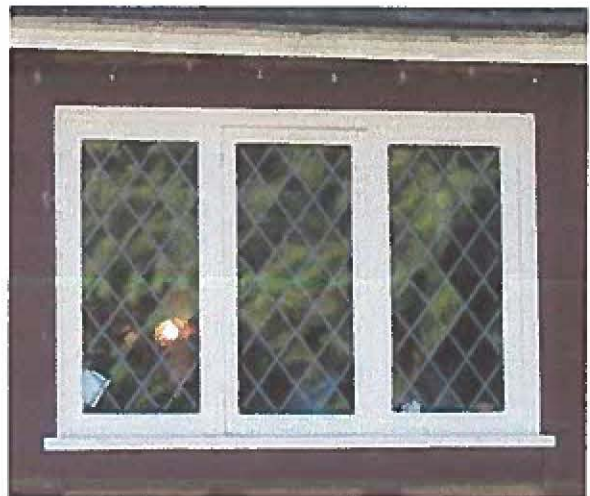
*Typical condition of existing tripartite windows on the front facade to the north.*

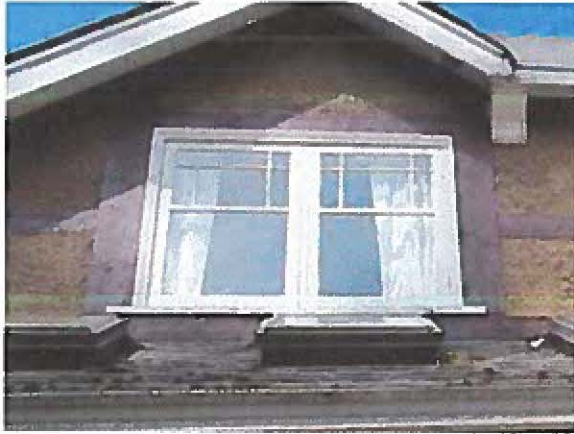
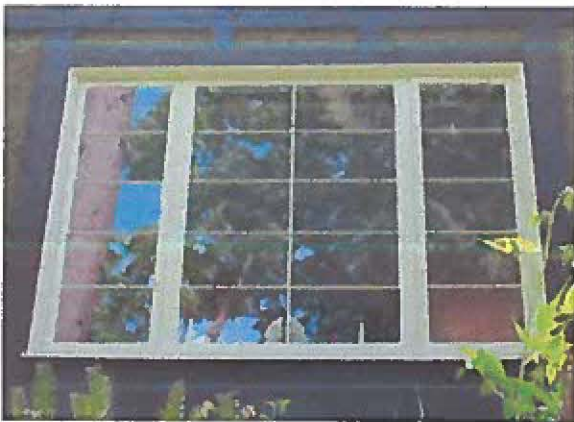
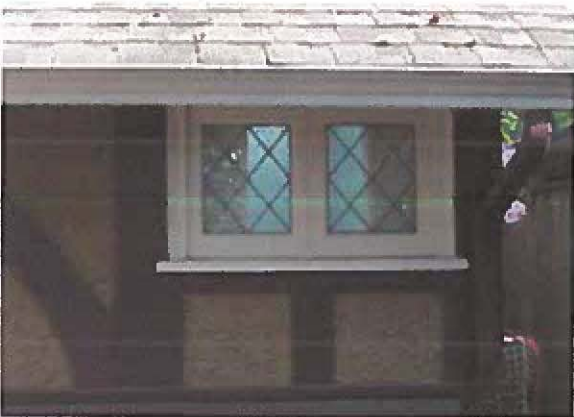
Photos showing typical condition of extant exterior wood windows in different configurations.

prepared for repainting. Paint according to colour schedule devised by Heritage Consultant.

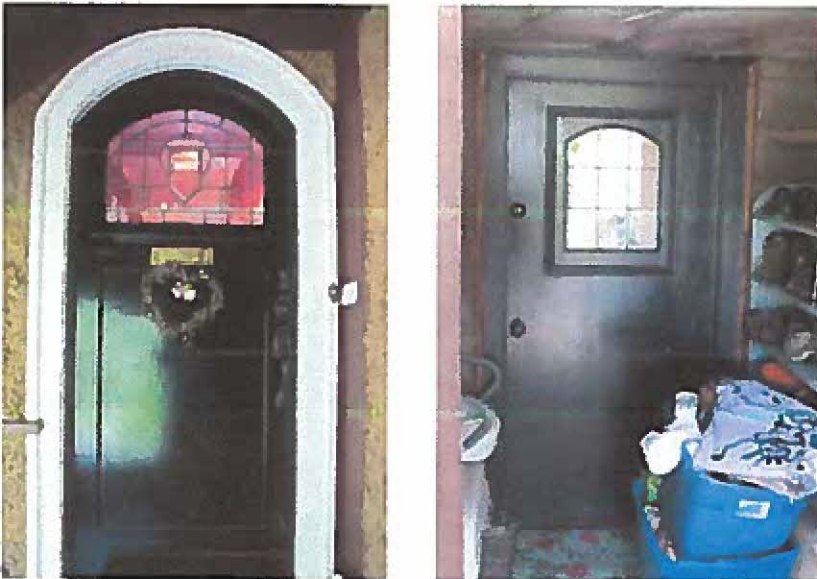
Generally, the exterior condition of the existing doors appear to be in good condition. The original arched wooden front door and associated features is a significant character-defining element, and should be preserved. The extant secondary wooden panelled doors are sympathetic to the historic character of the house, and should be retained in their original locations and restored as necessary.

*Photos showing existing exterior wood doors in different configurations and locations: the original wooden front door at the west return of the front facade to the north (left); and south elevation (right). Note that all doors feature multi-pane leaded glass windows and true-divided lights.*

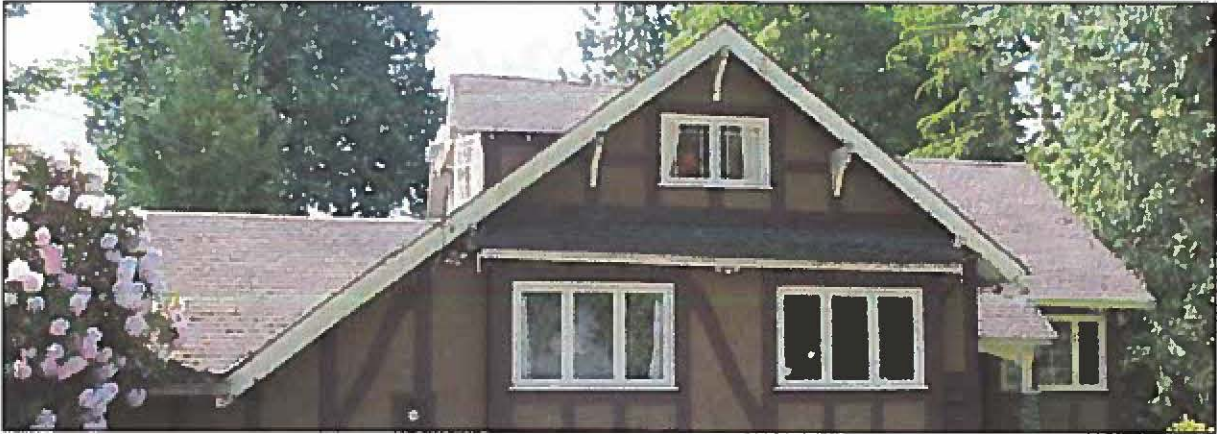
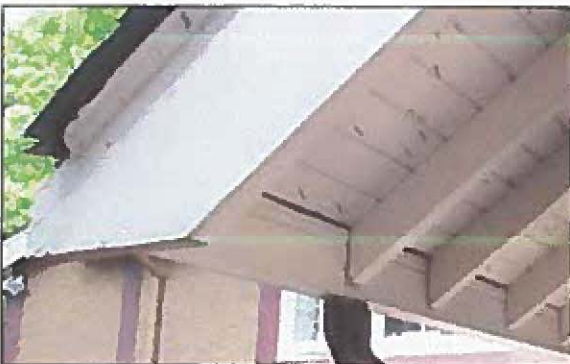
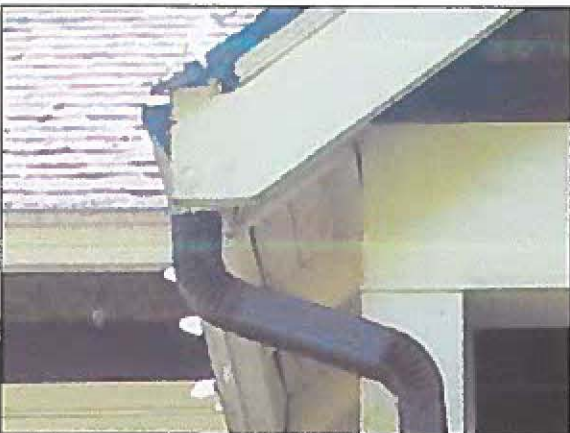
*Cross-gabled roof structure of the Sutherland House (top);  
exposed roof rafters and nailing boards (middle); and typical  
condition of roof drainage (bottom)*

- If required, roofing membrane and cladding system may be rehabilitated.
- Retain the original bargeboards and fascia boards, as well as the soffit any exposed roof elements.
- Design and install adequate rainwater disposal system and ensure proper drainage from the site is maintained. Wood gutters with galvanized steel downspouts are recommended.
- Paint all drainage system elements according to colour schedule devised by Heritage Consultant.

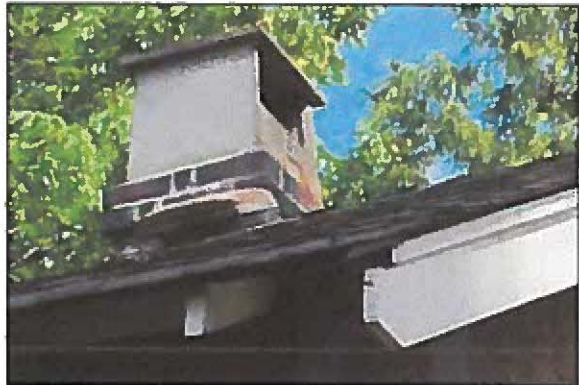
The Sutherland House features one original chimney, and another chimney that was added later on as part of the expansion of the house.

*Existing rectangular chimneys: chimney with metal flashing above roof ridge of side-gable (top); and brick chimney with metal chimney cap above roof line to the south.*

- Preserve the chimneys in their original configuration, if possible.
- Chimney may require structural stabilization.
- Investigate condition of brickwork. If required, brickwork may be repointed and cleaned using a natural bristle brush and mild rinse detergent.

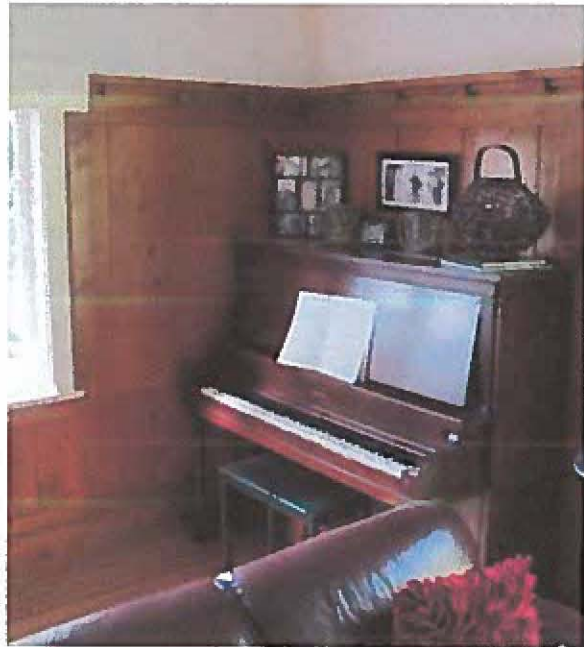
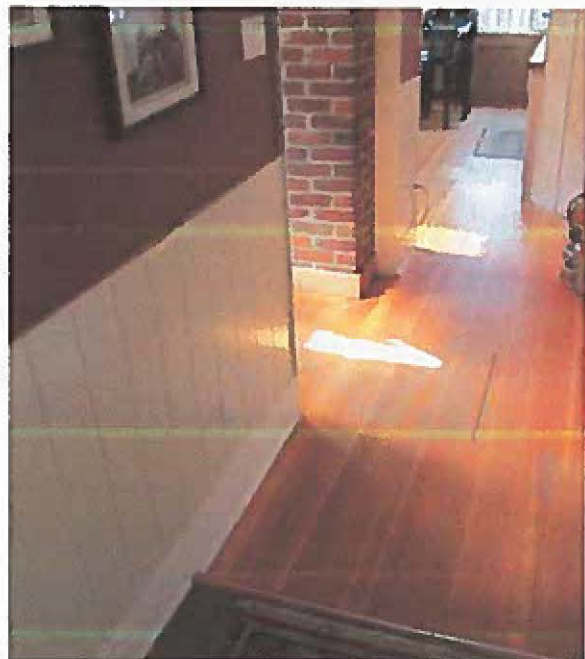
*Photos showing typical condition of original interior wall finishes.*

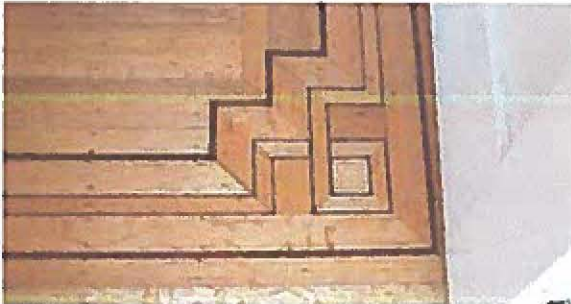
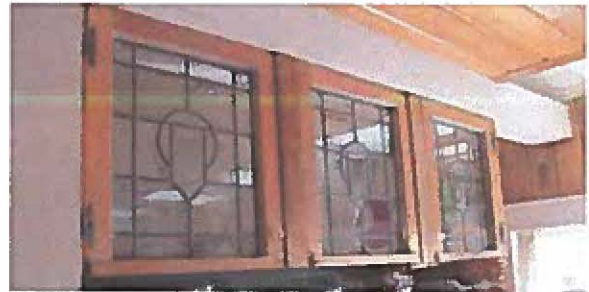
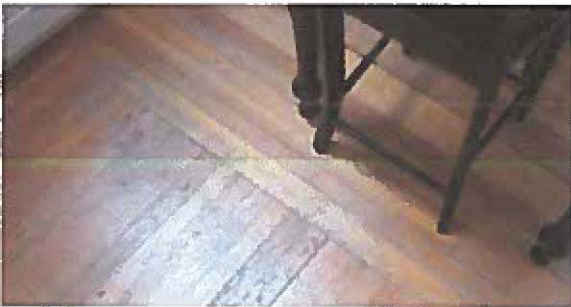
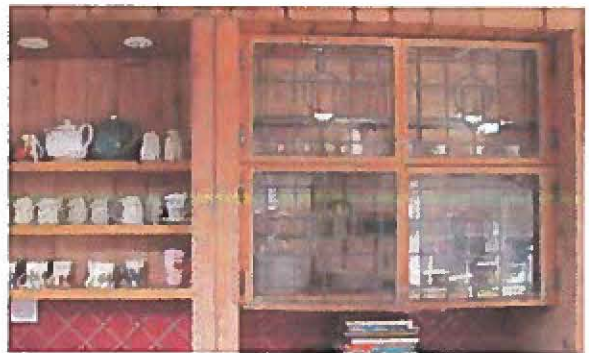
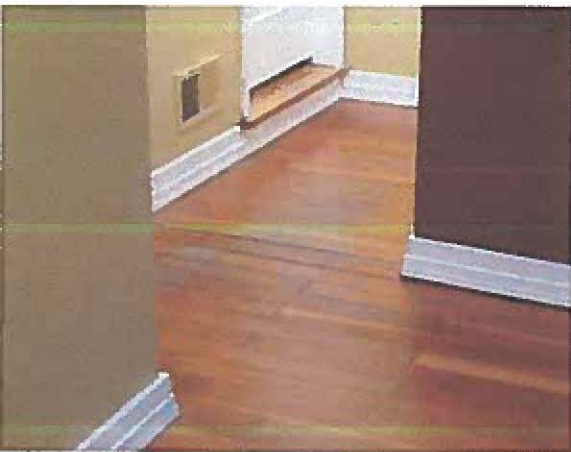
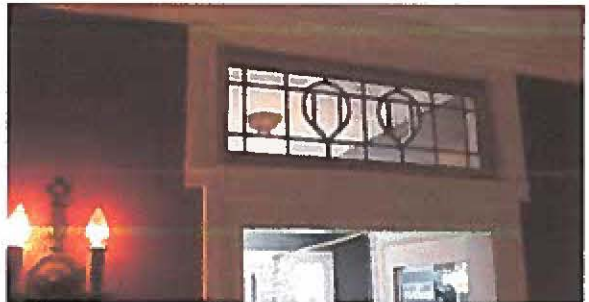
The Sutherland House features extant, original hardwood oak floors, with some areas elaborately detailed with corner and trim inlay. They appear to be in good condition. These are character-defining elements of the historic house, and should be preserved, as possible.

*Photos showing typical condition of original hardwood floor in different areas of the historic house.*

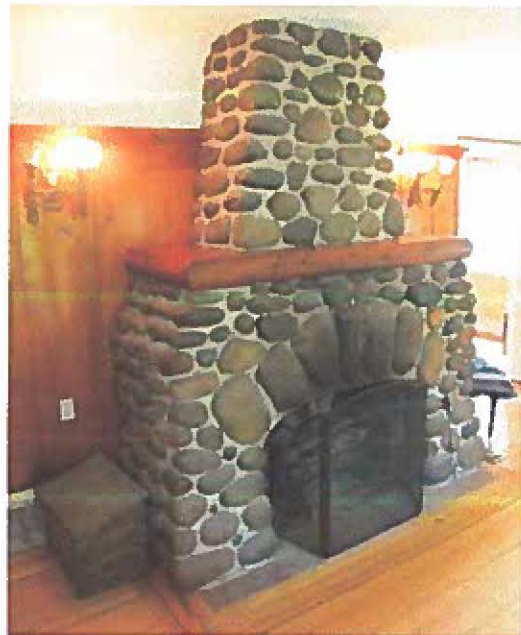
*Photos showing existing original stone fireplace in the living room (top).*

- Preserve the stone fireplace, and repair as necessary.
- If cleaning is necessary, do not use any abrasive methods that may damage the fireskin surfaces. Only approved chemical restoration cleaners may be used. Sandblasting or any other abrasive cleaning method of any kind is not permitted.
