**Heritage Revitalization Agreement Bylaw No. 4943, 2017
(1768 Inglewood Avenue)**

SUTHERLAND HOUSE

1768 INGLEWOOD AVENUE, WEST VANCOUVER, BC

5.0 CONSERVATION RECOMMENDATIONS

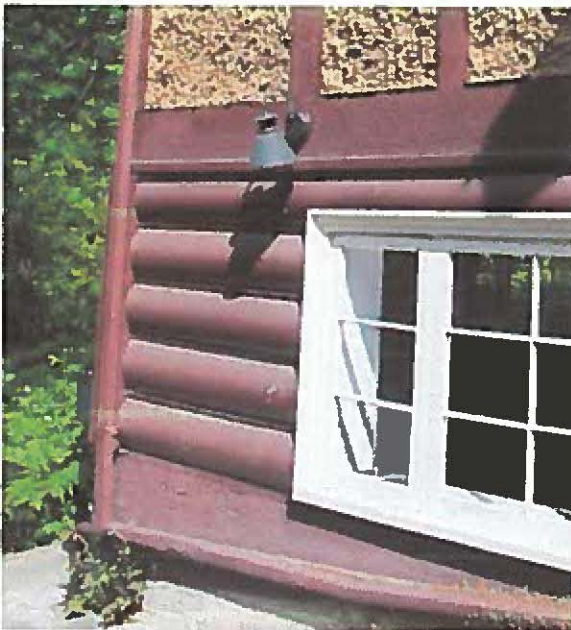
Typical condition of foundation, as seen from the southwest corner of the historic house.

- Existing foundations should be preserved, if possible.
- If new foundations are proposed, concrete is a suitable material. New material should match original in appearance, as viewed from the exterior.

- Foundations should be reviewed by a Structural Engineer. Once condition is assessed, conservation recommendations can be finalized.
- To ensure the prolonged preservation of the new foundations, all landscaping should be separated from the foundations at grade by a course of gravel or decorative stones, which help prevent splash back and assist drainage. New vegetation may assist in concealing the newly exposed foundations, if desired.

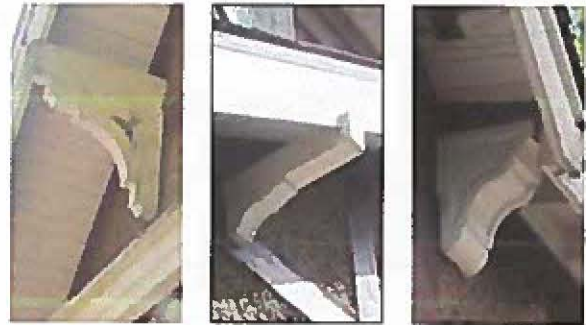
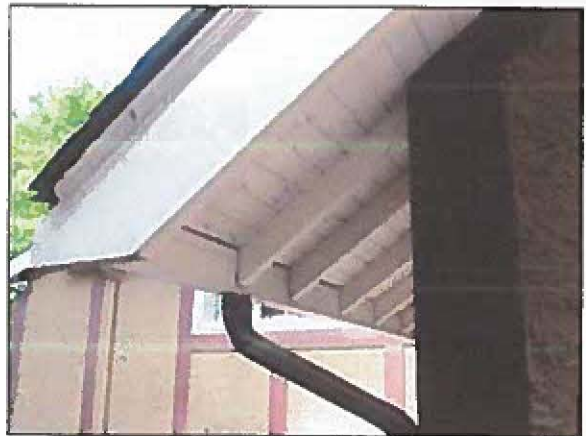
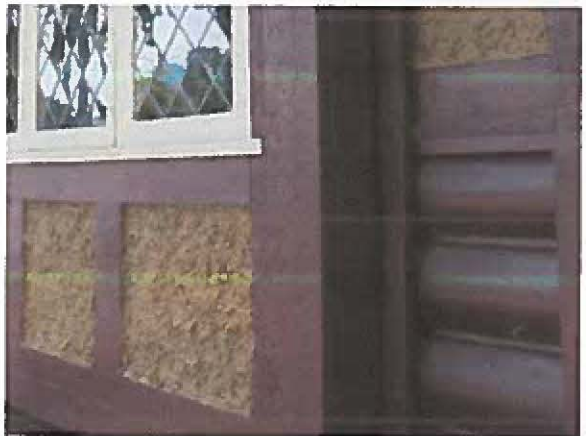
Photos showing typical condition of extant original wood trim work of the historic house, as seen from the ground.

- Any existing trim should be preserved. Any character-defining elements that are missing or heavily deteriorated beyond repair should be restored using new materials that are visually and physically compatible with the original.
- Salvage and reinstate original wood trim work where new exterior walls are proposed. If new trim work is required, it should be installed on the rear elevation and original material should be relocated to the front, as necessary.

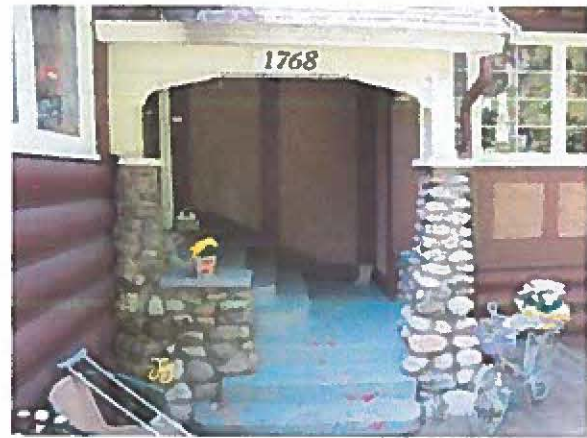
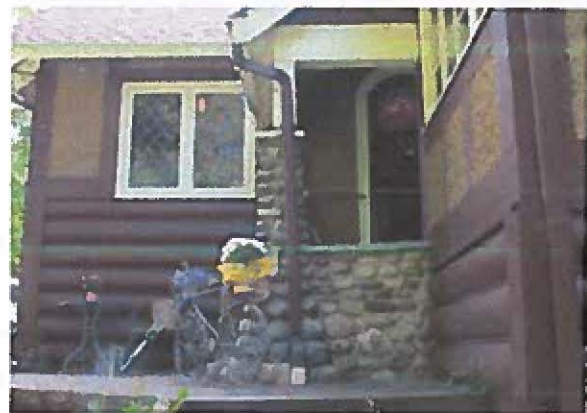
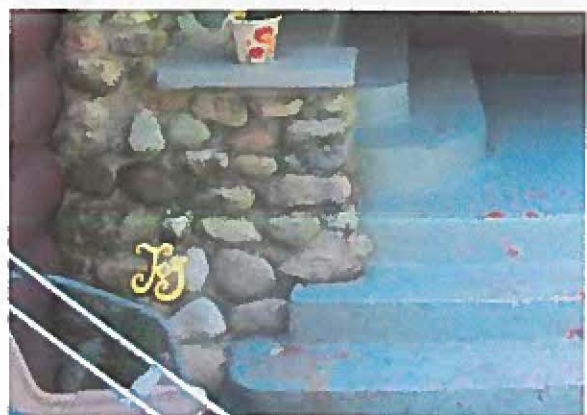
Photos showing typical condition of extant original side-entry porch and stairs of the historic house. Note the crack along the mortar, which also shows biological growth.

- Larger cracks should be cut out, and prepared for more extensive repair. A professional plasterer may be required if the stucco requires extensive repair work. All existing holes or openings should be patched. Likewise, all openings resulting from the removal of original windows should be patched. All patch work and repairs should be made with a visually and physically compatible stucco material.

- All repair methods should be carried out in an inconspicuous sample location, to ensure all repairs are compatible with the historic stucco.

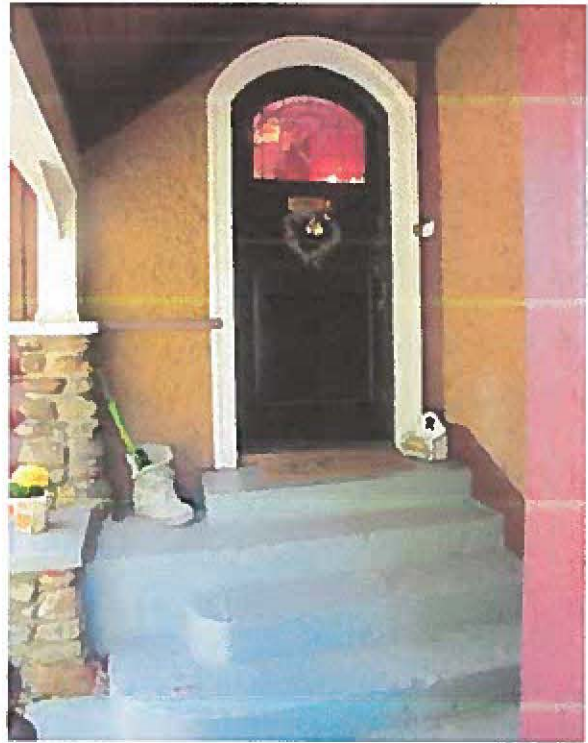
Existing entrance door above concrete stairs of entry porch. Note low stone balustrade and stained soffit beneath porch canopy.

- Preserve original details of the entry porch and stairs.
- Extant original stone piers and low balustrades should be retained and preserved. Exterior surface of stone can be cleaned, as necessary. No abrasive cleaning methods should be used.
- Mortar condition should be assessed, and localized repointing may be required. Any new mortar repair work should be visually and physically consistent with historic original. Heritage Consultant should review specifications prior to commencement of work.
- Wood elements should be cleaned, and

prepared for repainting. Paint according to colour schedule devised by Heritage Consultant.

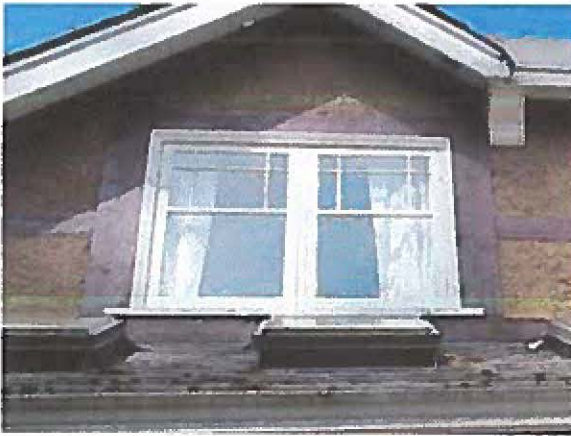
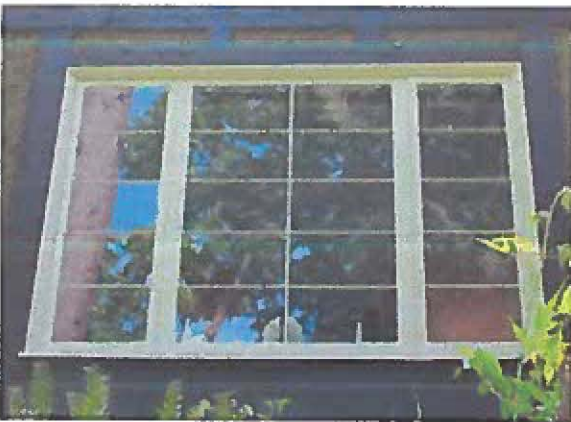
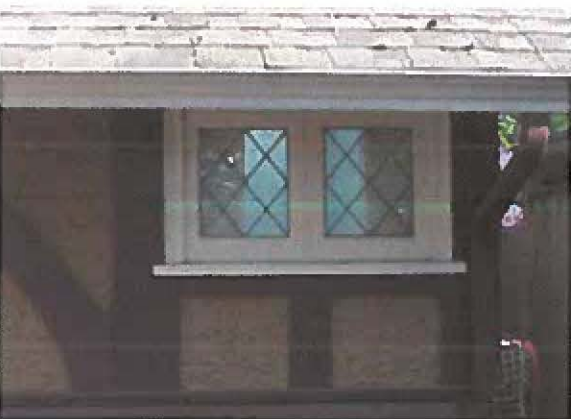
Photos showing typical condition of extant exterior wood windows in different configurations.

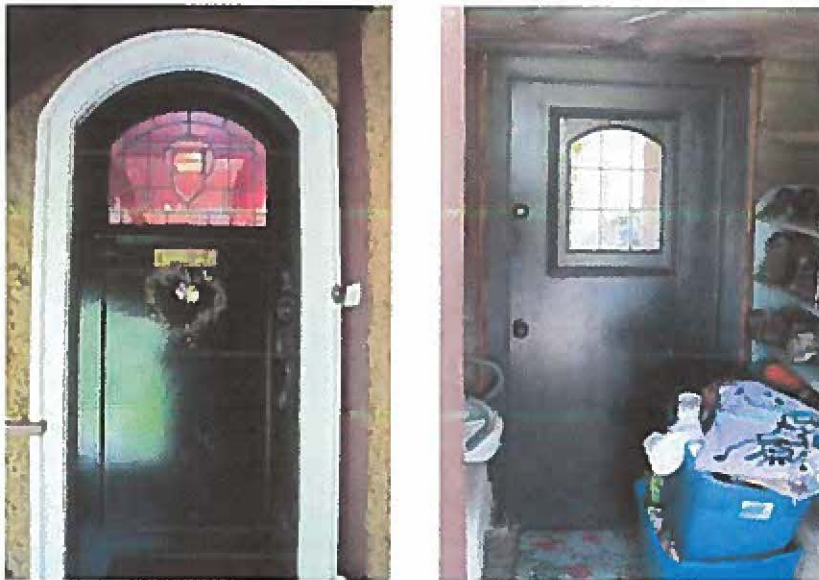
Generally, the exterior condition of the existing doors appear to be in good condition. The original arched wooden front door and associated features is a significant character-defining element, and should be preserved. The extant secondary wooden panelled doors are sympathetic to the historic character of the house, and should be retained in their original locations and restored as necessary.

Photos showing existing exterior wood doors in different configurations and locations: the original wooden front door at the west return of the front facade to the north (left); and south elevation (right). Note that all doors feature multi-pane leaded glass windows and true-divided lights.

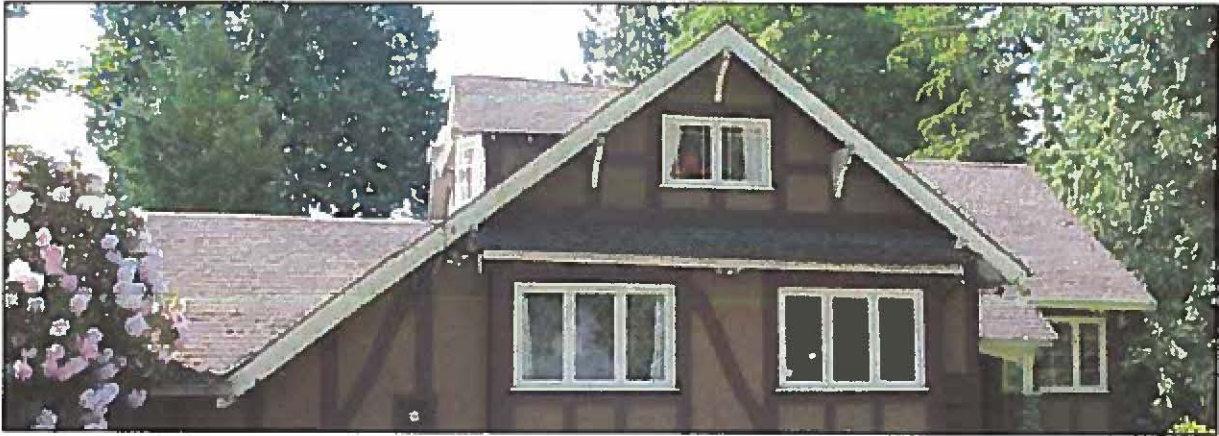
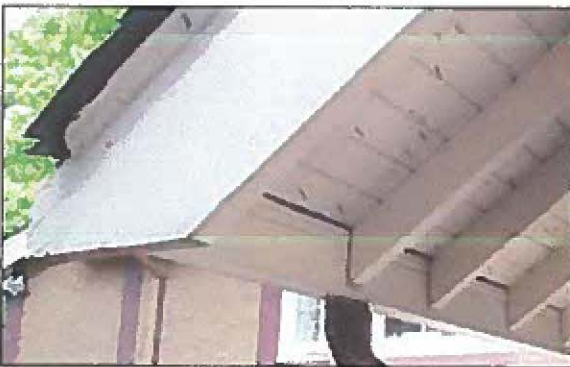
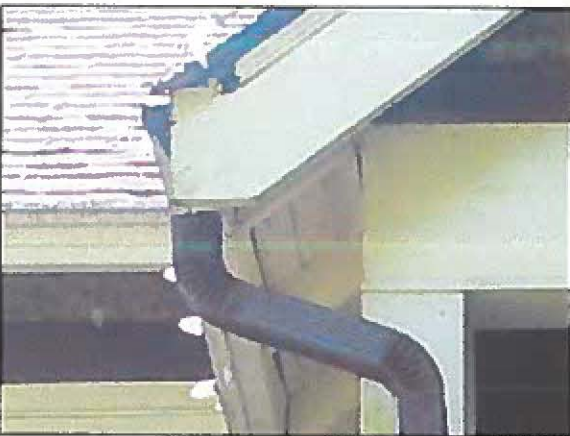
Cross-gabled roof structure of the Sutherland House (top); exposed roof rafters and nailing boards (middle); and typical condition of roof drainage (bottom)

- If required, roofing membrane and cladding system may be rehabilitated.
- Retain the original bargeboards and fascia boards, as well as the soffit any exposed roof elements.
- Design and install adequate rainwater disposal system and ensure proper drainage from the site is maintained. Wood gutters with galvanized steel downspouts are recommended.
- Paint all drainage system elements according to colour schedule devised by Heritage Consultant.

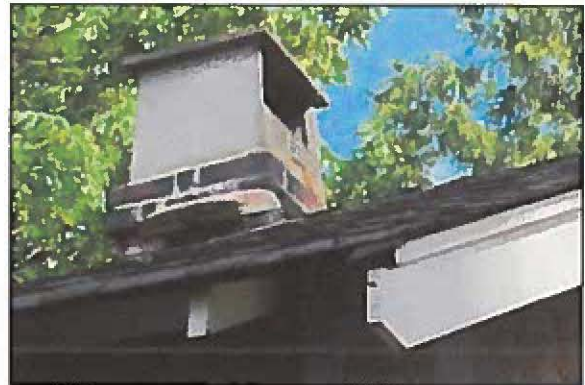
The Sutherland House features one original chimney, and another chimney that was added later on as part of the expansion of the house.

Existing rectangular chimneys: chimney with metal flashing above roof ridge of side-gable (top); and brick chimney with metal chimney cap above roof line to the south.

- Preserve the chimneys in their original configuration, if possible.
- Chimney may require structural stabilization.
- Investigate condition of brickwork. If required, brickwork may be repointed and cleaned using a natural bristle brush and mild rinse detergent.

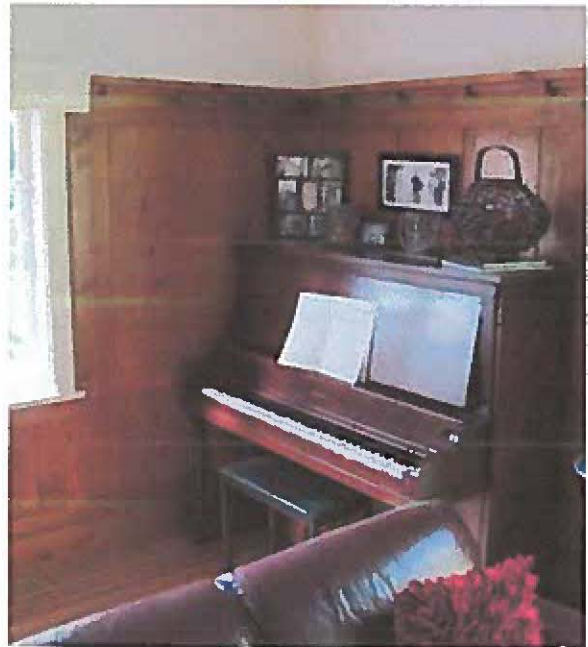
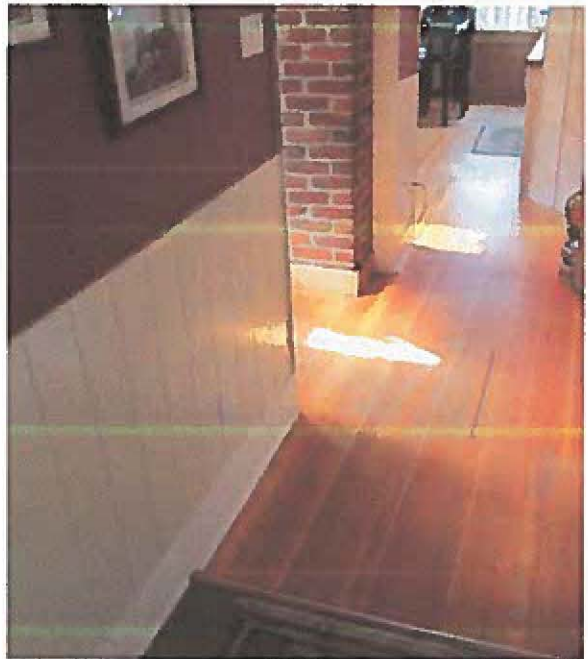
Photos showing typical condition of original interior wall finishes.

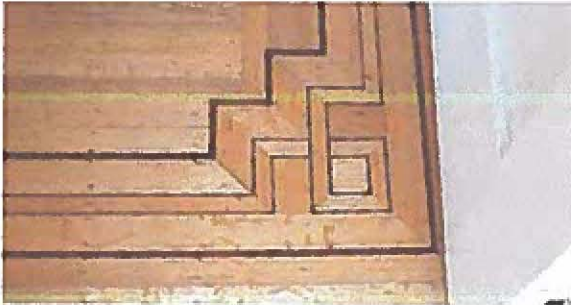
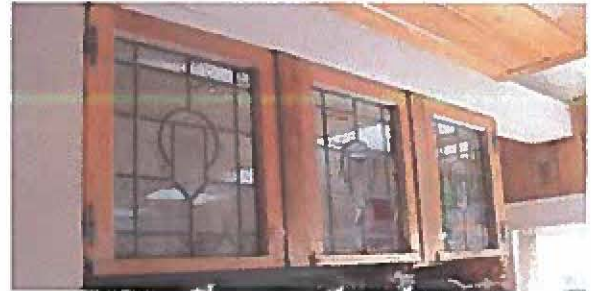
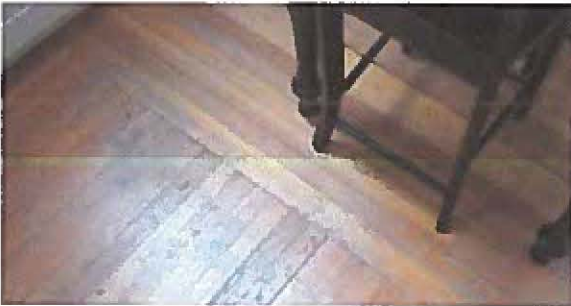
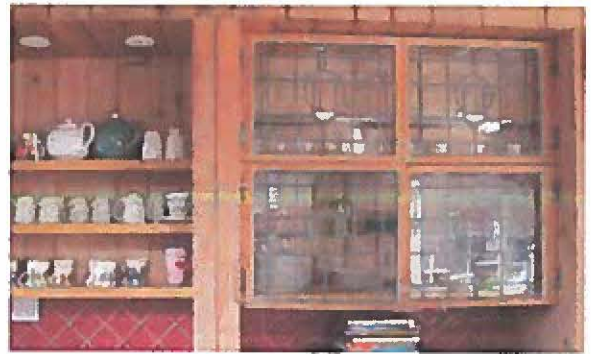
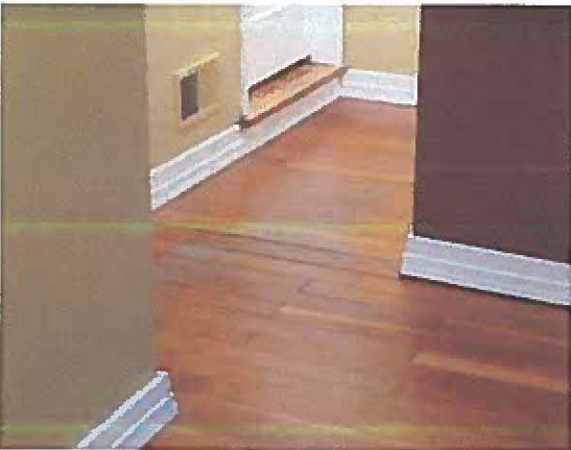
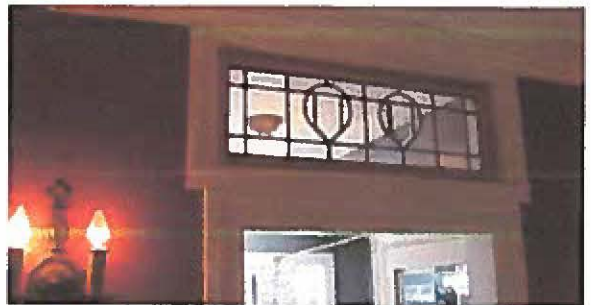
Photos showing typical condition of original hardwood floor in different areas of the historic house.

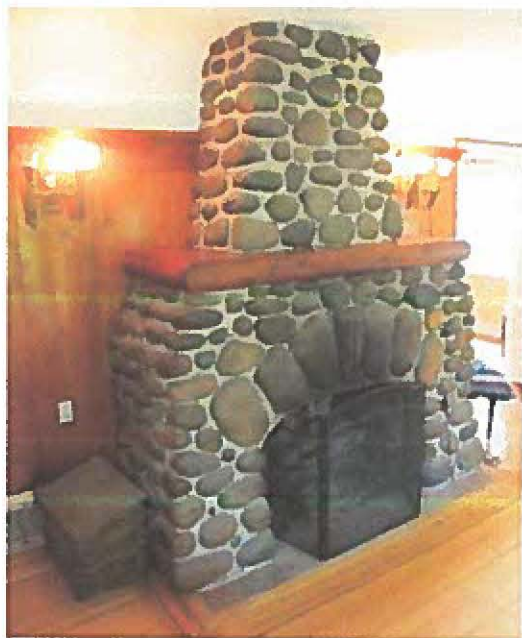
Photos showing existing original stone fireplace in the living room (top).

- Preserve the stone fireplace, and repair as necessary.
- If cleaning is necessary, do not use any abrasive methods that may damage the fireskin surfaces. Only approved chemical restoration cleaners may be used. Sandblasting or any other abrasive cleaning method of any kind is not permitted.
