## District of West Vancouver Heritage Alteration Permit No. 14-025

Civic Address: 4719 Pilot House Road

Legal Description: PID No. 007-324-111  
Lot E Block 2 District Lot 811 Plan 17059  
(the 'Lands')

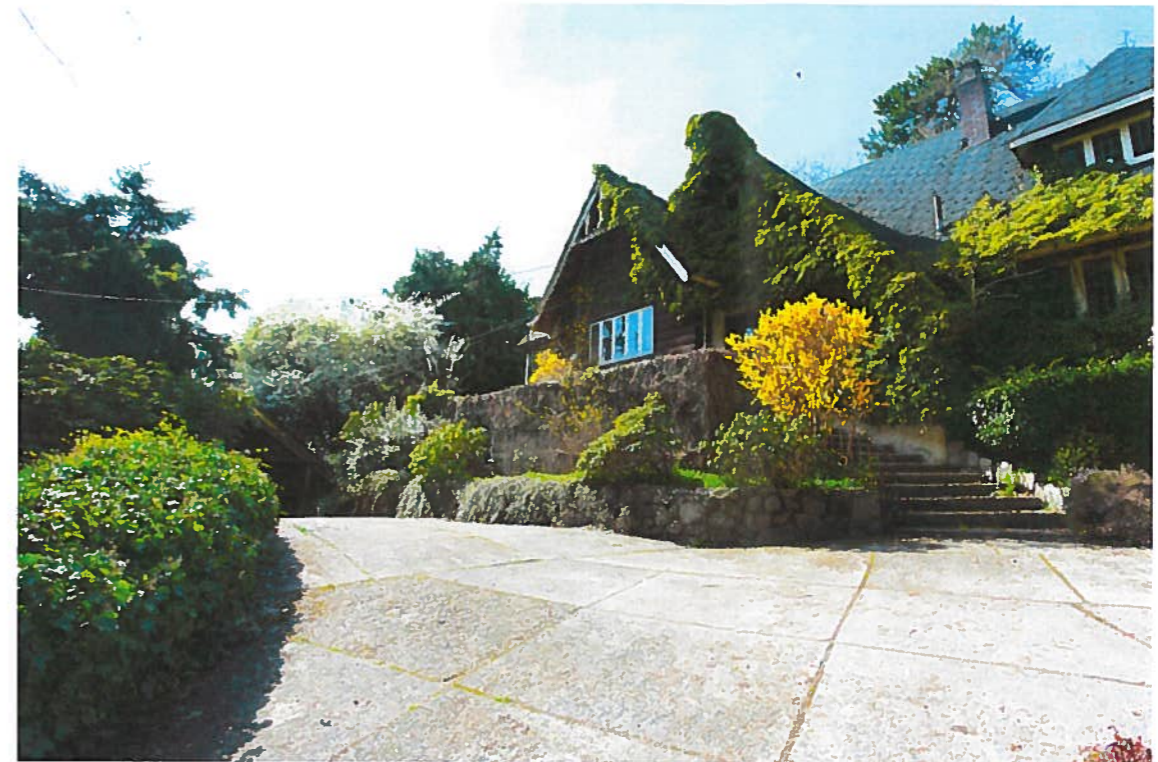
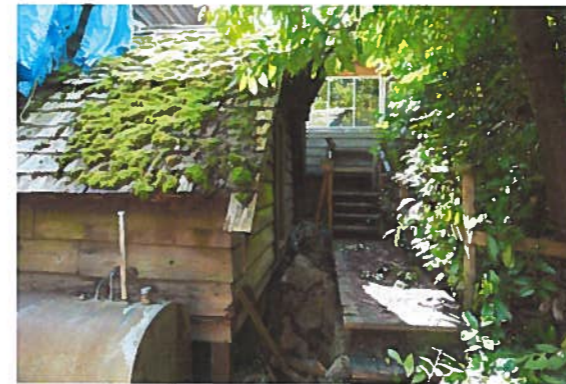
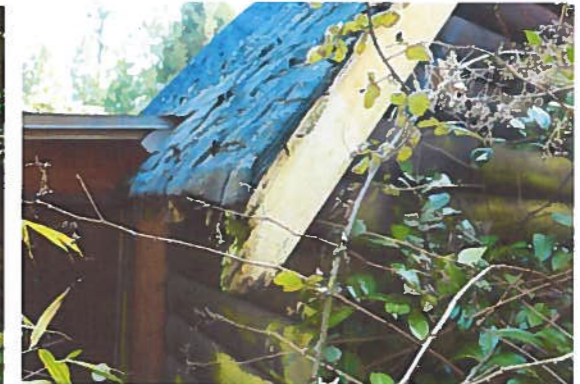
**1** The existing house was once a lovely English cottage in a lush, mature garden looking out to sea. Not any more. The house is literally falling apart, destroyed by rot and ivy and deferred maintenance. It is now a "Grey Gardens" house, completely unsalvageable.

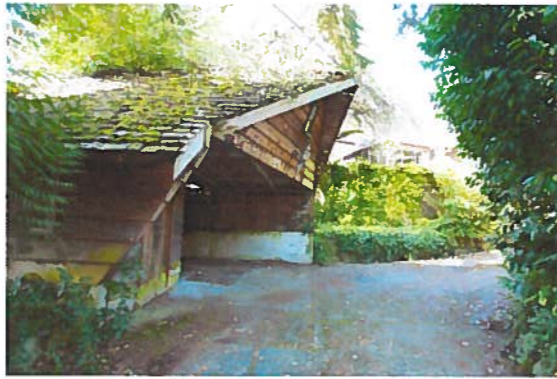
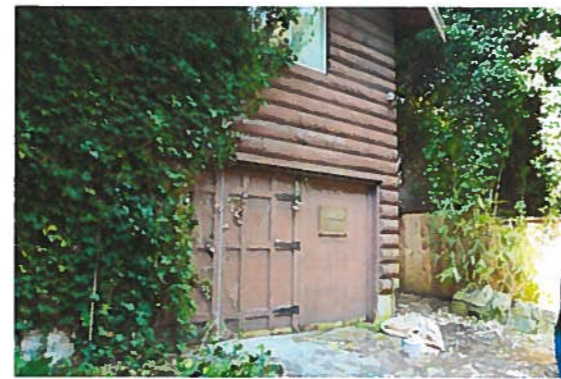
**7** The existing house has a collapsing carport in the second entrance to the circular driveway. The carport and circular driveway will be removed and replaced with terraced gardens, cutting the paved area to half its existing size. The old garage facing the street will be removed and a new garage will be completely hidden from view by stone walls and landscaping.

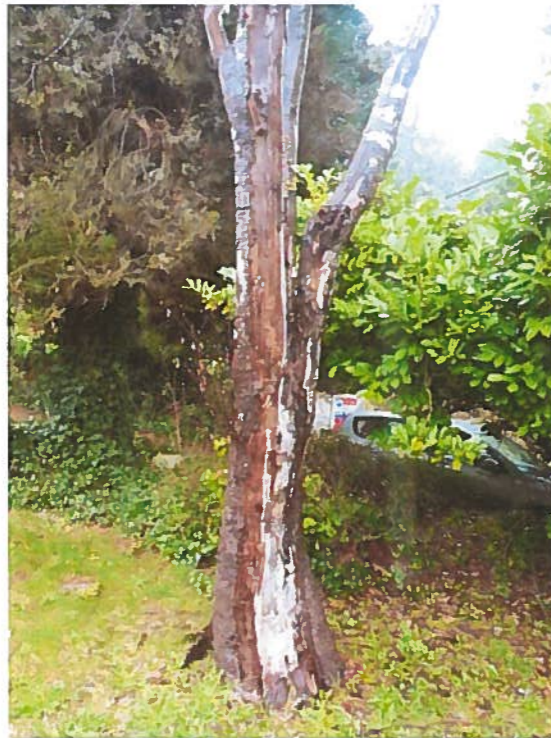
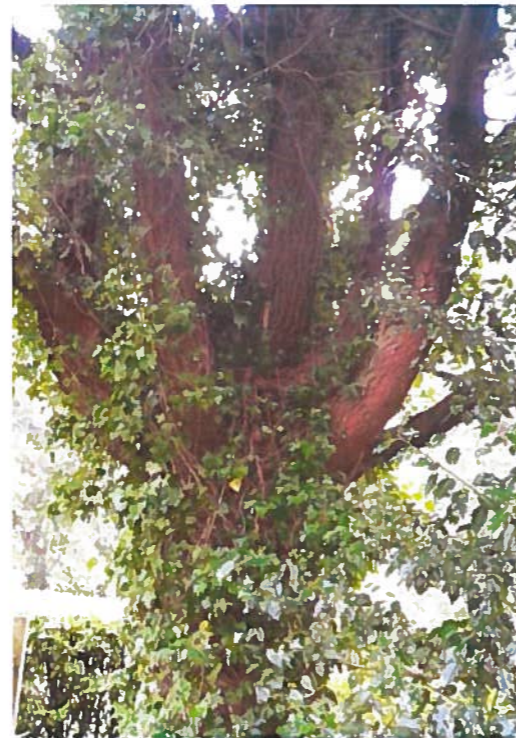
**17** Many of the existing trees have been topped in the past for views of the water but were then let go to grow into mangled masses. Others have simply rotted in place.

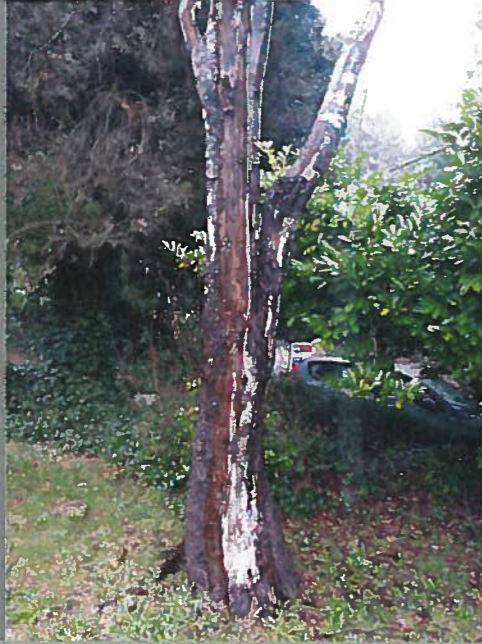
Photo 1. Tree # 7058, this dogwood tree is severe health and structural decline.

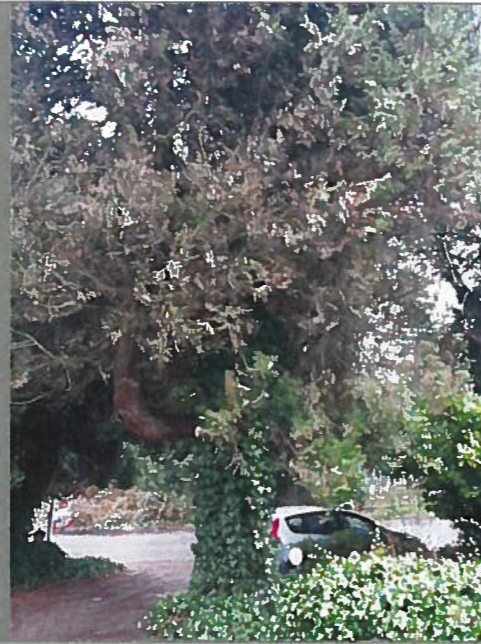
Photo 2. Tree # 7059, previously topped, displaying large patches of crown dieback.

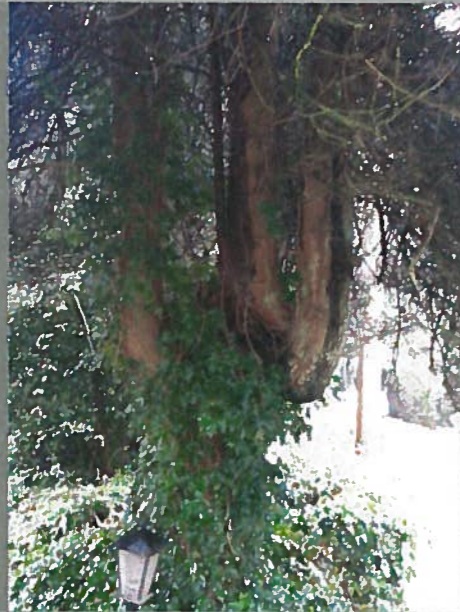
Photo 3. Tree # 7056, previously topped with decay visible at the stem union.

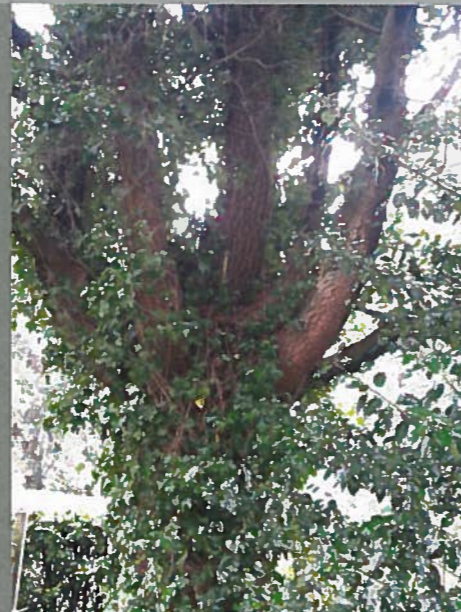
Photo 4. Tree # 5988 previously topped that resulted in the large replacement leaders.

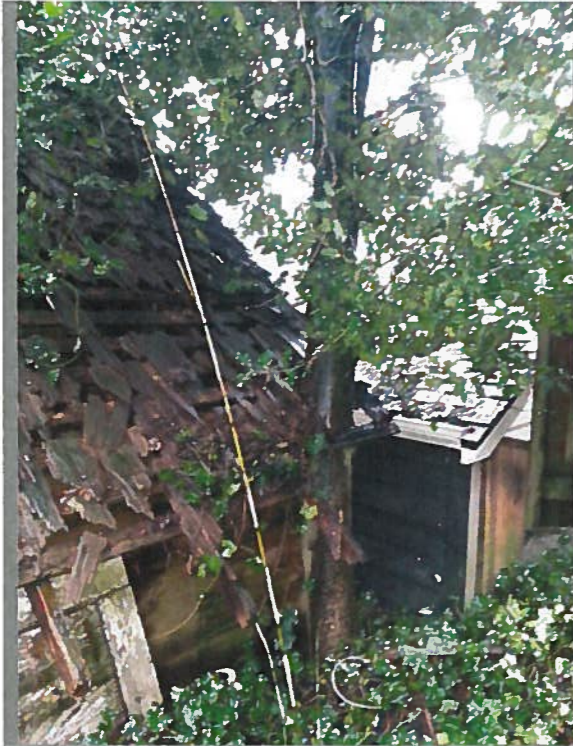
Photo 5. Tree # 5985 is growing through the existing carport roof.

5985	English Holly	<i>Ilex aquifolium</i>	28	5	Very poor	Unsuitable	This tree is growing through the existing carport roof, and there several boards embedded in the tree's trunk. In addition the tree has been topped to approximately 5m above grade.	Remove	Due to pre-existing very poor health and structural condition. This tree will not survive demolition of the adjacent carport.
5986	Western redcedar	<i>Thuja plicata</i>	80	8	Very poor	Unsuitable	This tree has been previously topped at approximately 5m above grade, resulting in the formation of several replacement leaders. These replacement leaders have been topped as well. This tree is growing adjacent the concrete deck and the deck is embedded into the trunk. The tree's crown is infested with ivy.	Remove	Due to pre-existing very poor health and structural condition. This tree will not survive demolition of the adjacent wood and concrete deck.

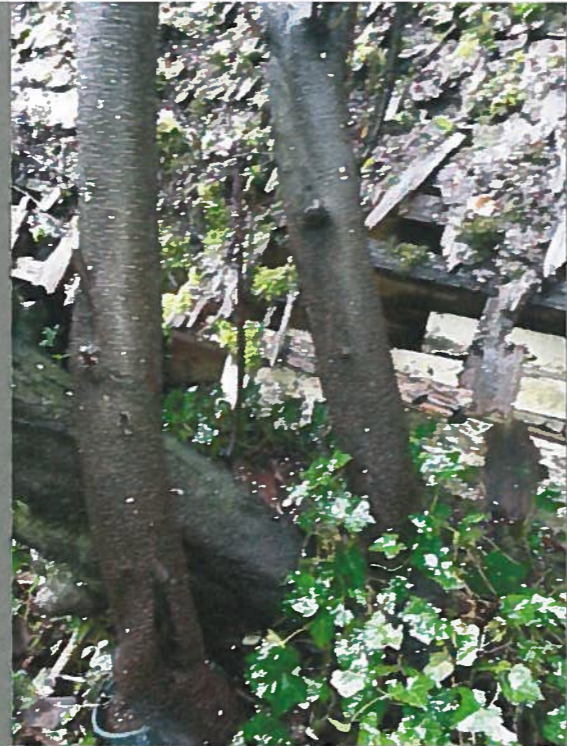
Photo 6. Tree # 5984, is growing in close proximity to the existing carport.

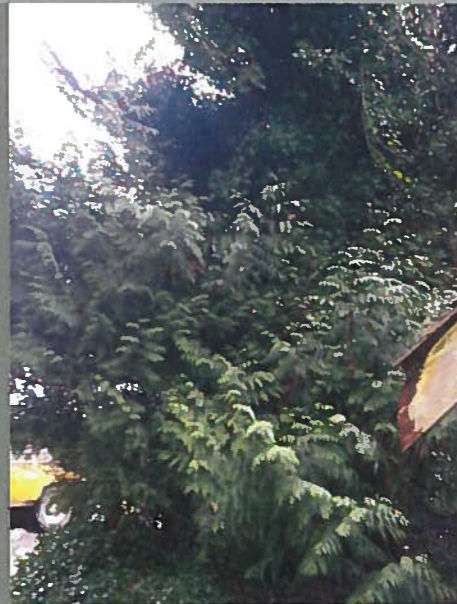
Photo 7. Showing topped tree # 5982.

Tag #	Common Name	Botanical Name	DBH (cm)	Ht (m)	Overall Condition	Retention Suitability	Comments	Retain/Remove	Tree Retention Comments
5982	Western redcedar	<i>Thuja plicata</i>	54	7	Very poor	Unsuitable	This tree has been previously topped to the height of 7m for overhead Hydro line clearance. Decay is visible at the historic topping wounds. The tree is growing in an above grade rock walled planter.	Remove	Due to pre-existing very poor health and structural condition.
5983	Western hemlock	<i>Tsuga heterophylla</i>	93	10	Very poor	Unsuitable	This tree has been previously topped and there is decay visible at the historic topping site. There is a fruiting body of decay (conk - Ganoderma applanatum) located approximately 1.5m above grade. This conk is an indicator of severe internal decay.	Remove	Due to pre-existing very poor health and structural condition.
5984	Purpleleaf plum	<i>Prunus cerasifera</i>	Mul ti	5	Very poor	Unsuitable	This tree has been previously topped with the limbs having been headed. The crown is comprised mostly of shoot growth. There are significant decay cavities throughout the main stems. This tree is growing adjacent a retaining wall for the adjacent carport.	Remove	Due to pre-existing very poor health and structural condition.

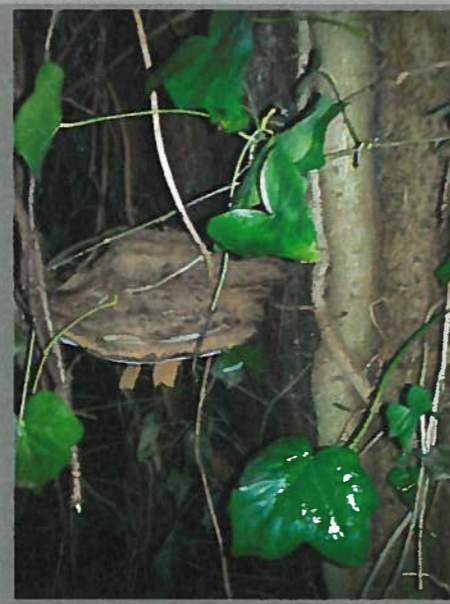
Photo 8. Showing the decay conk growing on Tree # 5983.

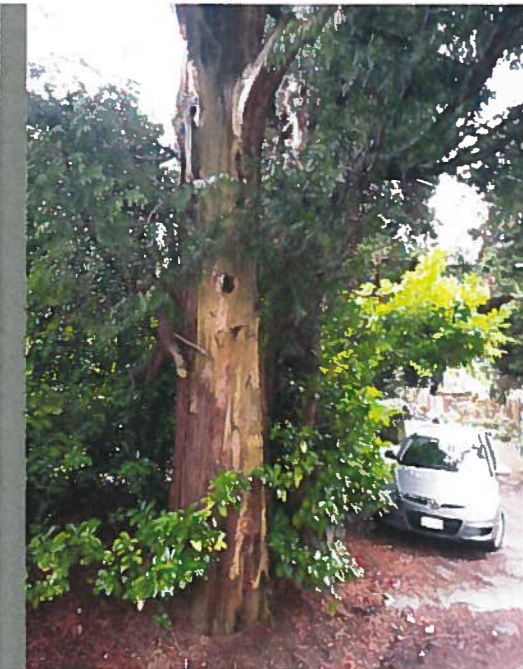
Photo 1: The subject tree has significant wounds on both trunks most likely from historic vehicle damage.

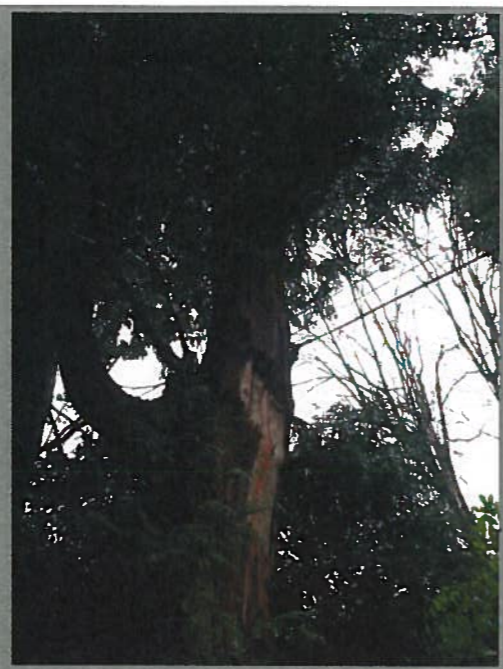
Photo 2: View of a previous replacement leader failure.

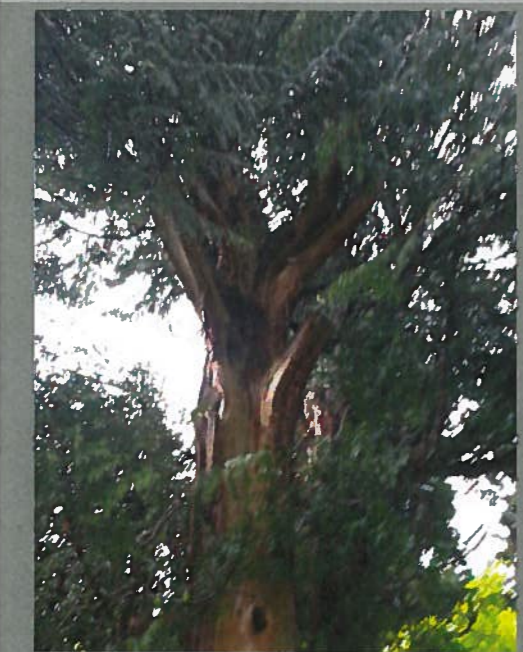
Photo 1: View of the very poor structural condition and the previously topped from of the subject tree. Note the necrotic bark extends from the base to into the top.

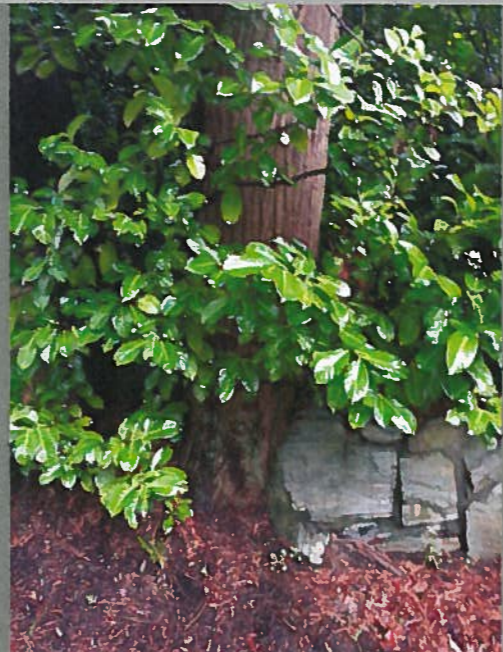
Photo 2: The existing rock wall is embedded into the trees trunk.
