SUTHERLAND HOUSE

1768 INGLEWOOD AVENUE, WEST VANCOUVER, BC

CONSERVATION PLAN

JUNE 2017

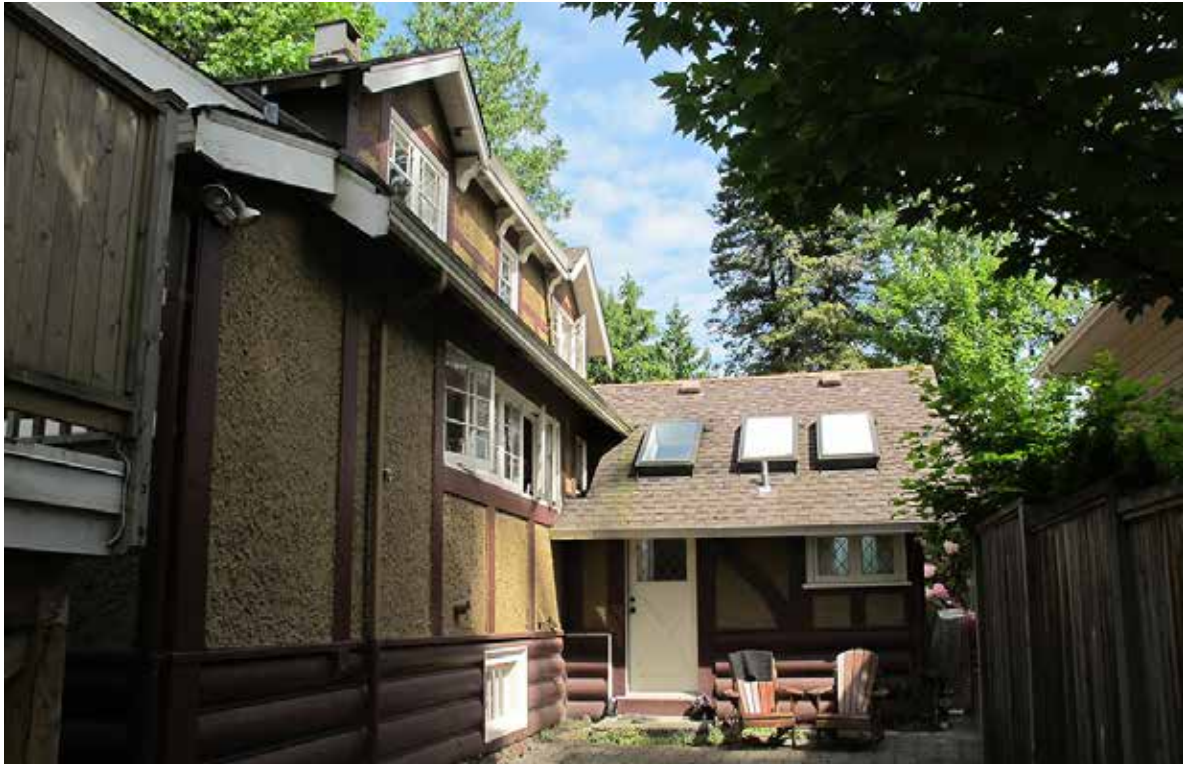
Later additions include a side-gabled extension to the east; a flat-roof extension to the attic, an enclosed porch that is connected to an elevated patio deck at the rear elevation to the south. Not all of the features of the later additions are sympathetic to the historic character of the house, particularly the siding of the exterior wall of the flat-roof extension to the attic. Unsympathetic features can be replaced, as required.

Partial east elevation and later side-gabled extension.

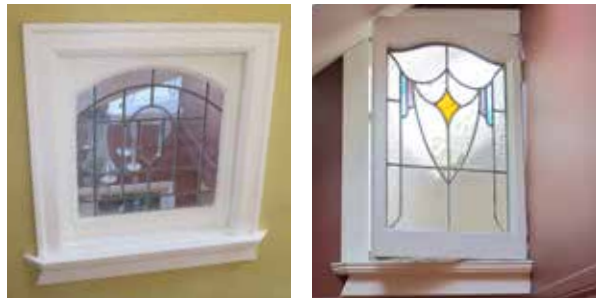
Photos showing existing interior multi-pane stained and leaded glass windows that were formerly exterior windows.

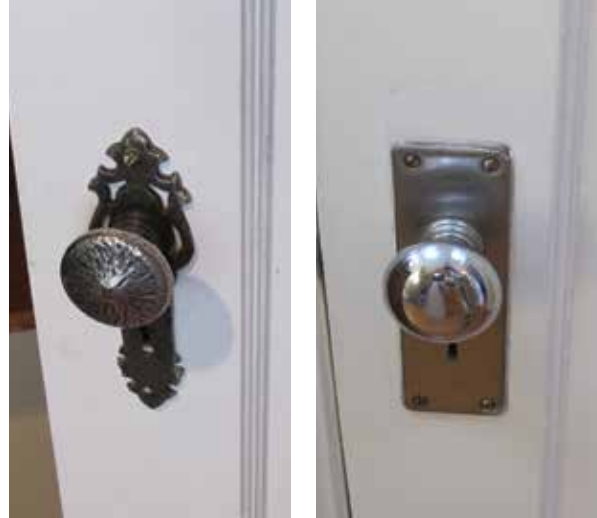
Existing metal door knobs of interior wooden doors.
