RUSH HOUSE

1195 12TH STREET, WEST VANCOUVER, BC

CONSERVATION PLAN

APRIL 2017

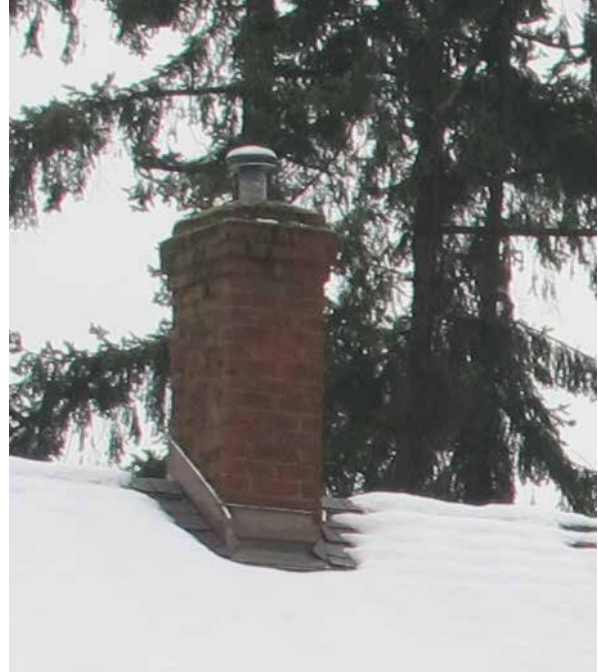
5.5.1 CHIMNEYS

The Rush House features two, original, interior brick chimneys that appear to be in fair condition based on visual review from the ground level. The brick masonry units of both chimneys above the roofline show varying degrees of deterioration, as evident by discolouration, bird deposit staining, biological growth, and deteriorated or missing mortar joints. The surviving, original brick masonry chimneys are character-defining elements of the heritage asset, and should be preserved, and repaired as necessary.

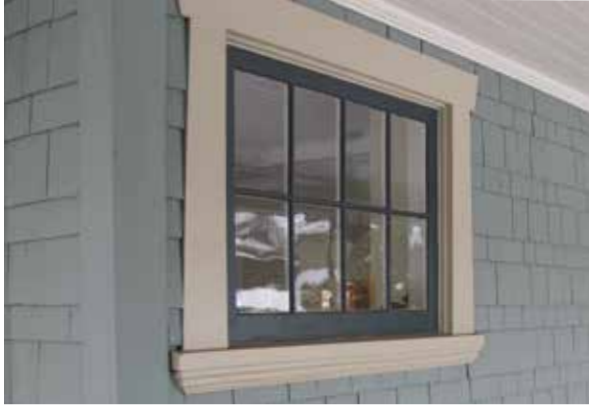
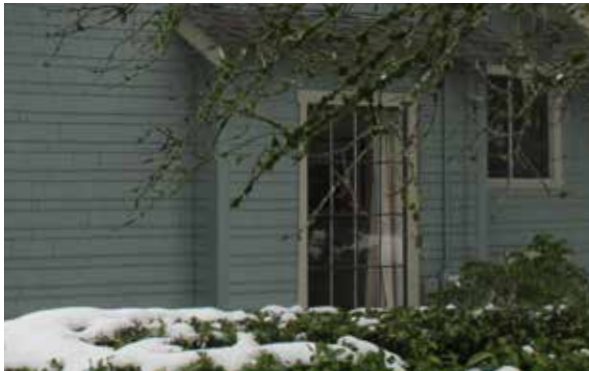
Photos showing existing condition of wrap-around verandah. Note the later porch-deck extension to the verandah (top, left)
