Final Report

Vinson, Brothers, and Hadden Creeks Integrated Stormwater Management Plan

October 2017
KWL File No. 409.073-300

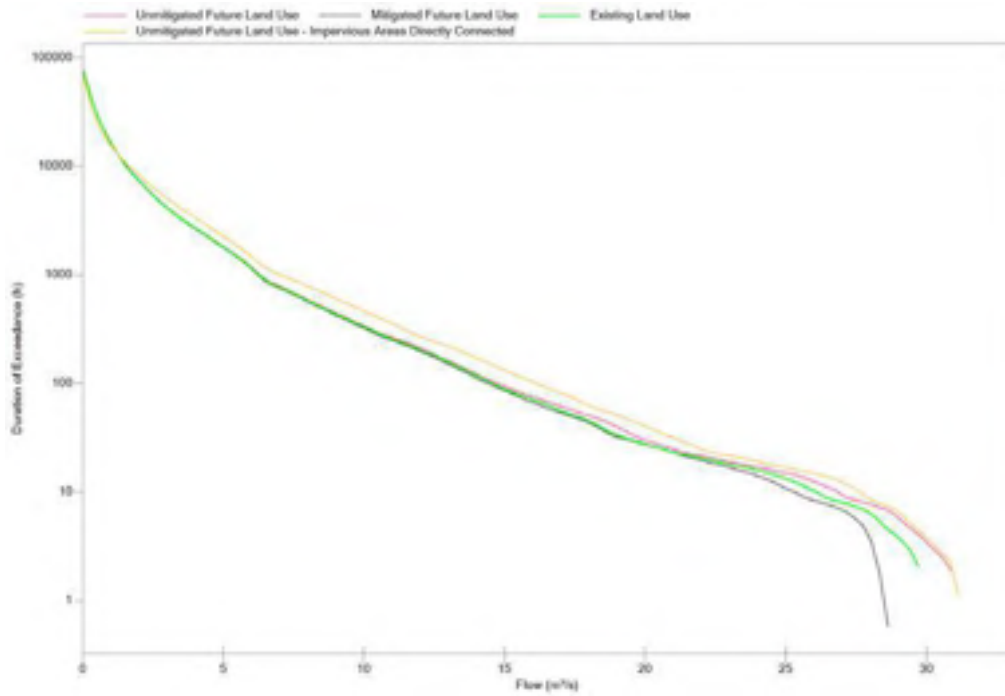
Figure 6-4: Flow Exceedance-Duration Curves for Brothers/Hadden Creek at Confluence with Capilano River

Exceedance-duration curves were developed for each of the modelled scenarios at four key locations in the creeks. These curves are shown in Figures 6-1 to 6-4.

The Unmitigated Future Land Use curves show higher peak flows in the creeks than the Existing Land Use curve and, in general, these flows are sustained for longer durations. The Unmitigated Future Land Use - Impervious Areas Directly Connected scenario shows a longer duration of exceedance for the mid-range flows in addition to the peak flows. The duration of low flows are decreased as compared to all other scenarios because the smaller rain events which would typically infiltrate into the soil and return to the creeks as baseflow are now showing up as runoff, returning to the creeks at higher peak flows.

The Mitigated Future Land Use curve shows decreased magnitude and duration of flows as compared to the Unmitigated Future Land Use curves. The additional topsoil depth provides volume capture to mitigate the increased runoff from impervious areas, while the storage facilities attenuate peak flows. This draws the exceedance-duration curve down to meet the Existing Land Use curve, showing that the recommended mitigation measures are effective in maintaining both the magnitude and duration of flows in the creeks.

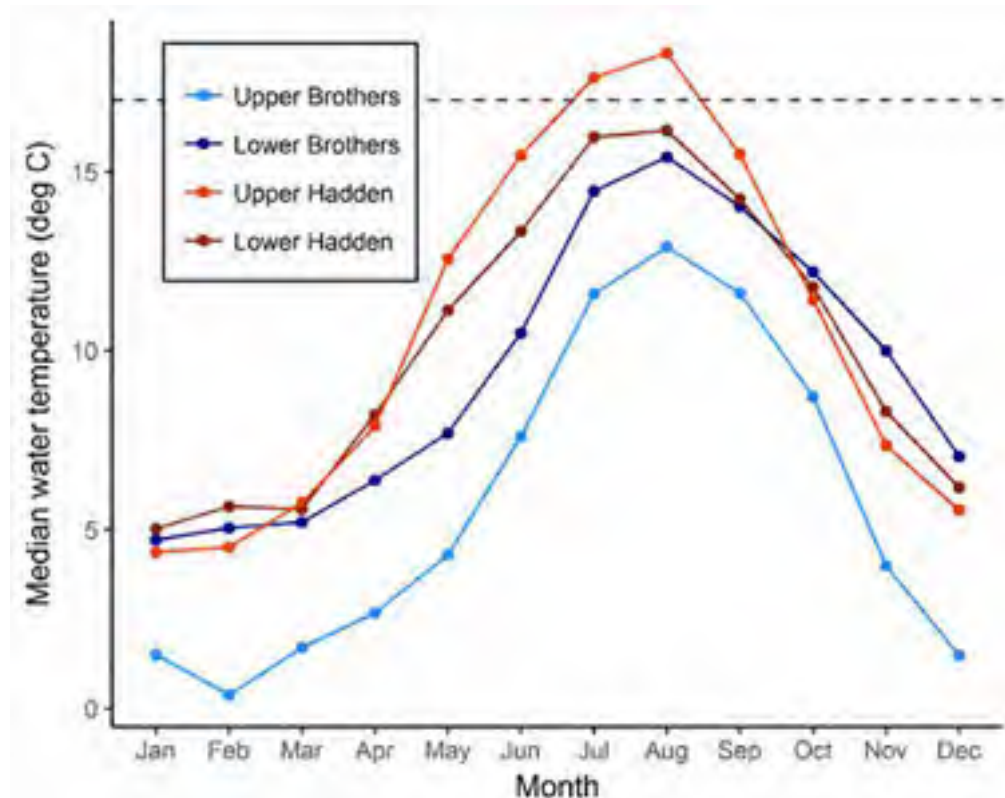
Graph C-1: Monthly Median Water Temperature at Four Monitoring Stations from 2011-2016.¹

there are two ponds in segment HA-2.2, where direct sunlight warms the water that flows downstream. Upstream of the golf course, reaches HA-3 and HA-4 also have low percentages of riparian forest cover (15-31%). In contrast, segment HA-1.3 (between the Upper and Lower Hadden temperature monitoring stations) has 93% forest cover in its riparian zone. This cover likely allows for the water to cool as it flows downstream.

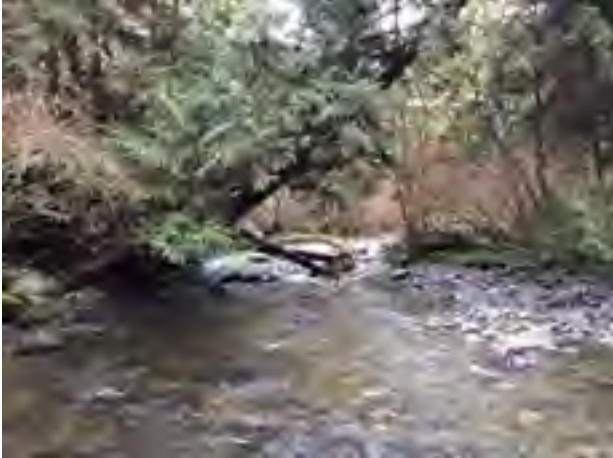
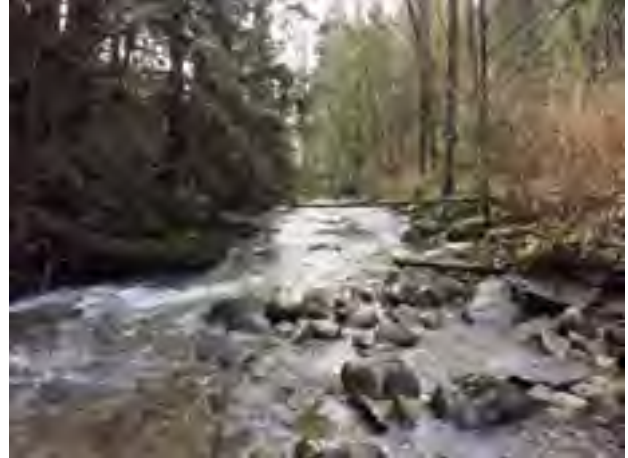
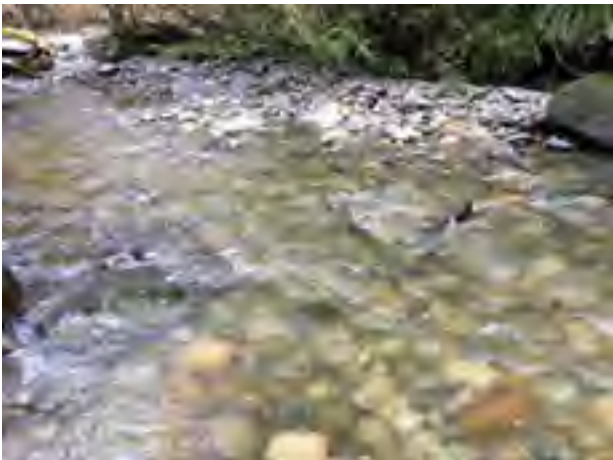
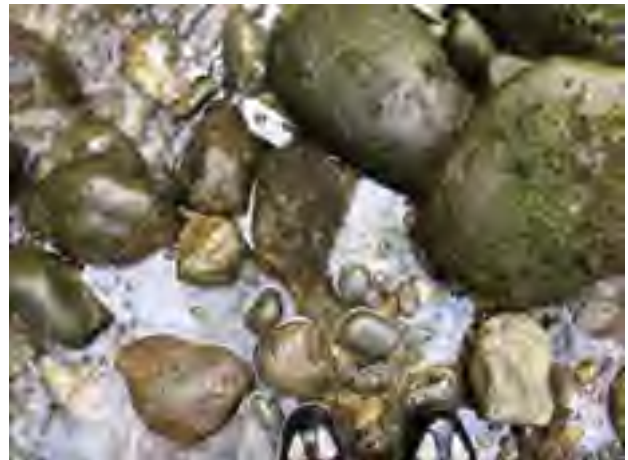
Brothers Creek **Segment: BR-1.1**

February 2, 2016 Between confluence with Capilano River and Keith Rd

Wetted width: 8 m	Instream cover: 5%	Spawning gravel: Extensive
Bankfull width: 9.4 m	LWD: Few	Rearing habitat: Moderate
General comments:	High quality habitat but lacking large woody debris (LWD); naturally functioning channel processes. Consistent riparian area tree size and structure throughout, substrate dominated

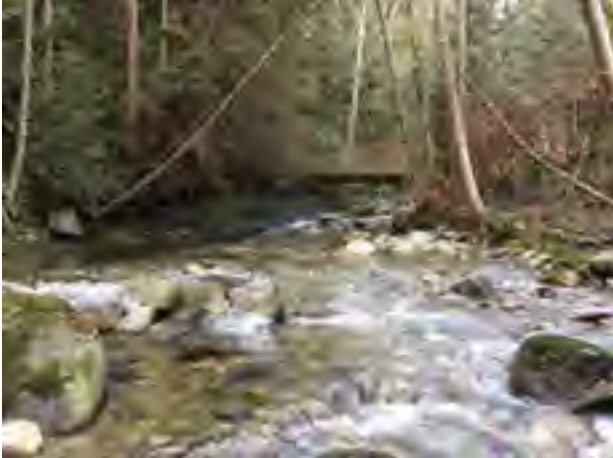
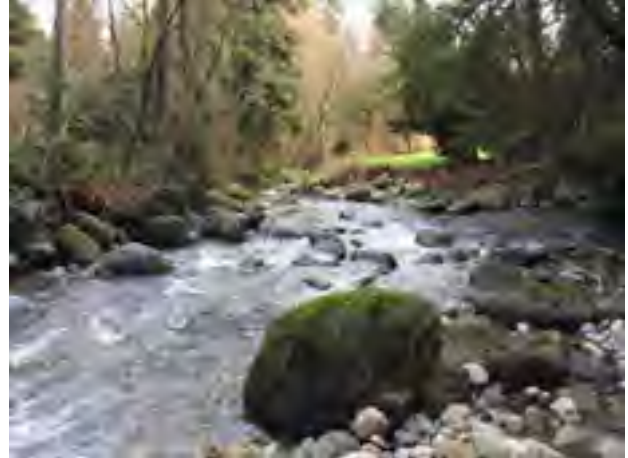
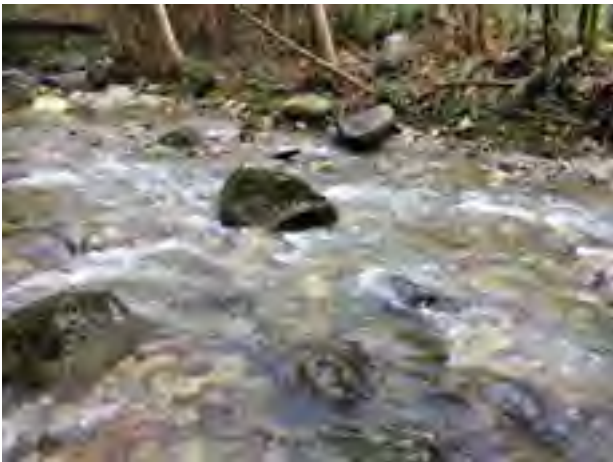
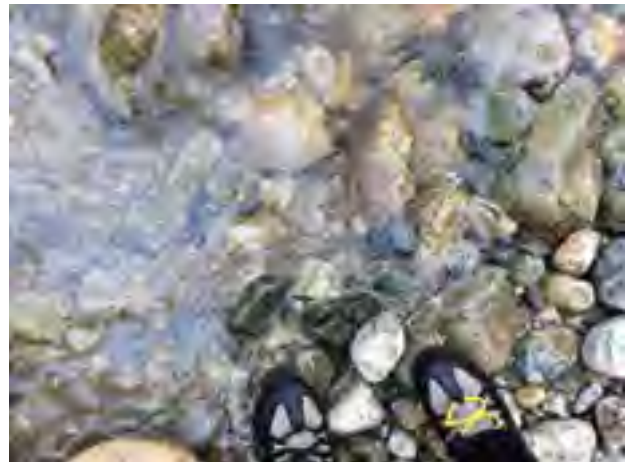
Between Keith Rd and Inglewood Ave

Wetted width: 7 m	Instream cover: 10%	Spawning gravel: Extensive
Bankfull width: 9 m	LWD: Few	Rearing habitat: Moderate
General comments:	Deep ravine lower down, frequent out-falls, concrete manholes for sewer access every 100 m, concrete sewer pipes in stream, generally good fish habitat, little LWD, abundant English ivy and other invasive plants.

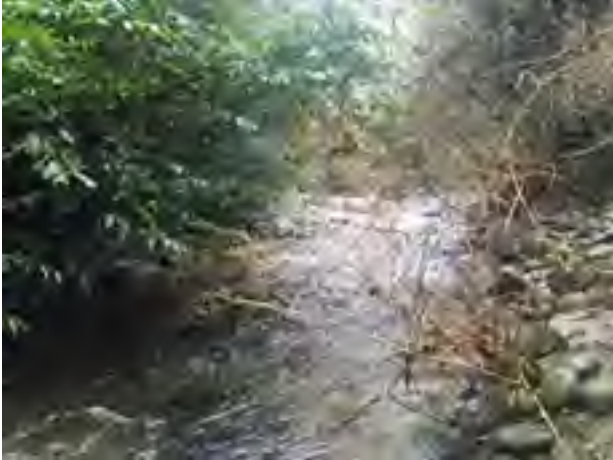
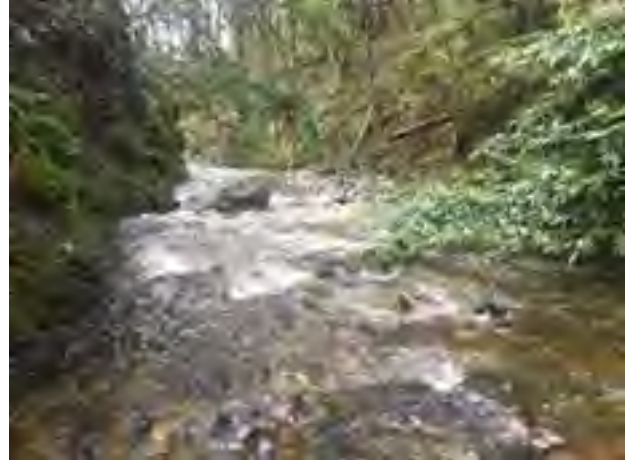
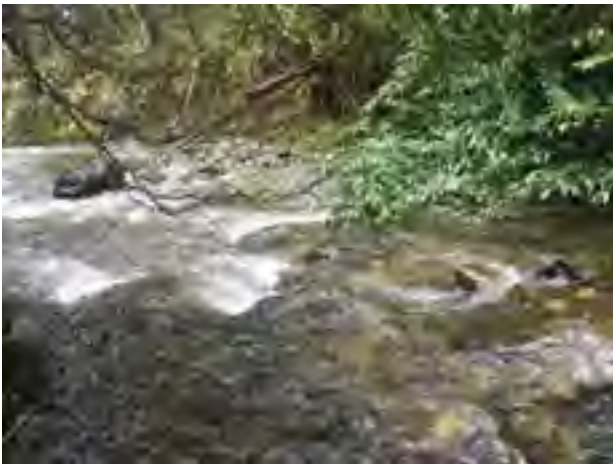
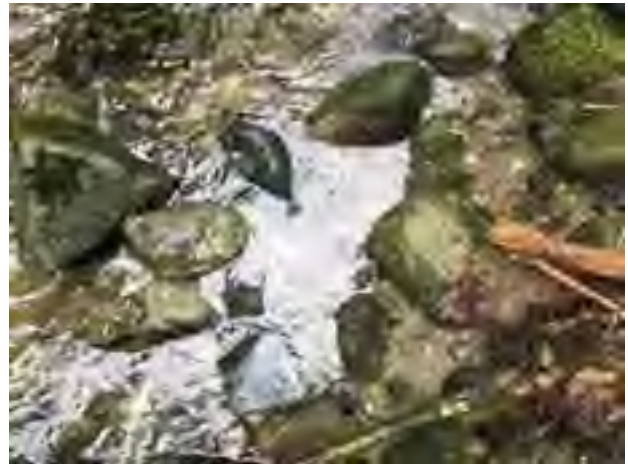
Brothers Creek Segment: BR-1.3

February 4, 2016 Confluence with Hadden Creek to Inglewood Ave

Wetted width:	7 m	Instream cover:	15%	Spawning gravel:	Extensive
Bankfull width:	8.5 m	LWD:	Few	Rearing habitat:	Moderate
General comments:	Generally good fish habitat, lacking abundant LWD. Confined along ~50% of length by steep bedrock banks. Remnants of small dam with diversion reach and aqueduct. Mid-section with frequent bank armouring. Some large trees on the right bank, midway along the segment. More accumulation of fines than downstream segments BR-1.1 and BR-1.2.

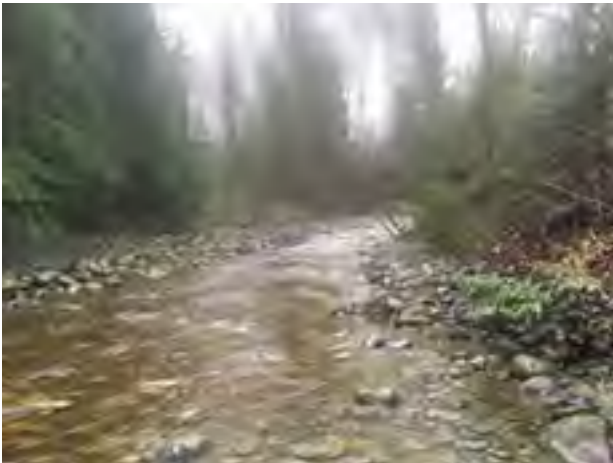
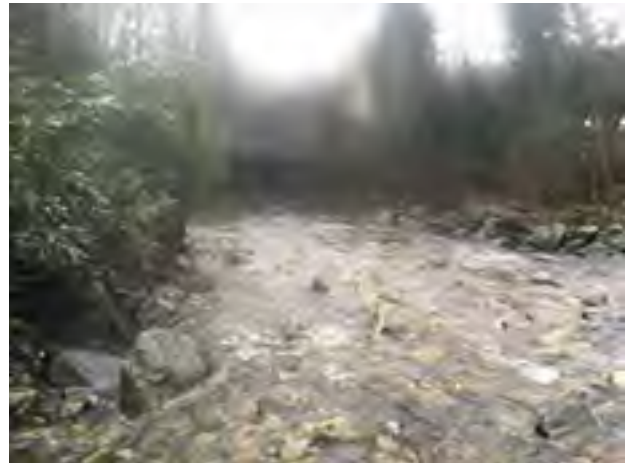
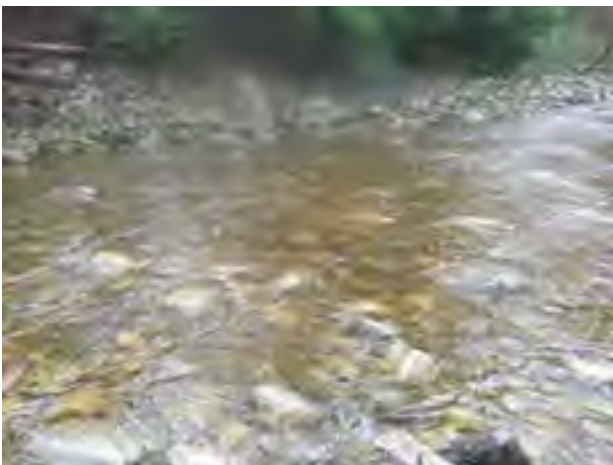
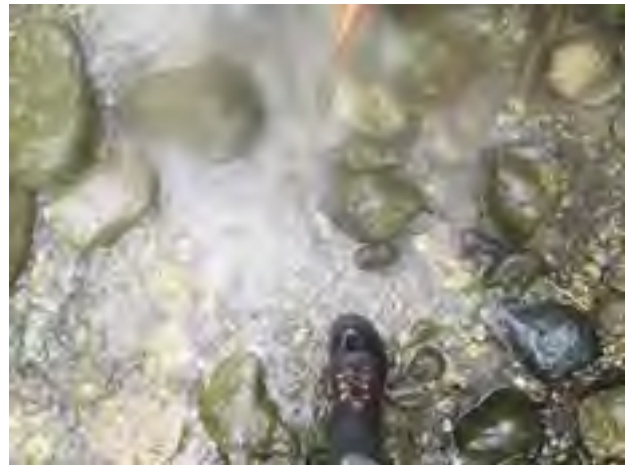
From the confluence of with Hadden Creek to Highway 1 culvert

Wetted width: 12 m Instream cover: 5% Spawning gravel: Extensive

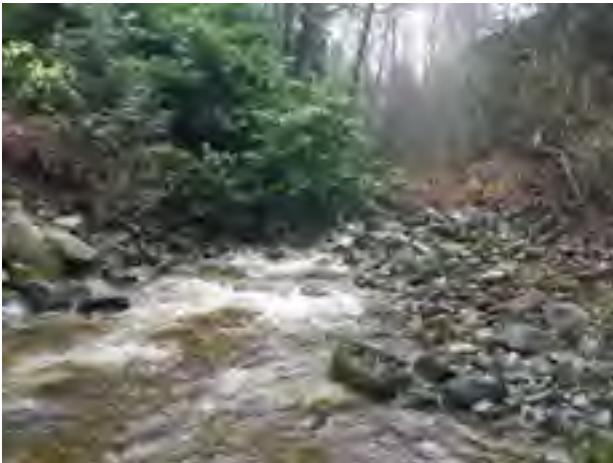
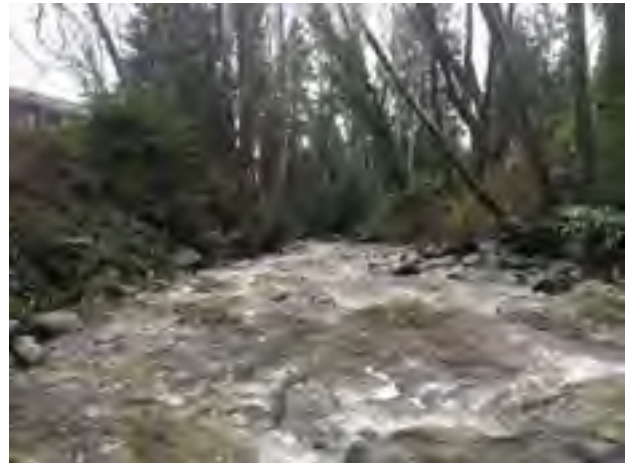
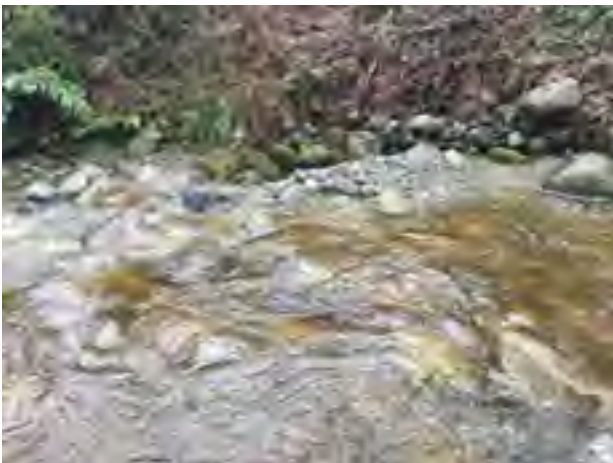
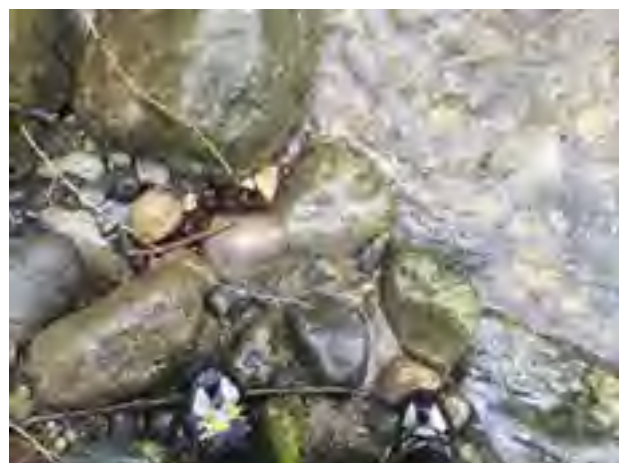
Brothers Creek **Segment: BR-2.1**

February 10, 2016 From Highway 1 culvert to significant gradient change

Wetted width:	8 m	Instream cover:	10%	Spawning gravel:	Extensive
Bankfull width:	9 m	LWD:	Few	Rearing habitat:	Moderate
General comments:	Good fish habitat with abundant spawning gravel. Narrow riparian band. Little cover and LWD. Bank protection throughout segment.

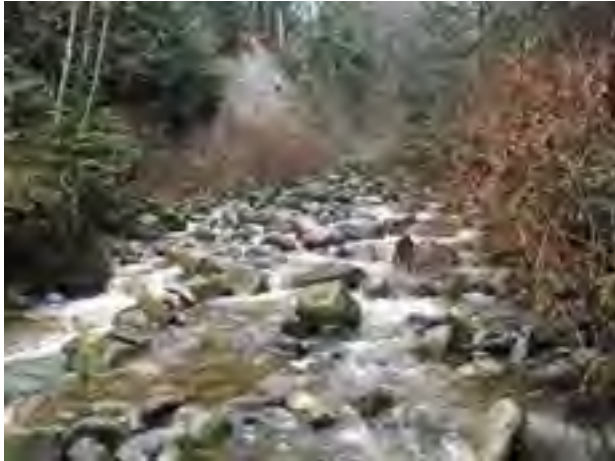
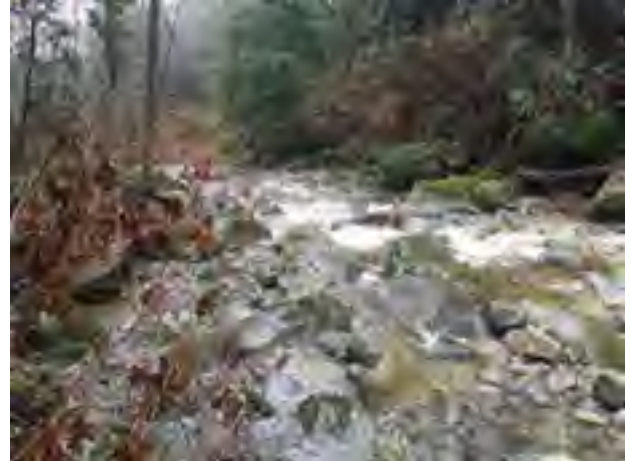
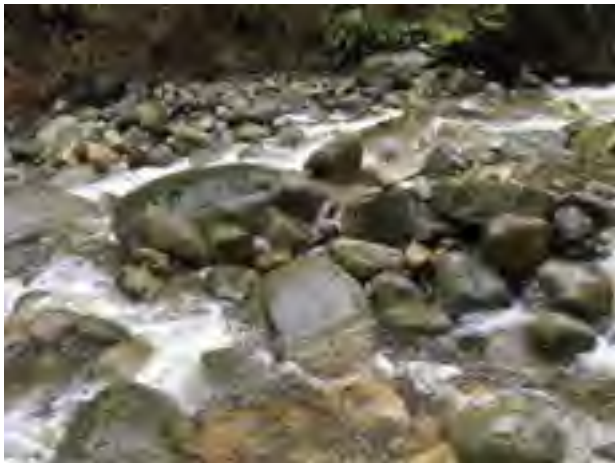
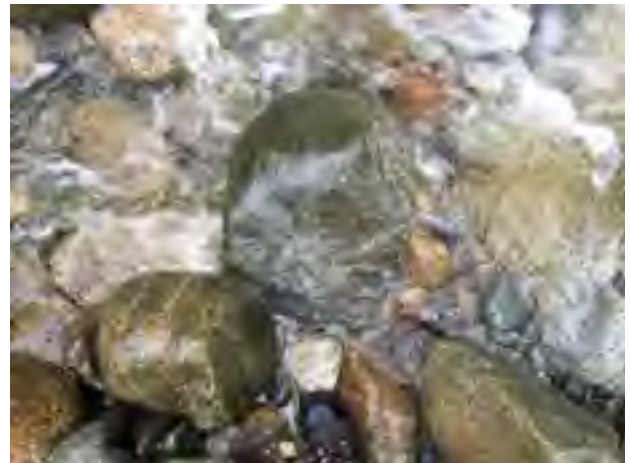
Brothers Creek **Segment: BR-2.2**

February 10, 2016 Upstream of the gradient change to the confluence with the east branch tributary, generally between Cross Creek Rd and Highway 1

Wetted width: 12 m Instream cover: 15% Spawning gravel: Extensive

General comments: High quality fish habitat with frequent pools and LWD input from forest. Some erosion of banks but low risk to property damage.

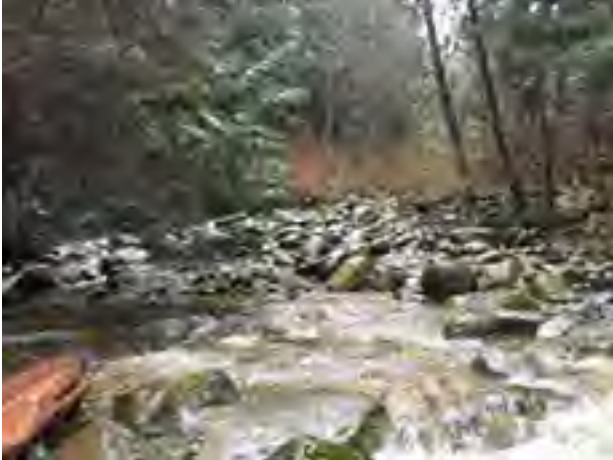
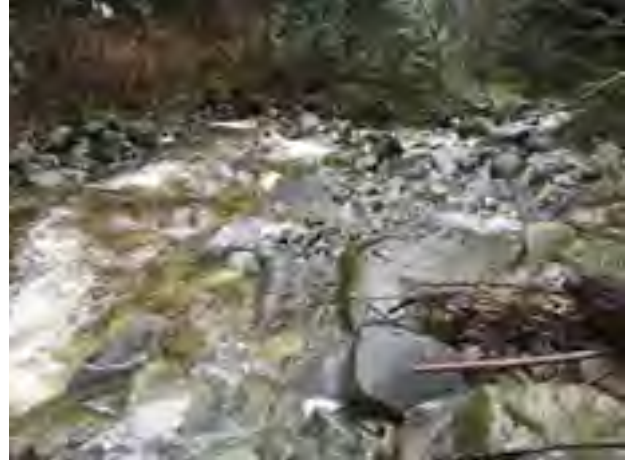
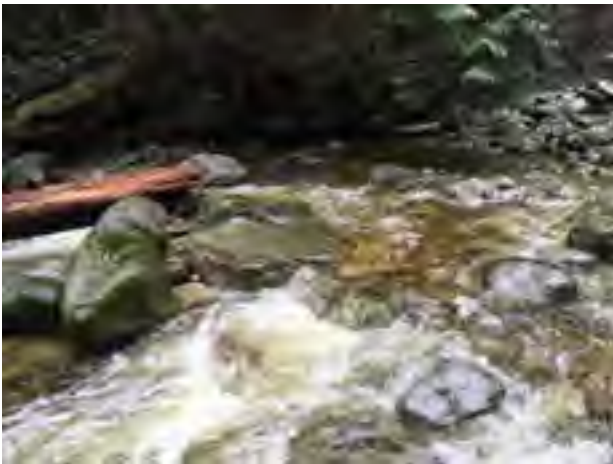
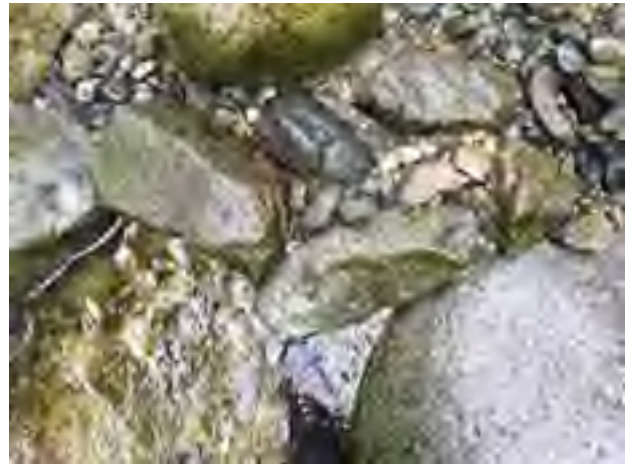
Brothers Creek Segment: BR-2.3

February 10, 2016 Downstream of Cross Creek Rd to the confluence with the east branch tributary

Wetted width:	12 m	Instream cover:	10%	Spawning gravel:	Abundant
Bankfull width:	14 m	LWD:	Abundant	Rearing habitat:	Moderate
General comments:	Cascade pool segment with potential fish barriers throughout. Mature riparian. Several large erosion points.

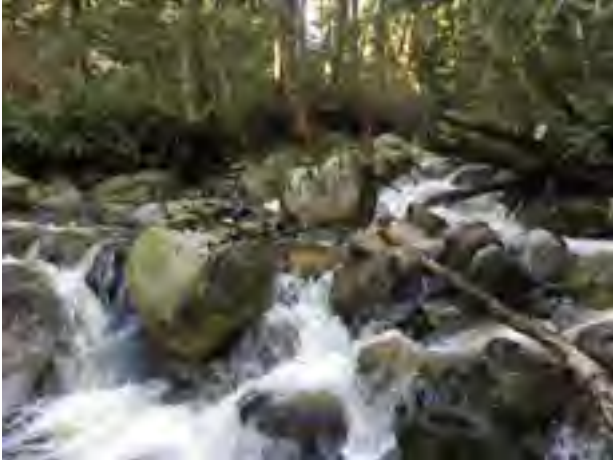
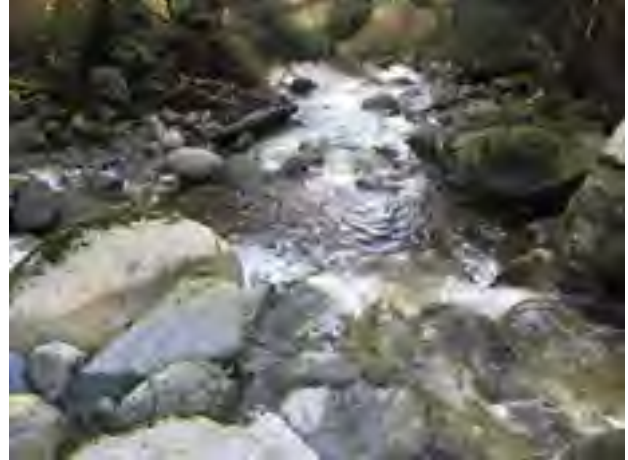
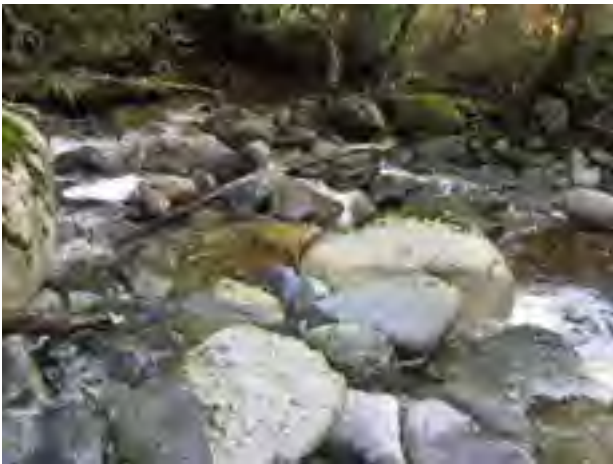
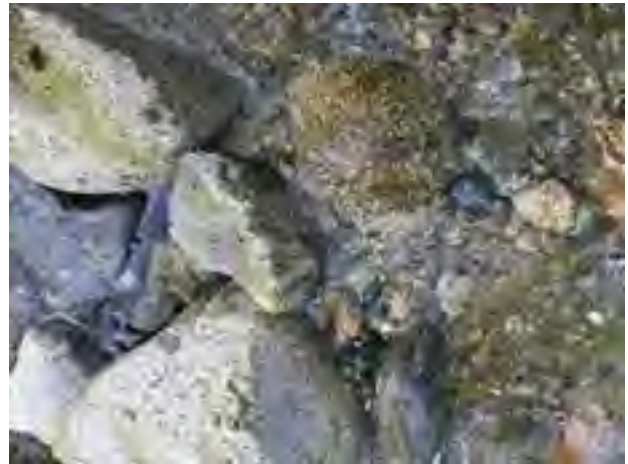
Brothers Creek Segment: BR-3.1

February 10, 2016 Upstream of Cross Creek Rd to Burnside Rd

Wetted width: 10 m	Instream cover: 10%	Spawning gravel: Little
Bankfull width: 13 m	LWD: Abundant	Rearing habitat: Moderate
General comments:	Abundant cascades and several significant fish barriers. Frequent pools and LWD. Possible resident fish presence, unlikely anadromous salmon.

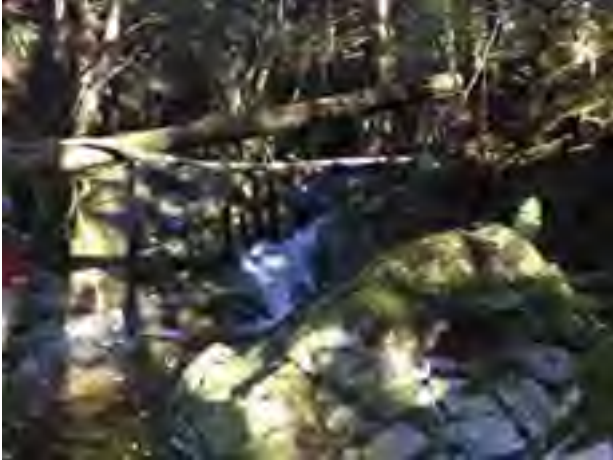
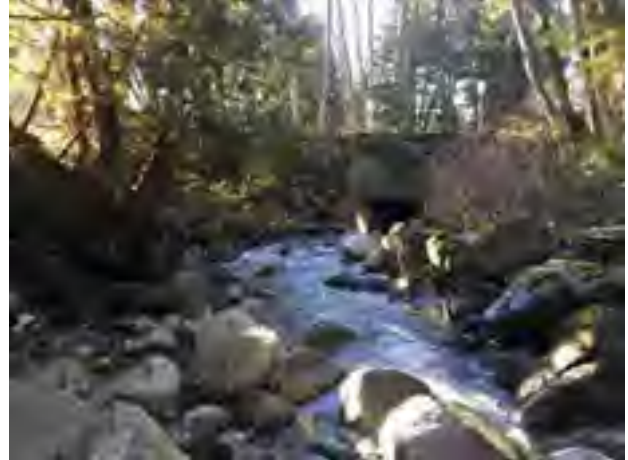
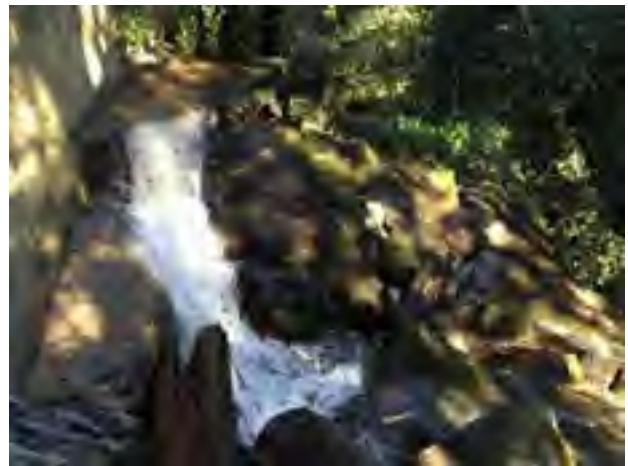
Brothers Creek Segment: BR-3.2

February 23, 2016 Between Burnside Rd and Crestwell Rd

Photo A-33: Looking Upstream

Photo A-34: Looking Downstream

Photo A-35: Typical Riffle

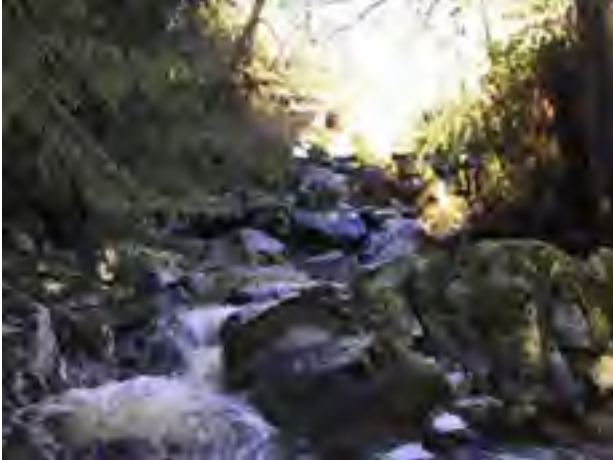
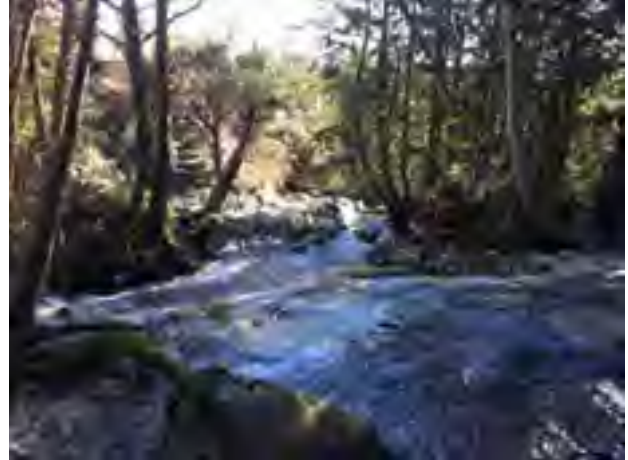
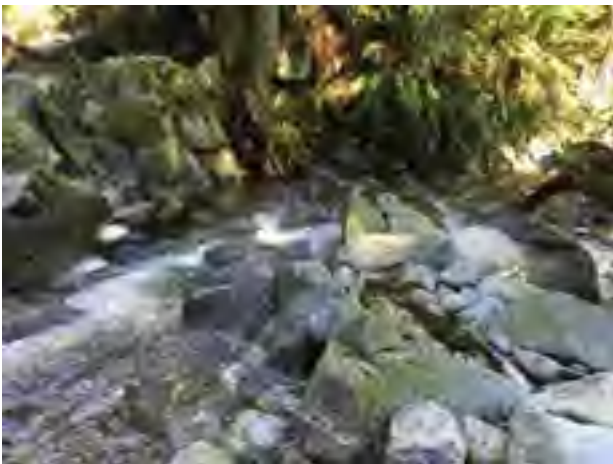
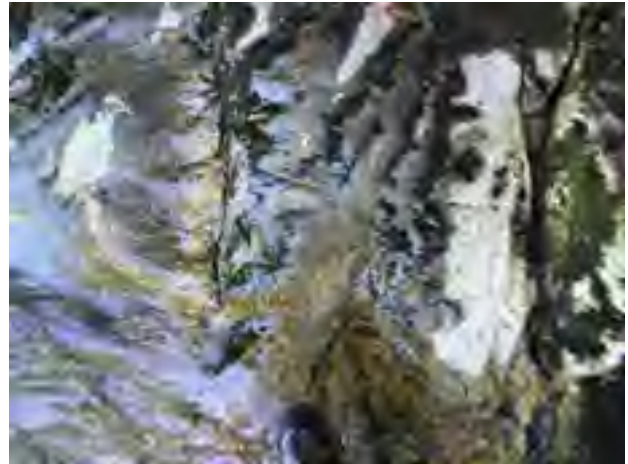
Brothers Creek Segment: BR-3.3

February 23, 2016 Between Crestwell Rd to Eyremount Rd

Photo A-37: Looking Upstream

Photo A-38: Looking Downstream

Photo A-39: Typical Riffle

Photo A-40: Typical Substrate Conditions

Wetted width:	3.5 m	Instream cover:	5%	Spawning gravel:	Little
Bankfull width:	4.5 m	LWD:	Few	Rearing habitat:	Little
General comments:	Encroachment increases upstream of canyon section. Loss of riparian trees throughout. Not accessible to anadromous fish. Frequent cascades.

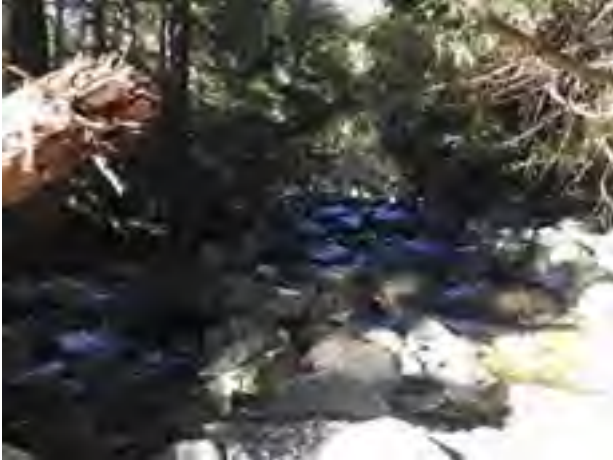
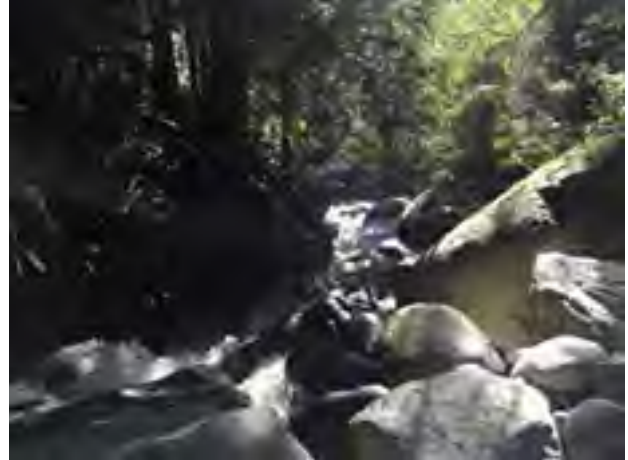
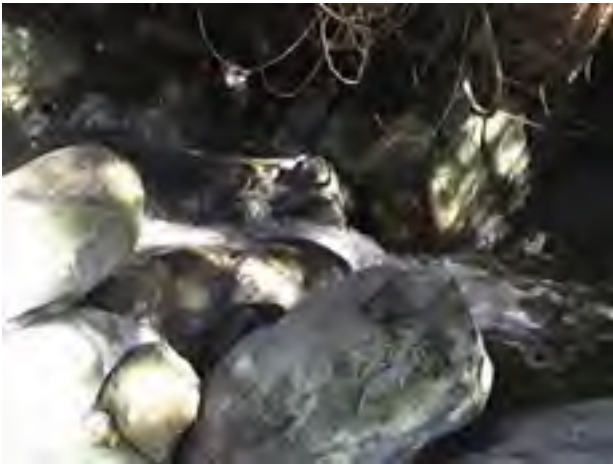
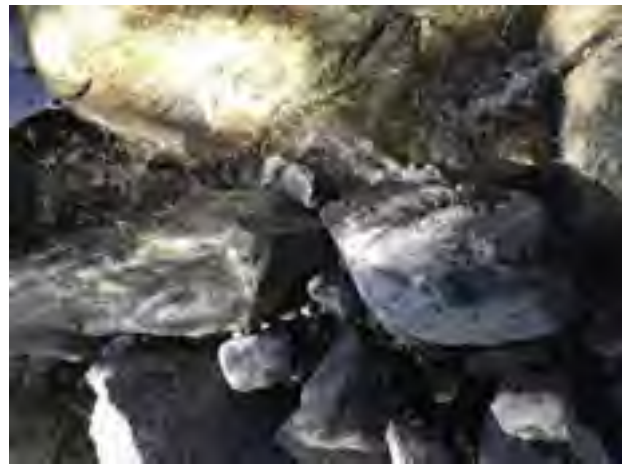
Brothers Creek Segment: BR-3.4

February 23, 2016 Between Eyremount Dr and Millstream Rd

Photo A-41: Looking Upstream

Photo A-42: Looking Downstream

Photo A-43: Typical Riffle

Photo A-44: Typical Substrate Conditions

Wetted width: 4 m	Instream cover: 5%	Spawning gravel: Little
Bankfull width: 5 m	LWD: Few	Rearing habitat: Little
General comments:	More intact riparian forest and less encroachment than downstream segment. Cascades throughout.

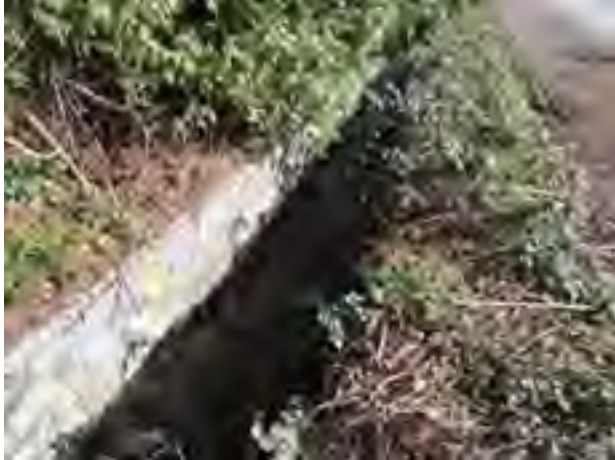
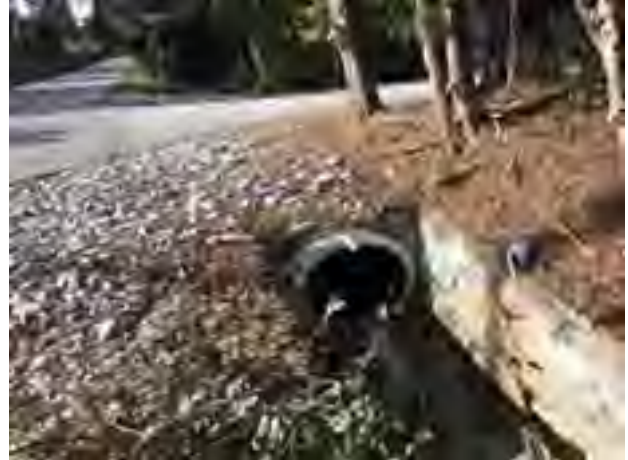
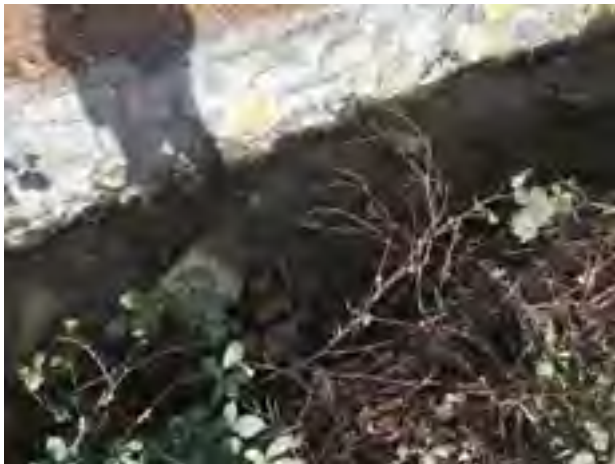
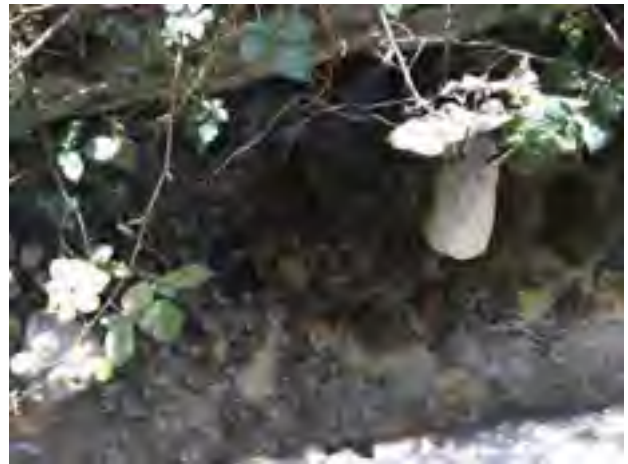
Brothers Creek Segment: BR-4.1

February 24, 2016 From confluence with Brothers Creek to the end of channelized segment

Photo A-45: Looking Upstream

Photo A-46: Looking Downstream

Photo A-47: Typical Riffle

Photo A-48: Typical Substrate Conditions

Wetted width:	1 m	Instream cover:	5%	Spawning gravel:	Extensive
Bankfull width:	1 m	LWD:	None	Rearing habitat:	None
General comments:	Poor fish habitat. Mostly channelized with grouted rock bottom. Some spawning gravels retained, but no rearing habitat.

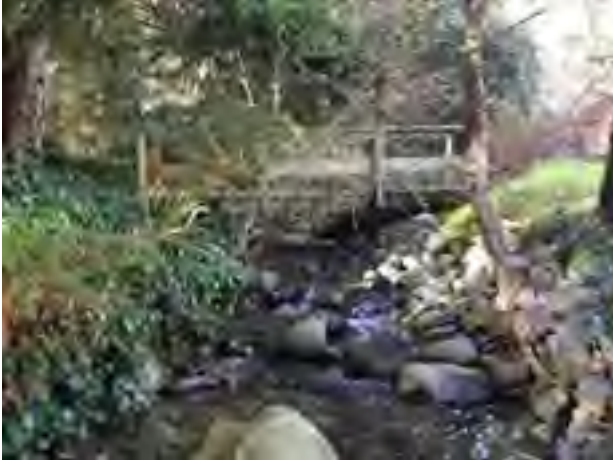
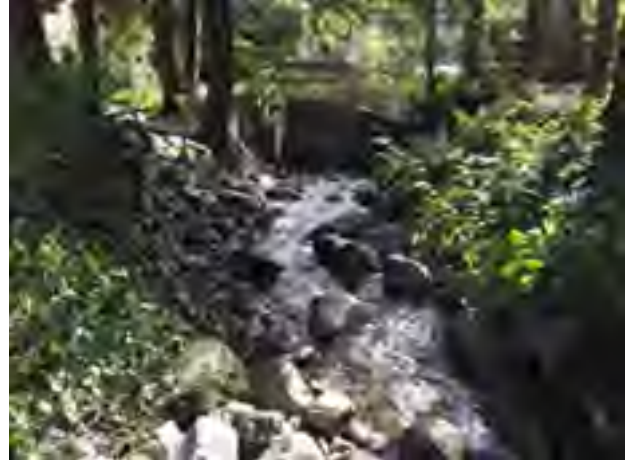
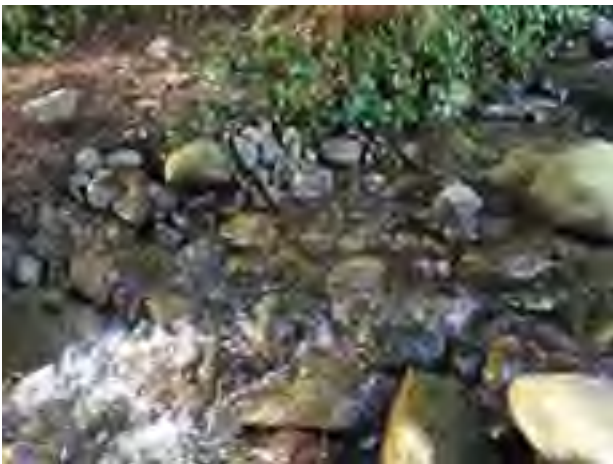
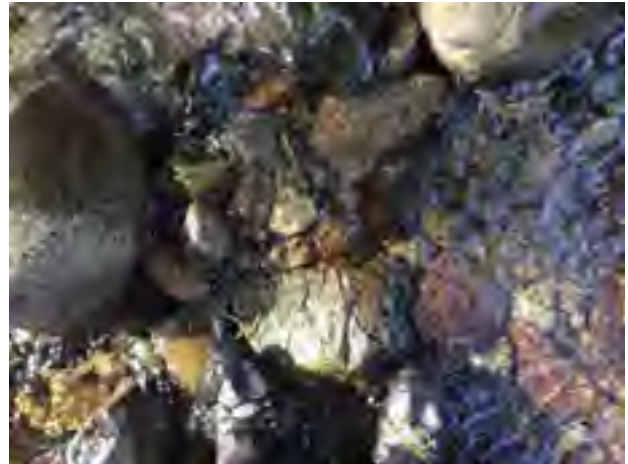
Brothers Creek Segment: BR-4.2

February 24, 2016 From channelized section to forested area

Photo A-49: Looking Upstream

Photo A-50: Looking Downstream

Photo A-51: Typical Riffle

Photo A-52: Typical Substrate Conditions

Wetted width: 2 m	Instream cover: 15%	Spawning gravel: Extensive
Bankfull width: 3 m	LWD: None	Rearing habitat: Moderate
General comments:	Landowner at upstream end says stream has been stable for 30 years. Really nice spawning habitat in lower reach of segment. Landowners mentioned lots of salmon fry and herons in summer. Stream modified with bank protect in many locations. Riparian area heavily impacted.

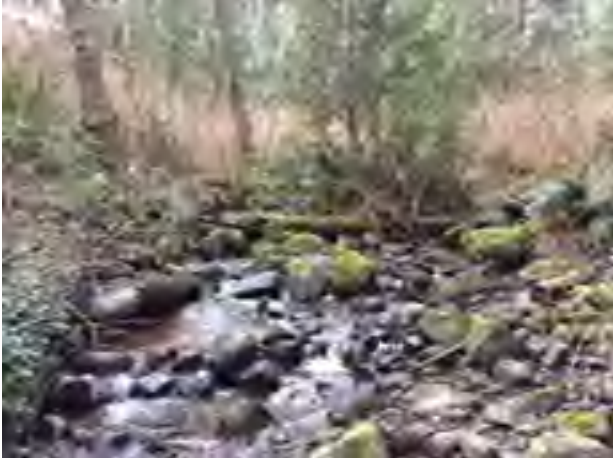
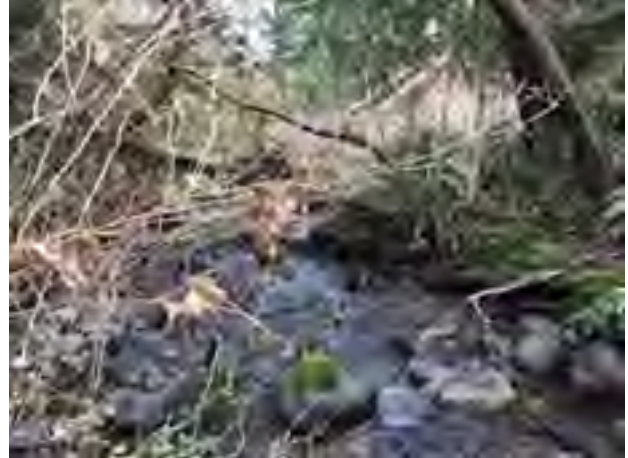
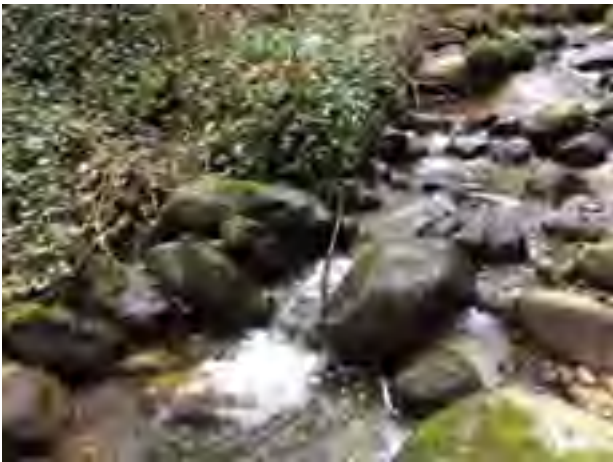
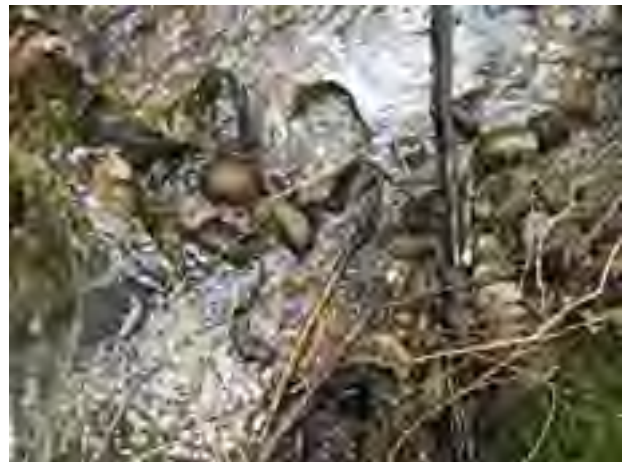
Brothers Creek Segment: BR-4.3

February 24, 2016 Forested section upstream to Cross Creek Dr

Photo A-53: Looking Upstream

Photo A-54: Looking Downstream

Photo A-55: Typical Riffle

Photo A-56: Typical Substrate Conditions

Wetted width: 2.5 m Instream cover: 20% Spawning gravel: Extensive

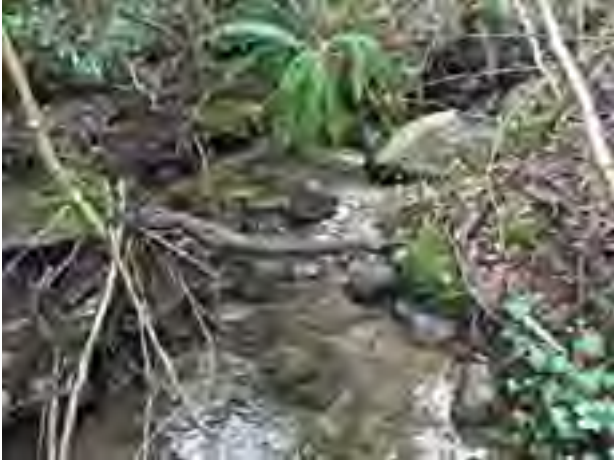
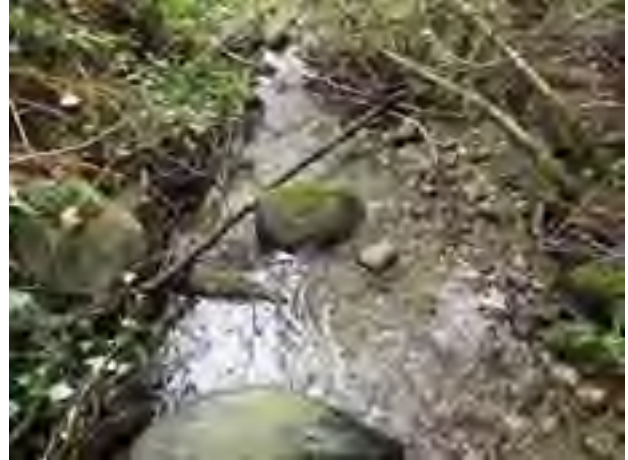
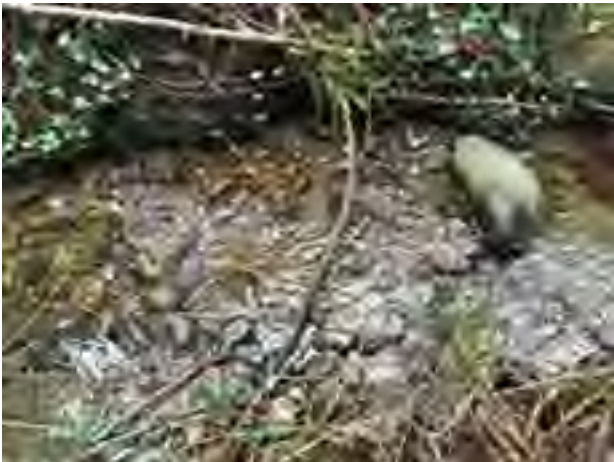
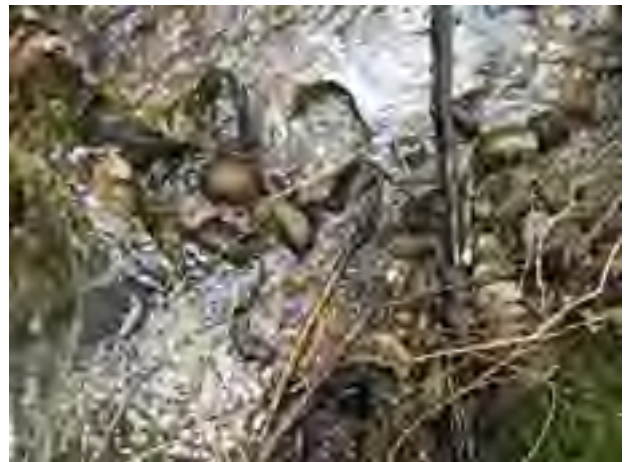
Brothers Creek Segment: BR-4.4

February 24, 2016 Upstream of Cross Creek Dr to Chartwell PI

Photo A-57: Looking Upstream

Photo A-58: Looking Downstream

Photo A-59: Typical Riffle

Photo A-60: Typical Substrate Conditions

Wetted width: 1.8 m	Instream cover: 10%	Spawning gravel: Extensive
Bankfull width: 2 m	LWD: Few	Rearing habitat: Moderate
General comments:	Some sections with relatively intact riparian forest. Others in backyards with active shrub and tree removal including salmonberry on river banks and 30 cm cedars within 4 m of stream. Invasive species throughout. One large gabion wall.

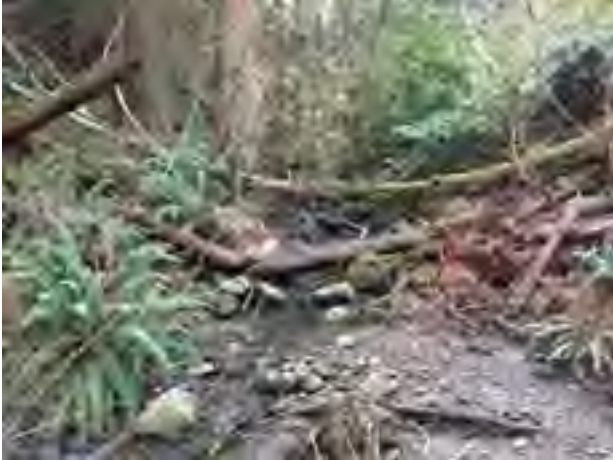
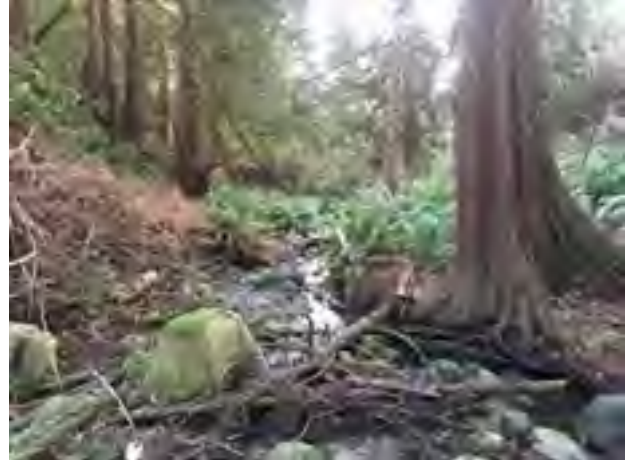
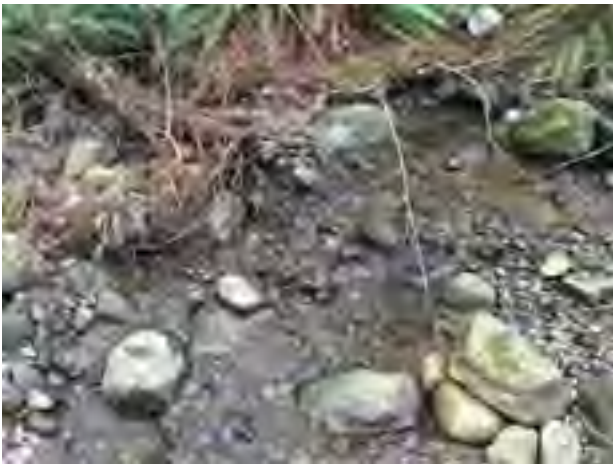
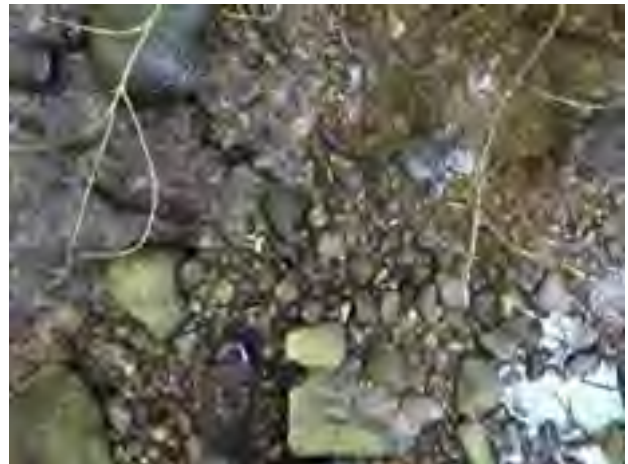
Brothers Creek Segment: BR-4.5

February 25, 2016 Upstream of Chartwell PI to the downstream extent of step-pool segment within Chartwell Park

Photo A-61: Looking Upstream

Photo A-62: Looking Downstream

Photo A-63: Typical Riffle

Photo A-64: Typical Substrate Conditions

Wetted width: 1.8 m Instream cover: 15% Spawning gravel: Extensive
