Final Report

Vinson, Brothers, and Hadden Creeks Integrated Stormwater Management Plan

October 2017
KWL File No. 409.073-300

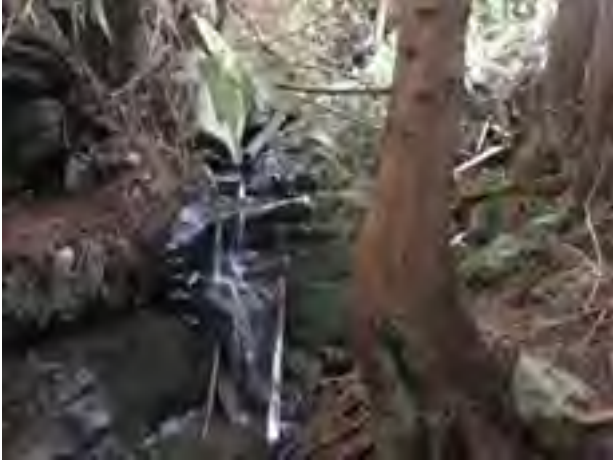
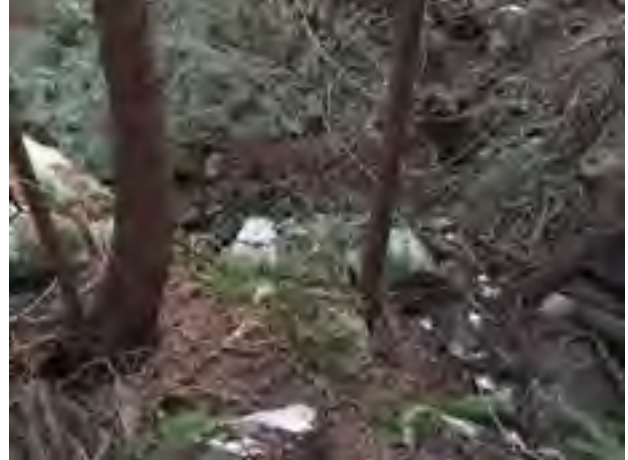
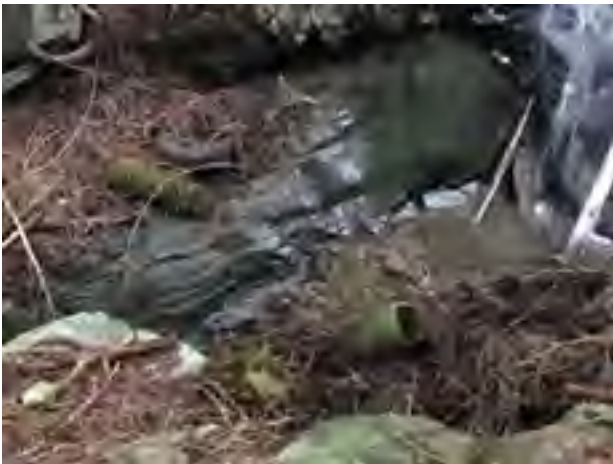
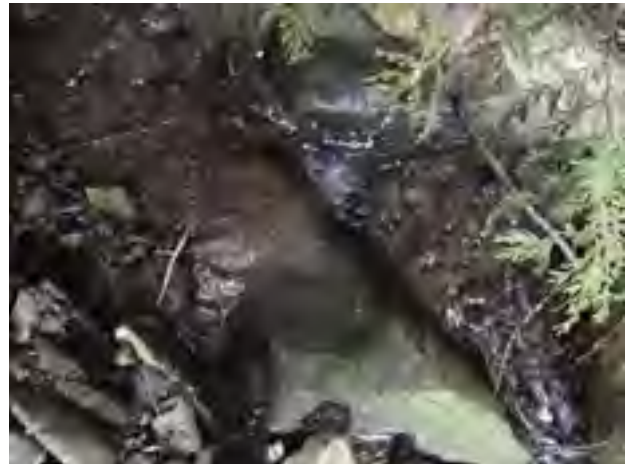
Brothers Creek Segment: BR-4.6

February 25, 2016 Step-pool segment of Chartwell Park, downstream of Burnside Rd

Photo A-65: Looking Upstream

Photo A-66: Looking Downstream

Photo A-67: Typical Riffle

Photo A-68: Typical Substrate Conditions

Wetted width: 1 m	Instream cover: 5%	Spawning gravel: None
Bankfull width: 1.5 m	LWD: Few	Rearing habitat: None
General comments:	Step pool canyon section mainly bedrock and boulder. Rapid gradient change from downstream segment. Fish barrier

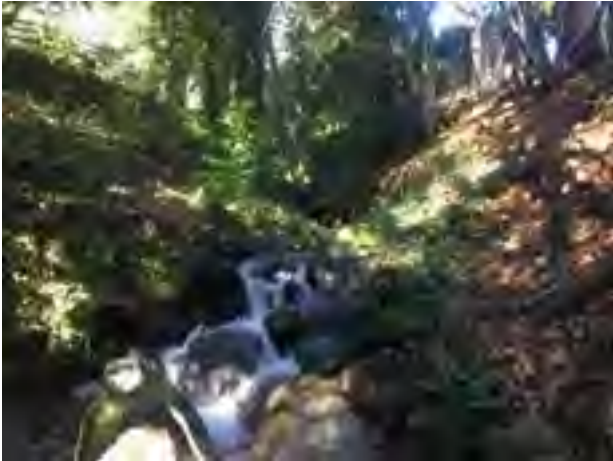
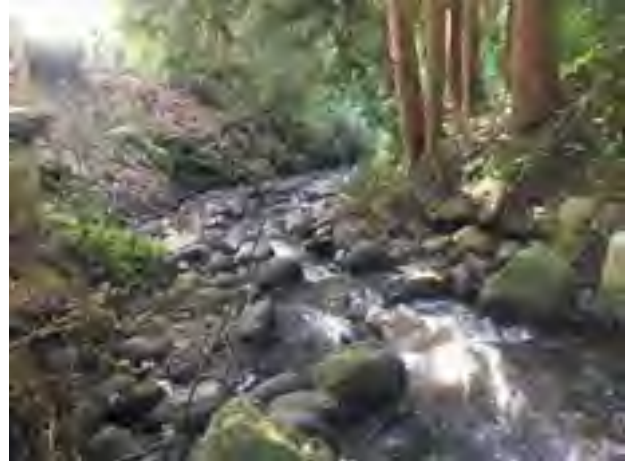
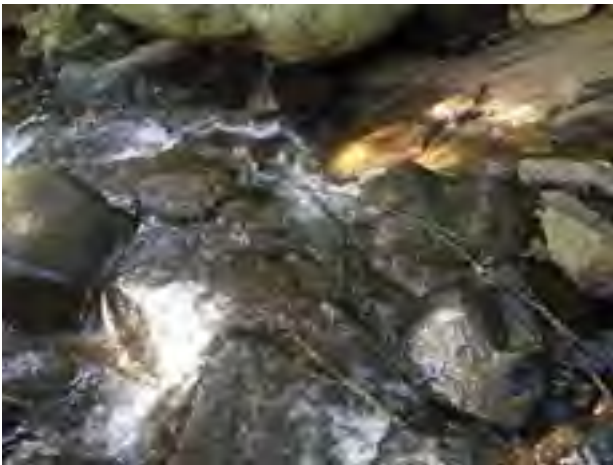
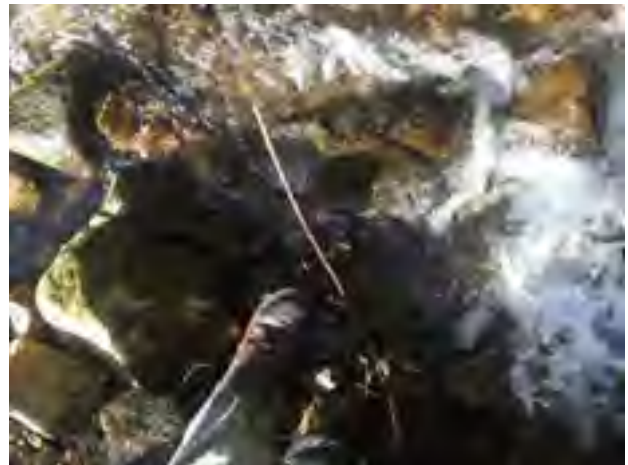
Brothers Creek Segment: BR-5.1

February 23, 2016 Tributary of Brothers Creek from confluence just downstream of Highland Dr to Eyremount Dr

Photo A-69: Looking Upstream

Photo A-70: Looking Downstream

Photo A-71: Typical Riffle

Photo A-72: Typical Substrate Conditions

Wetted width: 2 m	Instream cover: 15%	Spawning gravel: Extensive
Bankfull width: 2.6 m	LWD: Few	Rearing habitat: Moderate
General comments:	Tributary of Brothers Creek with potential fish barrier above confluence with Brothers creek. Narrow~5-10 m riparian.

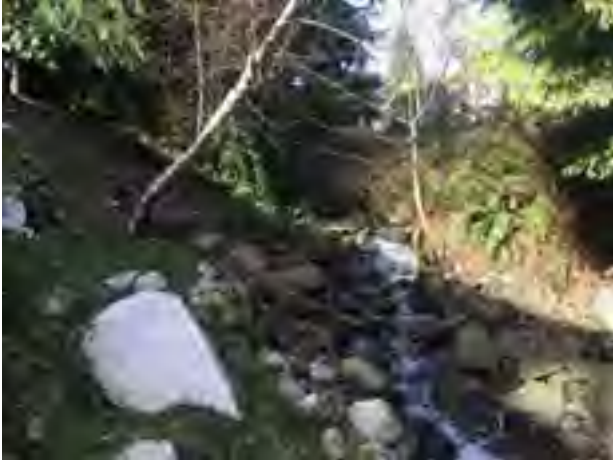
Brothers Creek Segment: BR-5.2

February 23, 2016 Upstream of Eyremount Dr to Groveland Rd

Photo A-73: Looking Upstream

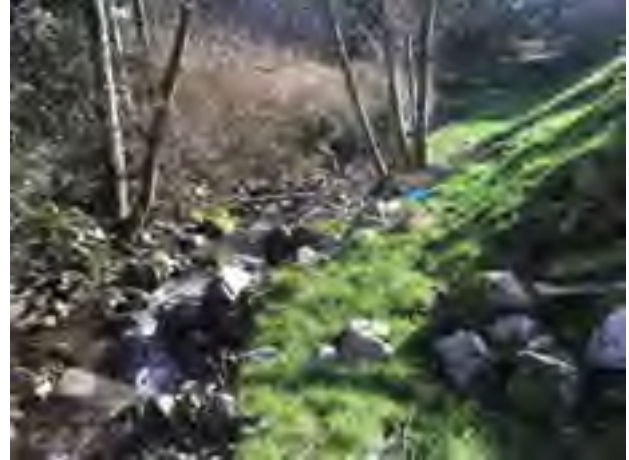
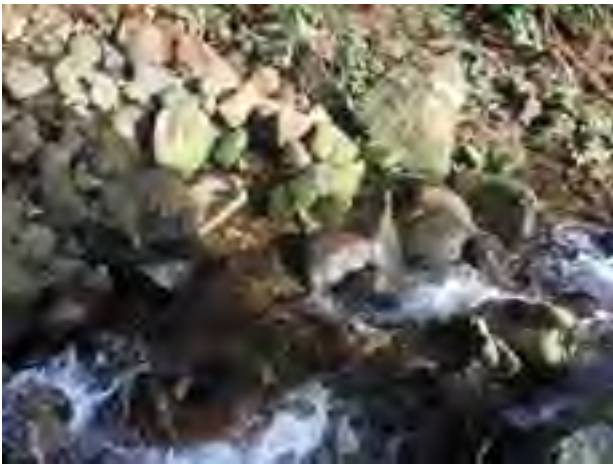
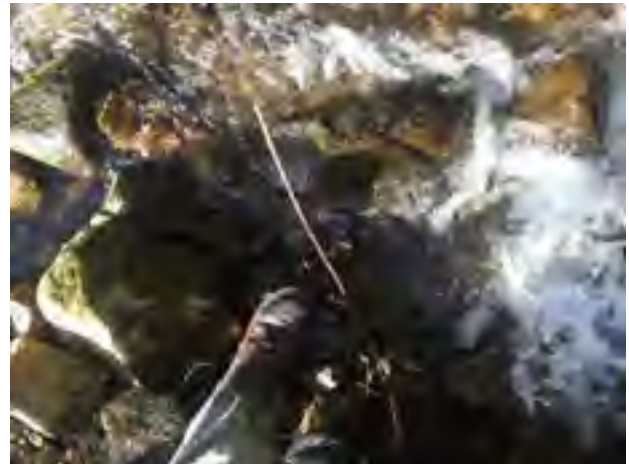
Photo A-74: Looking Downstream

Photo A-75: Typical Riffle

Wetted width: 2 m	Instream cover: 5%	Spawning gravel: Little
Bankfull width: 2.5 m	LWD: Little	Rearing habitat: Little
General comments:	High level of encroachment through segment. Falls constructed and several barrier culverts alter gradient to create flat areas separated by barriers. Low riparian forest cover. Flat areas have more gravel.

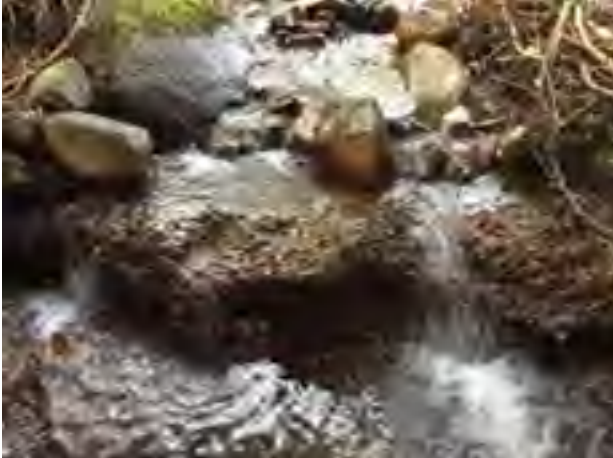
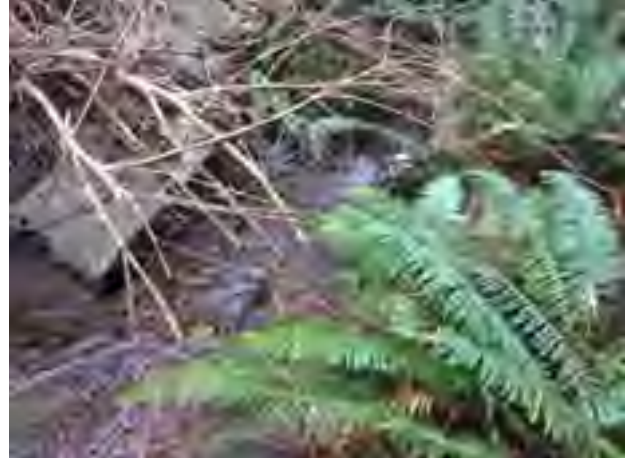
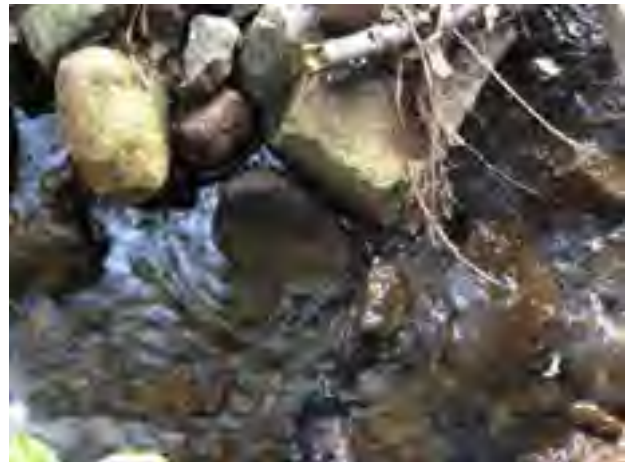
Brothers Creek Segment: BR-5.3

February 24, 2016 Upstream of Groveland Dr to Millstream Rd

Photo A-77: Looking Upstream

Photo A-78: Looking Downstream

Photo A-79: Typical Riffle

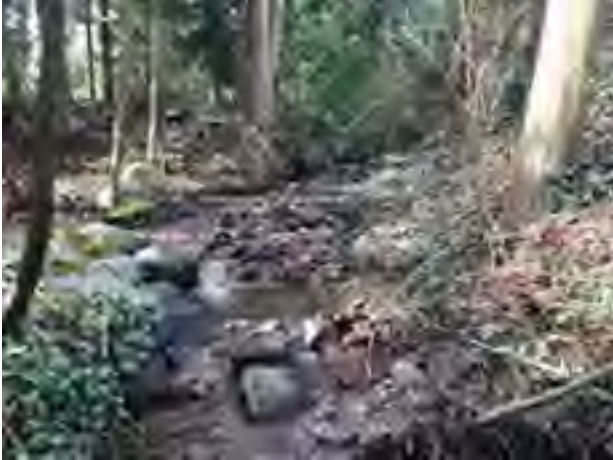
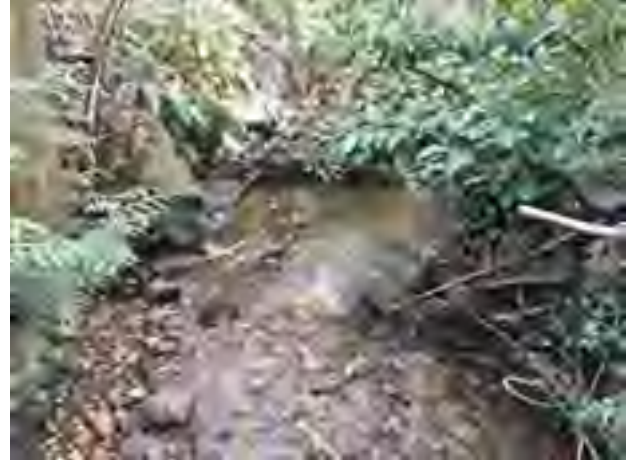
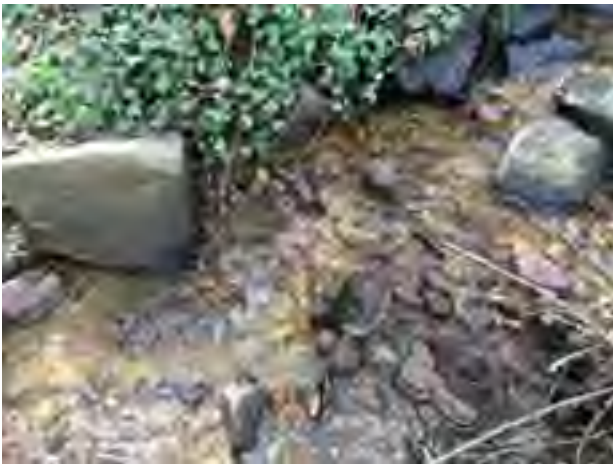
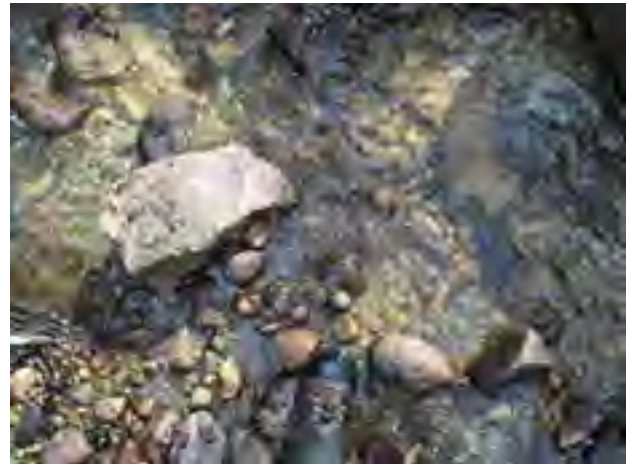
Brothers Creek Segment: BR-6.1

February 24, 2016 Unmapped tributary to Brothers Creek with confluence just downstream of Highway 1

Photo A-81: Looking Upstream

Photo A-82: Looking Downstream

Photo A-83: Typical Riffle

Photo A-84: Typical Substrate Conditions

Wetted width: 2 m	Instream cover: 10%	Spawning gravel: Extensive
Bankfull width: 2.5 m	LWD: Few	Rearing habitat: Moderate
General comments:	Unmapped tributary to Brothers creek. Streamkeepers reported salmon here in fall 2015. High quality spawning habitat. Moderate rearing habitat due to few pools and LWD cover.

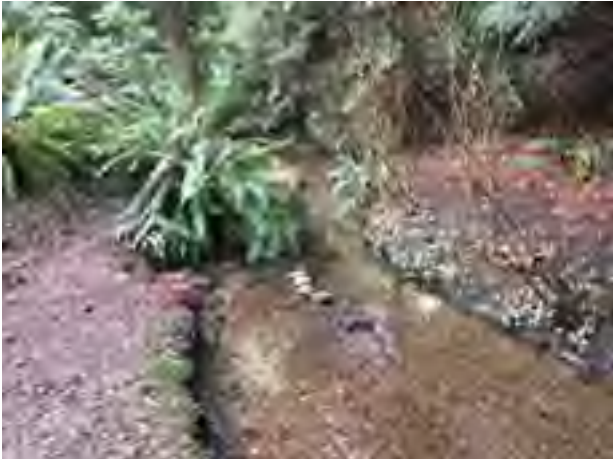
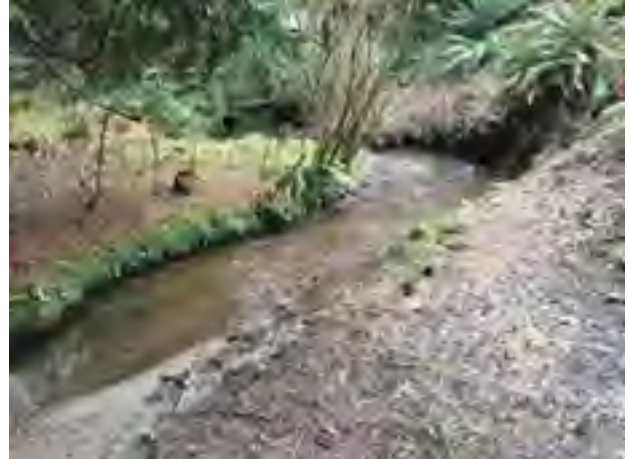
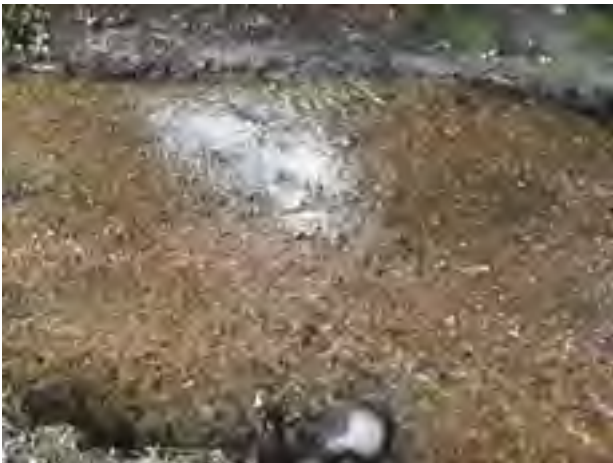
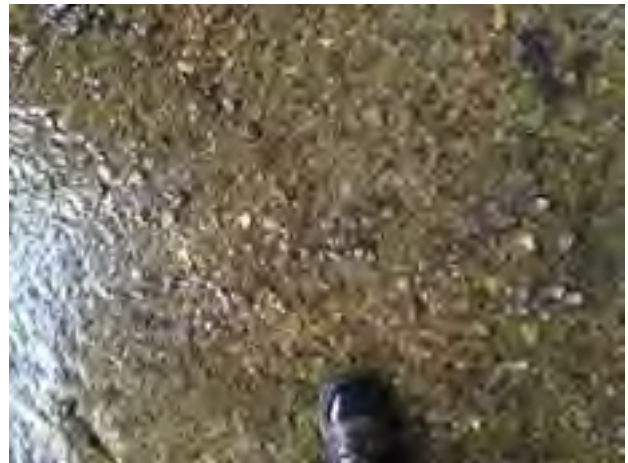
Tributary to Brothers Creek with confluence below Macbeth Cres

Photo A-85: Looking Upstream

Photo A-86: Looking Downstream

Photo A-87: Typical Riffle

Photo A-88: Typical Substrate Conditions

Wetted width: 2 m	Instream cover: 8%	Spawning gravel: Extensive
Bankfull width: 2.6 m	LWD: Few	Rearing habitat: Moderate
General comments:	Unmapped trib to brothers creek with confluence downstream of Inglewood. Moderate to good fish habitat with abundant spawning habitat. Active erosion and bank protection failure downstream of good spawning gravels. Some encroachment from back yards

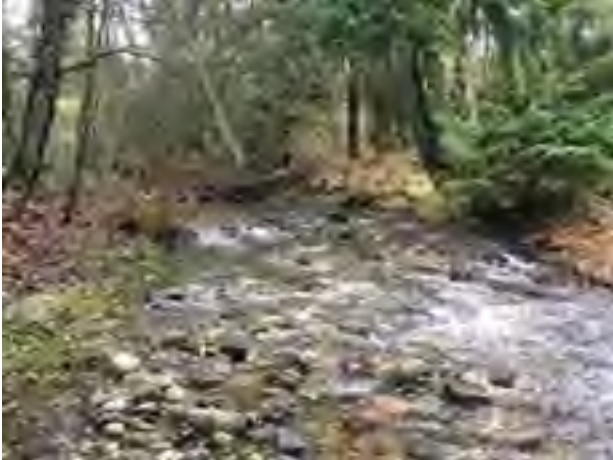
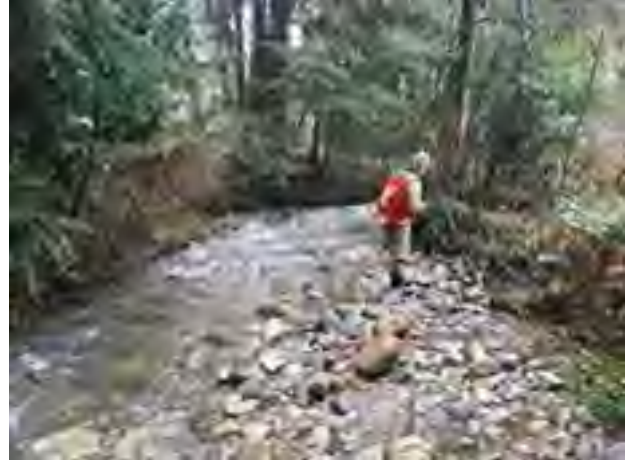
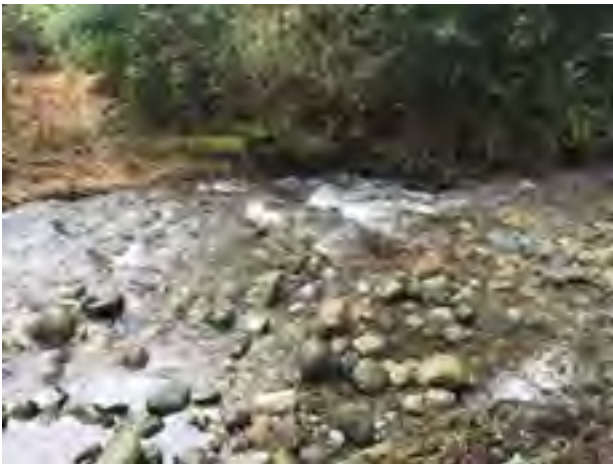
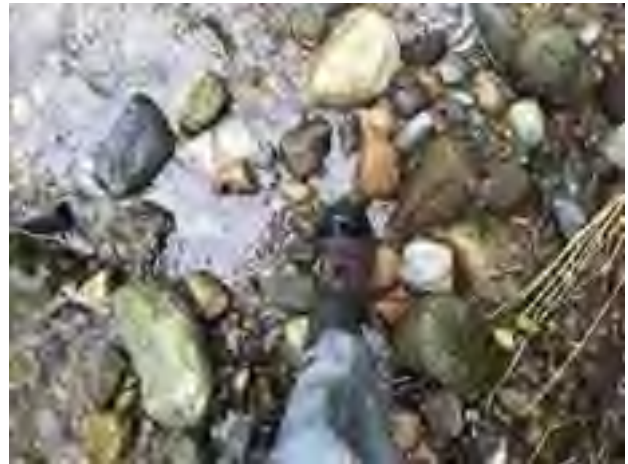
Between Highway 1 and confluence with Brothers Creek

Photo A-89: Looking Upstream

Photo A-90: Looking Downstream

Photo A-91: Typical Riffle

Photo A-92: Typical Substrate Conditions

Wetted width: 4 m	Instream cover: 10%	Spawning gravel: Extensive
Bankfull width: 4.5 m	LWD: Few	Rearing habitat: Moderate
General comments:	Abundant invasive plants, no bedrock, fish habitat lacks much LWD. Encroachment from yards especially right bank.

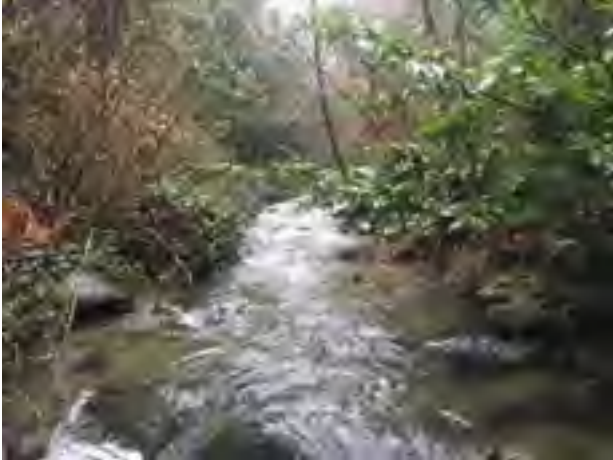
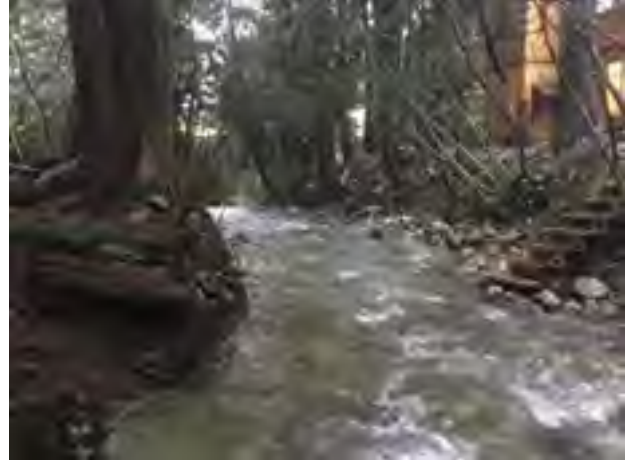
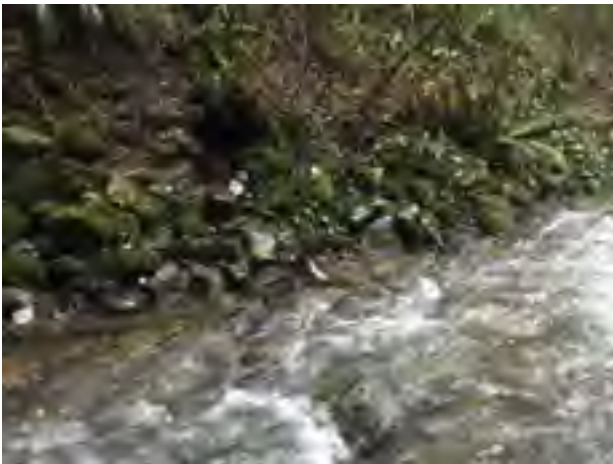
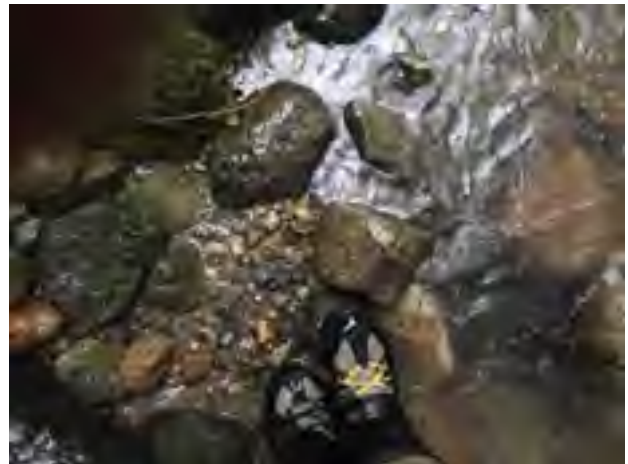
Between Highway 1 and Stevens Rd

Photo A-93: Looking Upstream

Photo A-94: Looking Downstream

Photo A-95: Typical Riffle

Photo A-96: Typical Substrate Conditions

Wetted width:	3.5 m	Instream cover:	15%	Spawning gravel:	Extensive
Bankfull width:	4.5 m	LWD:	Few	Rearing habitat:	Moderate
General comments:	Not much complexity through segment. Moderate fish habitat quality. Upper half of segment has wider riparian corridor. Houses in lower half encroaching and have channelized some of the stream. Lots of overhanging vegetation. Dominated by overhanging vegetation. Very little LWD, not much habitat complexity.

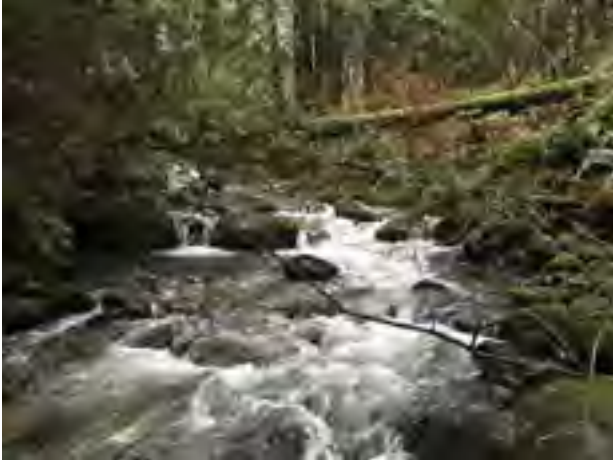
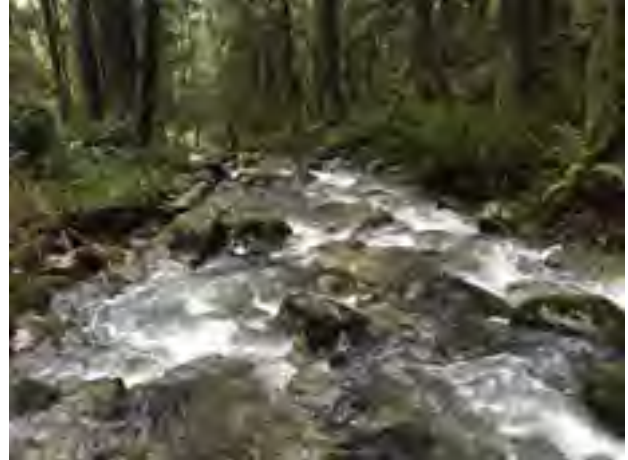
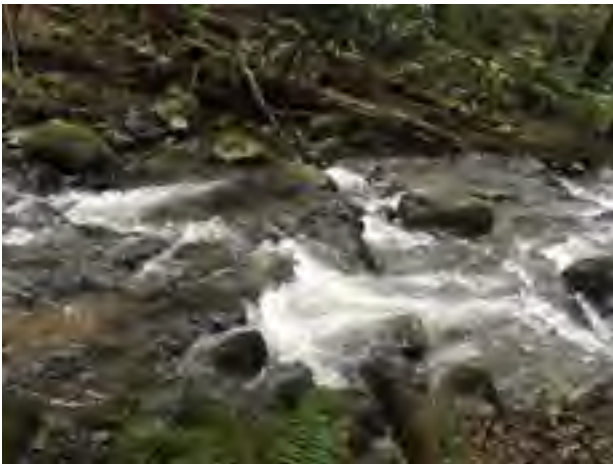
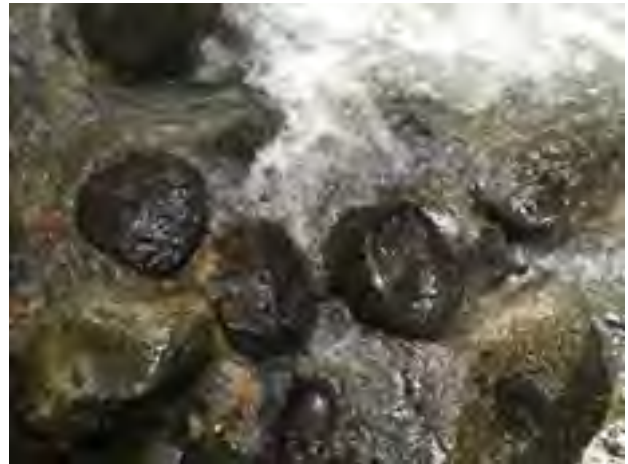
Hadden Creek **Segment: HA-1.3**
 February 4, 2016 Between Stevens Dr and Hadden Dr

Photo A-97: Looking Upstream

Photo A-98: Looking Downstream

Photo A-99: Typical Riffle

Photo A-100: Typical Substrate Conditions

Wetted width: 4.5 m Instream cover: 15% Spawning gravel: Extensive

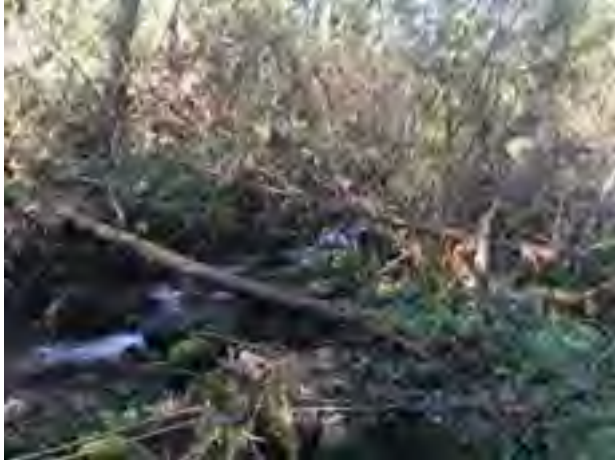
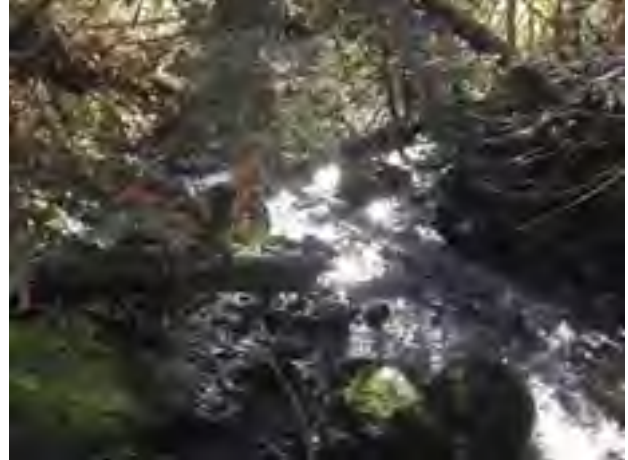
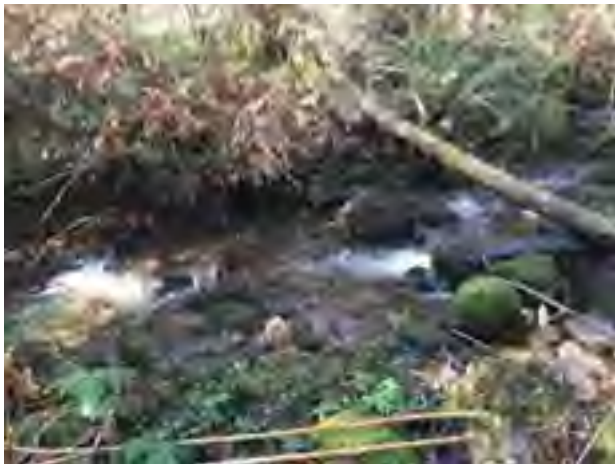
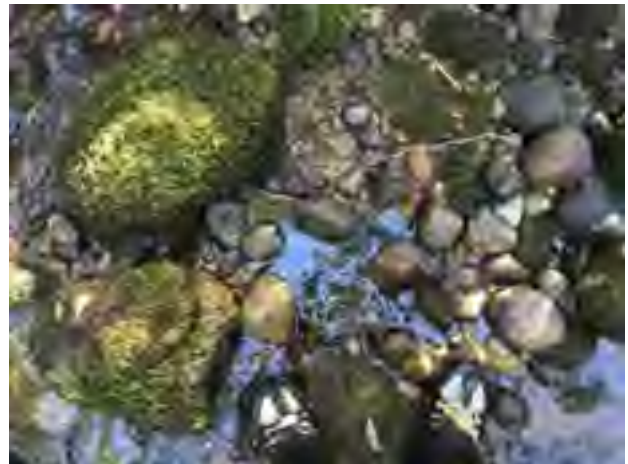
Hadden Creek Segment: HA-2.1

February 9, 2016 From Hadden Dr to Capilano Golf and Country Club

Photo A-101: Looking Upstream

Photo A-102: Looking Downstream

Photo A-103: Typical Riffle

Photo A-104: Typical Substrate Conditions

Wetted width: 4 m	Instream cover: 30%	Spawning gravel: Extensive
Bankfull width: 6 m	LWD: Abundant	Rearing habitat: Moderate
General comments:	Excellent fish habitat. Lots of LWD and cover from overhanging vegetation. Floodplain well vegetated, good channel complexity (mid-channel island), English ivy common. Lots of overhanging vegetation. Large second growth conifers, red alder and some bigleaf maple.

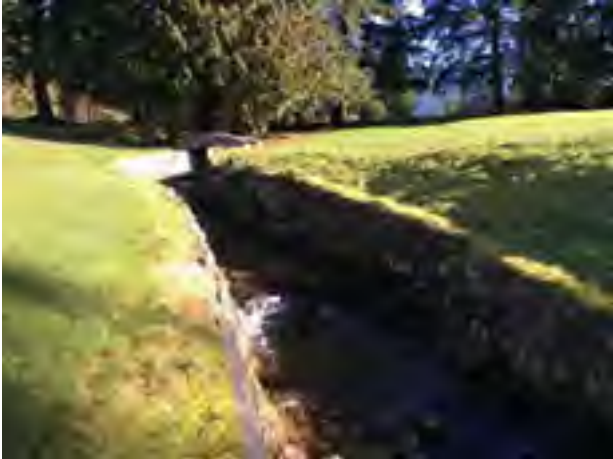
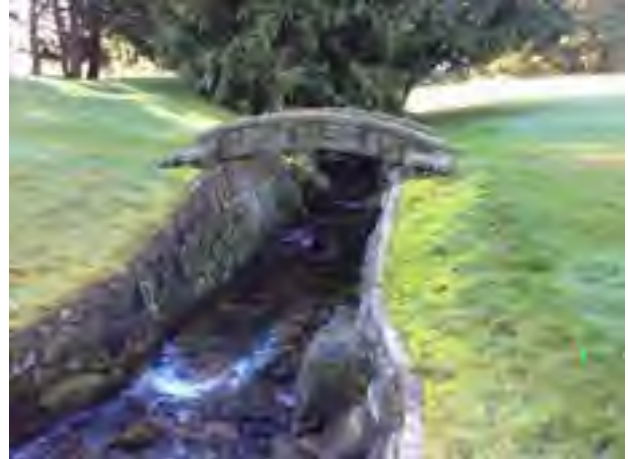
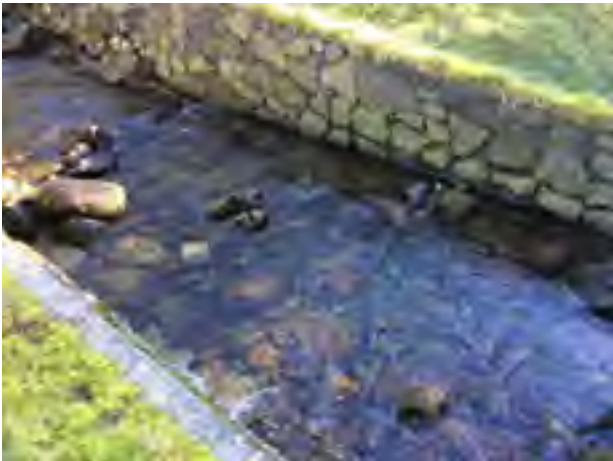
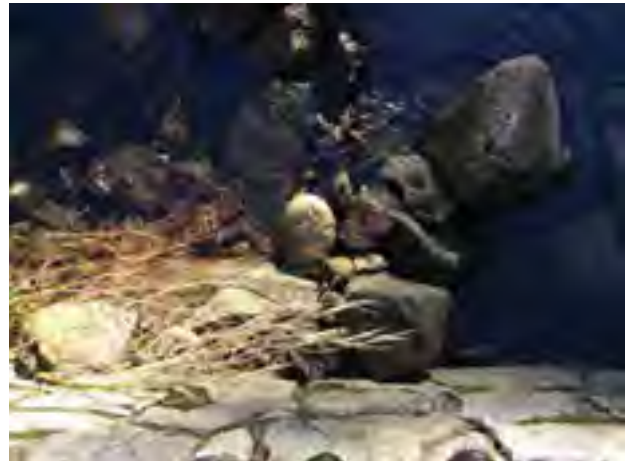
Within Capilano Golf and Country Club, from downstream end of south pond to upstream end of north pond

Photo A-105: Looking Upstream

Photo A-106: Looking Downstream

Photo A-107: Typical Riffle

Photo A-108: Typical Substrate Conditions

Wetted width:	1.5 m	Instream cover:	5%	Spawning gravel:	Little
Bankfull width:	1.5 m	LWD:	None	Rearing habitat:	Little
General comments:	Low quality fish habitat. Channelized with no cover, little rearing habitat. Lots of cobble but little spawning gravel. Almost no cover. Golf course manicured lawn to edge of bank. No native riparian vegetation.

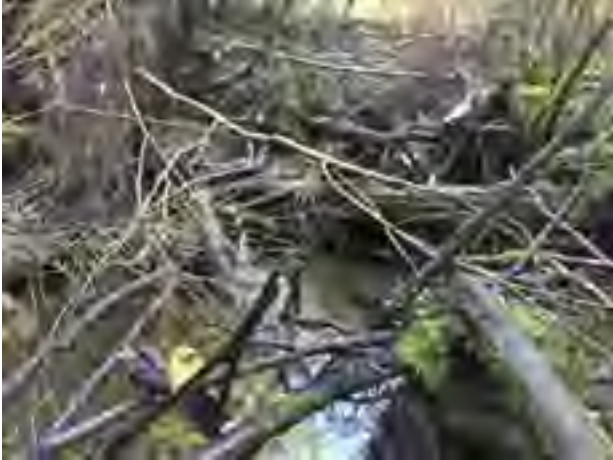
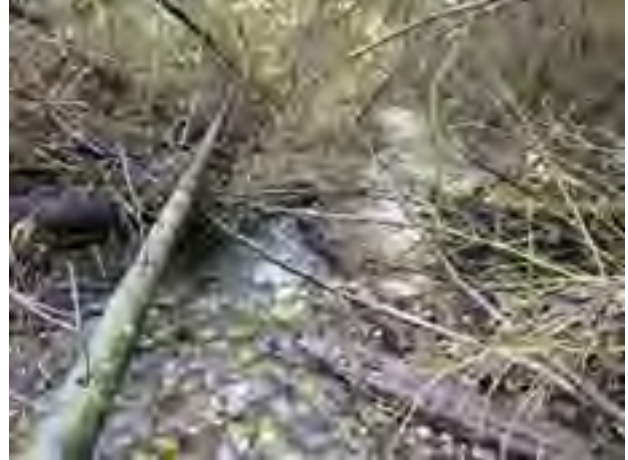
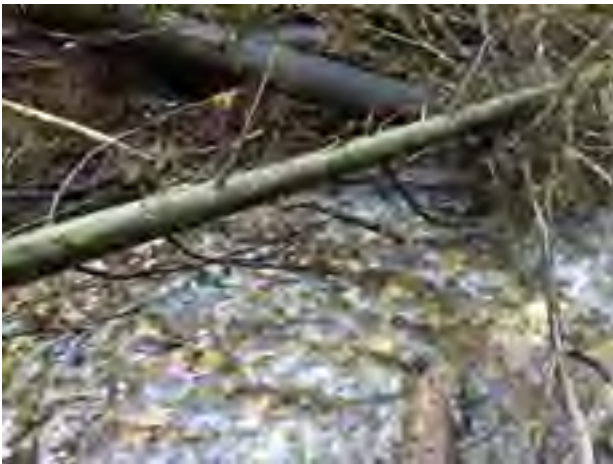
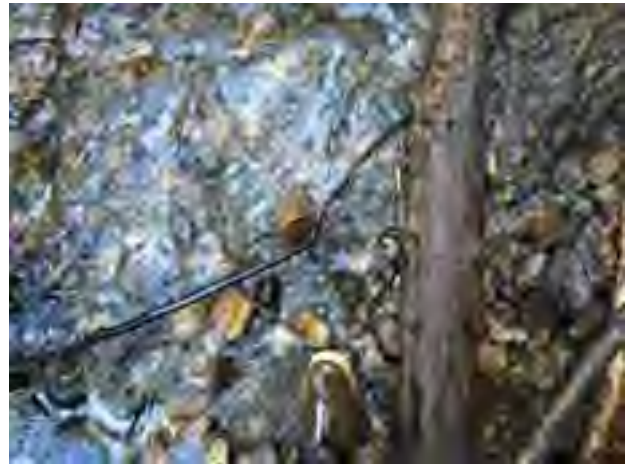
Hadden Creek Segment: HA-2.3

February 9, 2016 Forested stretch within Capilano Golf and Country Club upstream of north pond.

Photo A-109: Looking Upstream

Photo A-110: Looking Downstream

Photo A-111: Typical Riffle

Photo A-112: Typical Substrate Conditions

Wetted width: 2.3 m Instream cover: 15% Spawning gravel: Extensive

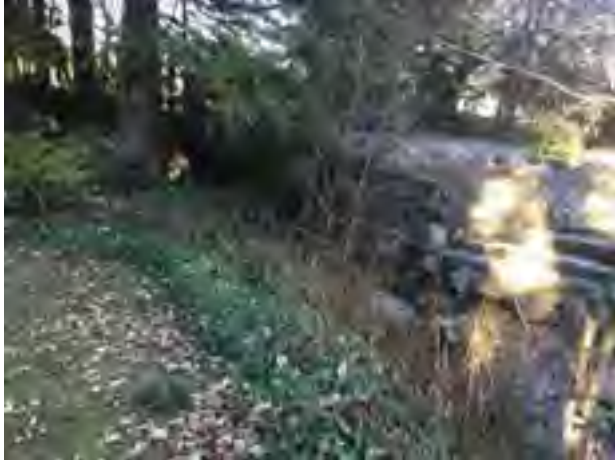
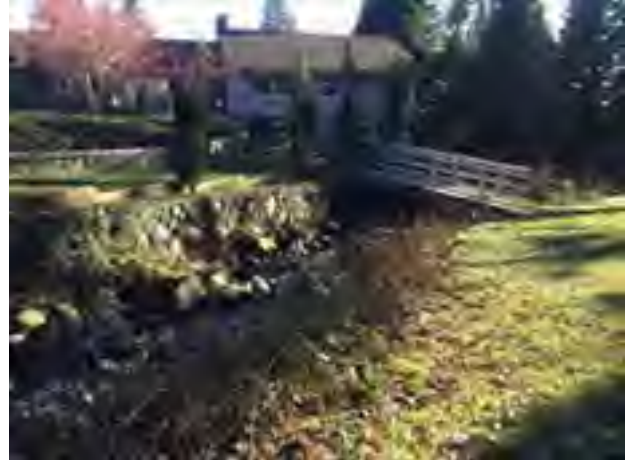
Hadden Creek Segment: HA-3.1

February 9, 2016 Between Southborough Dr to Kenwood Dr

Photo A-113: Looking Upstream

Photo A-114: Looking Downstream

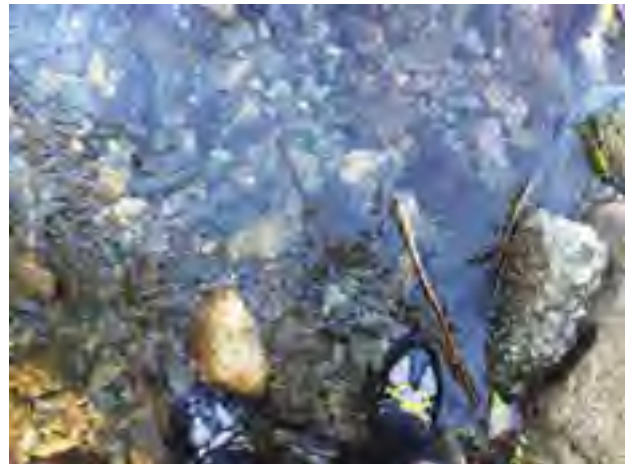
Photo A-116: Typical Substrate Conditions

Wetted width:	1.75 m	Instream cover:	5%	Spawning gravel:	Extensive
Bankfull width:	2 m	LWD:	None	Rearing habitat:	Little
General comments:	Poor fish habitat. Some good pools at the ends of cascades, but little rearing habitat due to channelization. Riparian area is heavily impacted by residences with ornamental plants. Little cover. Very little cover. Mostly channelized with hardened walls. Mostly encroached by lawns with ornamental plants. Many trees removed.

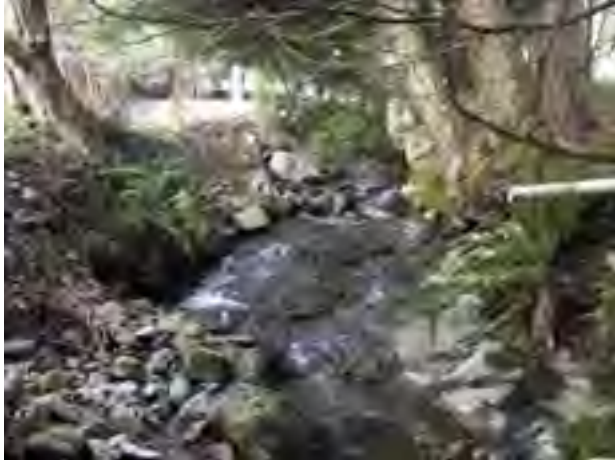
Photo A-117: Looking Upstream

February 24, 2016 Upstream from Kenwood Dr to survey boundary upstream of Millstream Rd

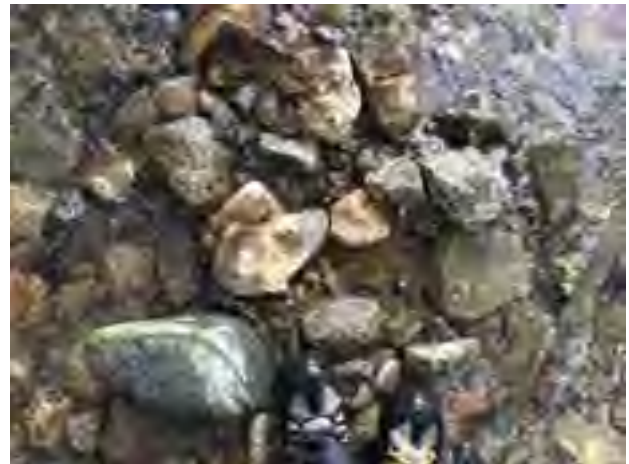
Photo A-120: Typical Substrate Conditions

Wetted width: 1.5 m Instream cover: 10% Spawning gravel: Little

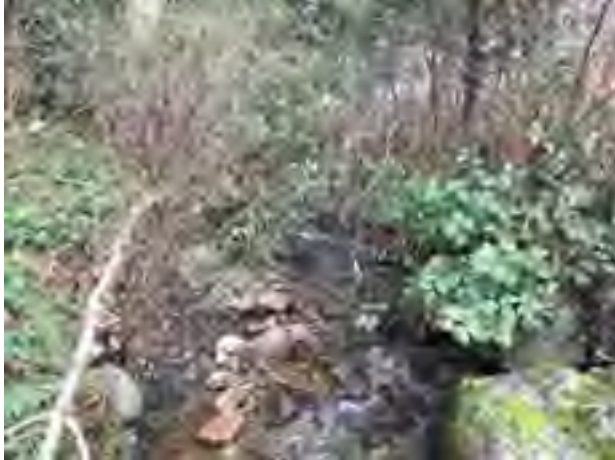
Photo A-121: Looking Upstream

February 24, 2016 East branch of Hadden Creek from its confluence with the mainstem upstream to St. Andrews Rd

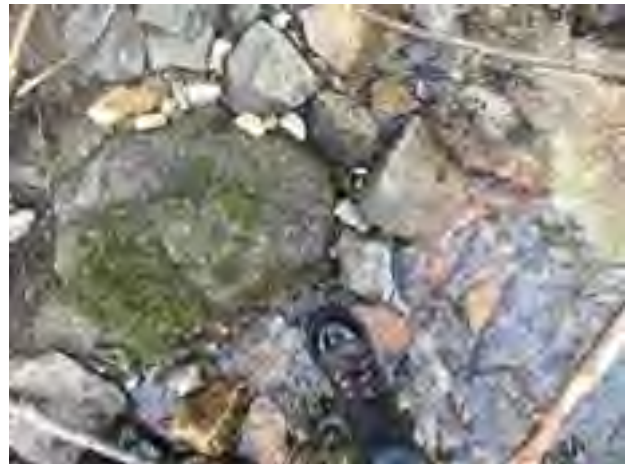
Photo A-124: Typical Substrate Conditions

Wetted width: 2 m Instream cover: 5% Spawning gravel: Little

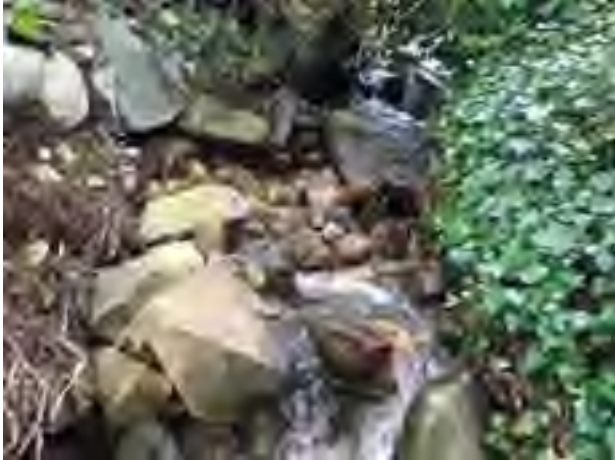
Photo A-125: Looking Upstream

February 24, 2016 Upstream of St. Andrews Rd to the survey boundary upstream of Millstream Rd

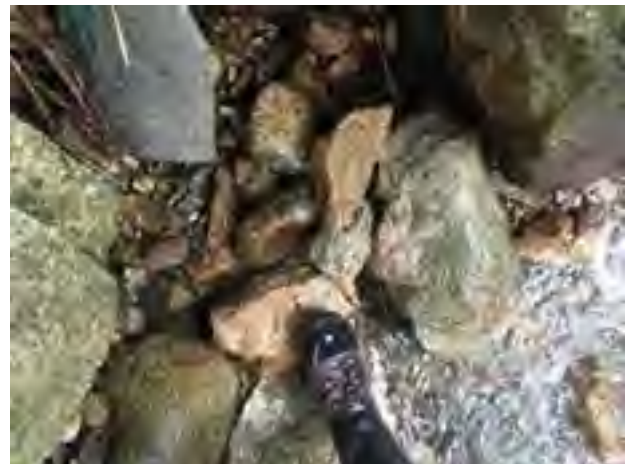
Photo A-128: Typical Substrate Conditions

Wetted width: 1.8 m Instream cover: 8% Spawning gravel: Little

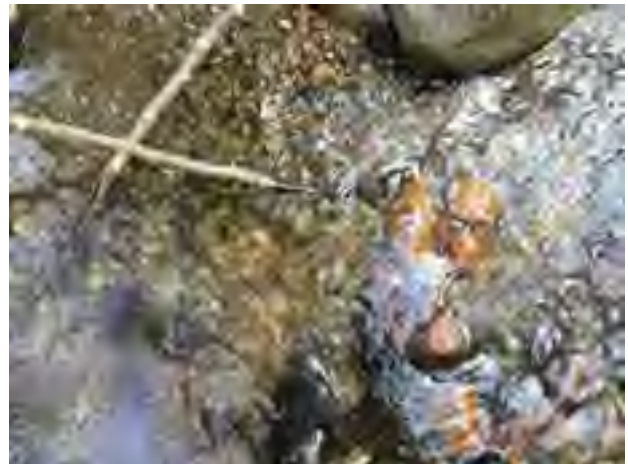
Photo A-132: Typical Substrate Conditions

Wetted width: 1.5 m	Instream cover: 15%	Spawning gravel: Extensive
Bankfull width: 2 m	LWD: Few	Rearing habitat: Little
General comments:	Rial rim vegetation has varied widely through segment due to backyards, ornamentals and invasives. Many properties have cleared vegetation to the bank.

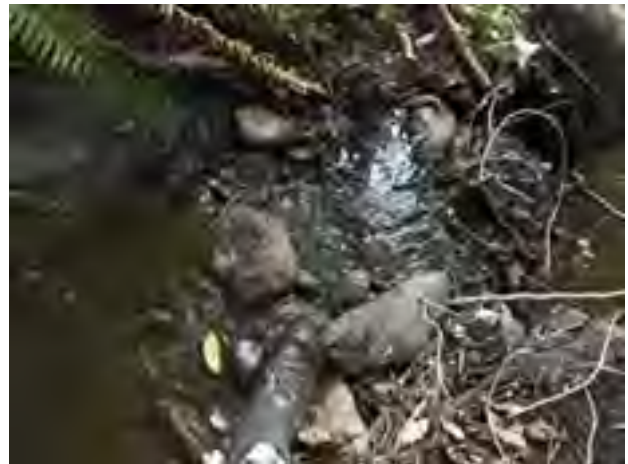
Photo A-140: Typical Substrate Conditions

Wetted width:	1.2 m	Instream cover:	5%	Spawning gravel:	Little
Bankfull width:	1.5 m	LWD:	Few	Rearing habitat:	Little
General comments:	Frequent encroachment and invasive species. downstream extent to Hwy 1 has 60 m concrete channel. Marginal fish habitat. Frequent bank armouring

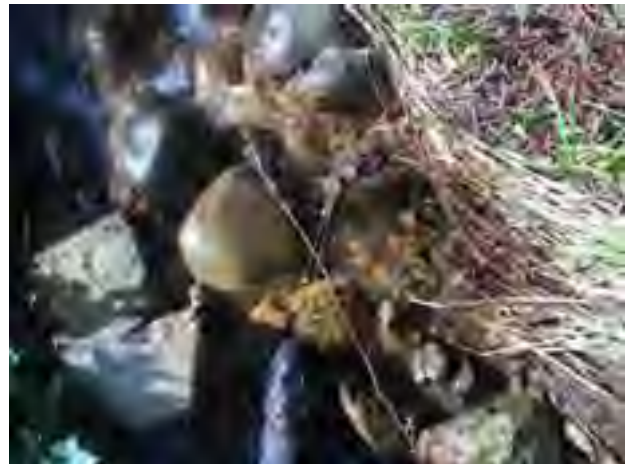
Photo A-144: Typical Substrate Conditions

Wetted width: 0.8 m	Instream cover: 5%	Spawning gravel: Little
Bankfull width: 1 m	LWD: Few	Rearing habitat: Little
General comments:	Frequent culverts and invasive plants. Marginal fish habitat. Very few pools or LWD.

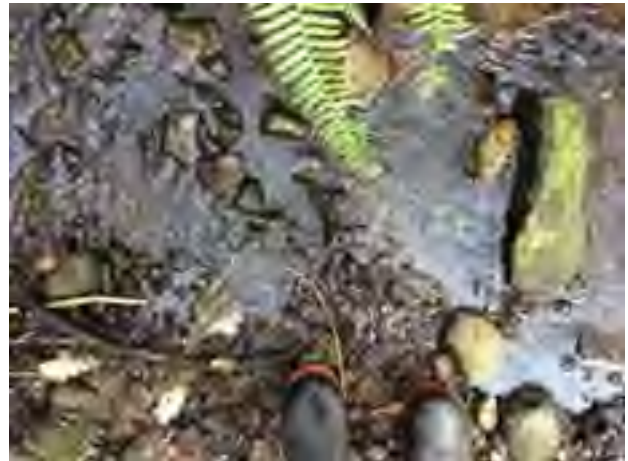
Photo A-148: Typical Substrate Conditions

Wetted width:	0.75 m	Instream cover:	5%	Spawning gravel:	Little
Bankfull width:	1 m	LWD:	None	Rearing habitat:	None
General comments:	More sedimentation and organics above culvert. Poor habitat, heavily modified channel and riparian area. Low flows through summer. Heavily modified. Encroached by lawns and gardens.

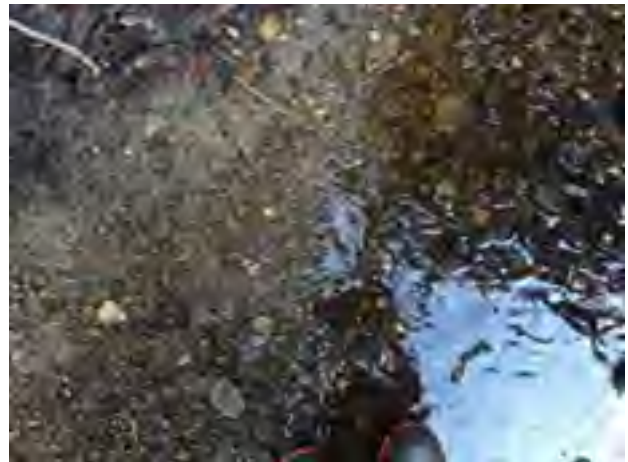
Photo A-152: Typical Substrate Conditions

Wetted width: 0.5	Instream cover: 1%	Spawning gravel: Little
Bankfull width: 1.5	LWD: Few	Rearing habitat: None
General comments:	Low gradient with small gravel and fines. Most natural channel in VIW-3. Almost no cover for fish but good canopy cover. Undergrowth severely impacted by park goers. Almost bare.

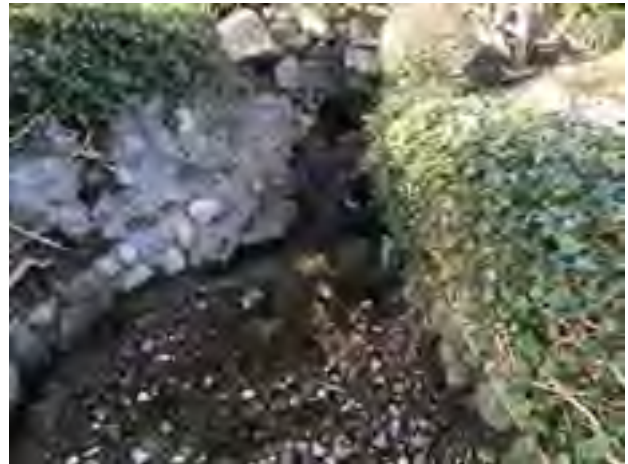
Photo A-156: Typical Substrate Conditions

Wetted width:	1.5 m	Instream cover:	4%	Spawning gravel:	Little
Bankfull width:	1.5 m	LWD:	None	Rearing habitat:	None
General comments:	Heavily modified segment that runs through residential area. Over 60% is channelized between bank protection or in culverts. Poor fish habitat. Riparian zone is mainly yards.

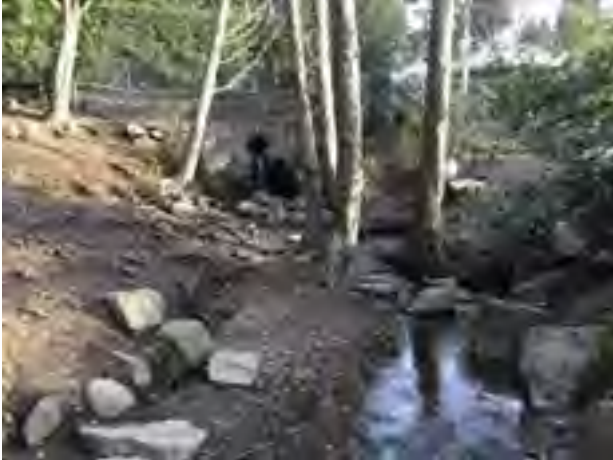
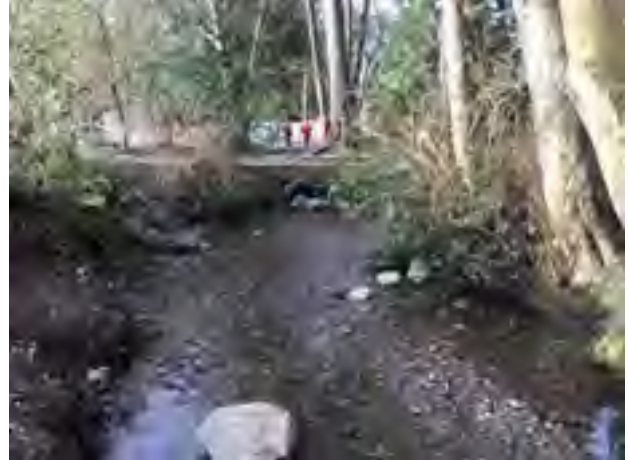
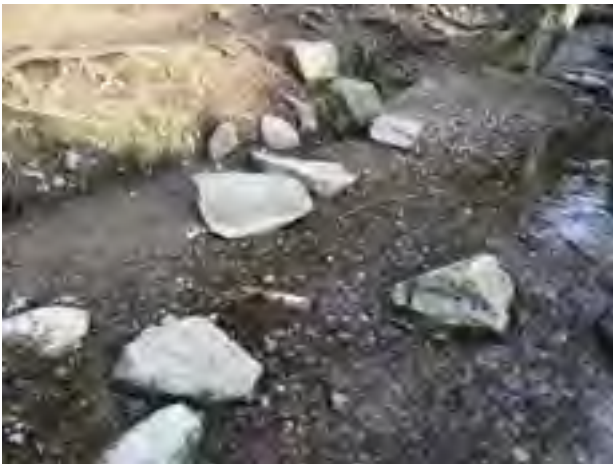
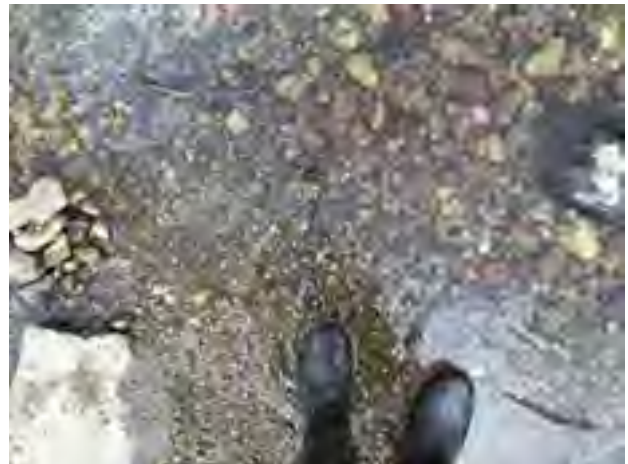
Vinson Creek East Segment: VIE-1.1

February 25, 2016 Upstream of 13th Ave to Mathers St

Photo A-157: Looking Upstream

Photo A-158: Looking Downstream

Photo A-159: Typical Riffle

Photo A-160: Typical Substrate Conditions

Wetted width: 2 m	Instream cover: 5%	Spawning gravel: Extensive
Bankfull width: 3 m	LWD: None	Rearing habitat: None
General comments:	Poor fish habitat - shallow, little cover. Good gravel. Very little riparian vegetation. In playground.

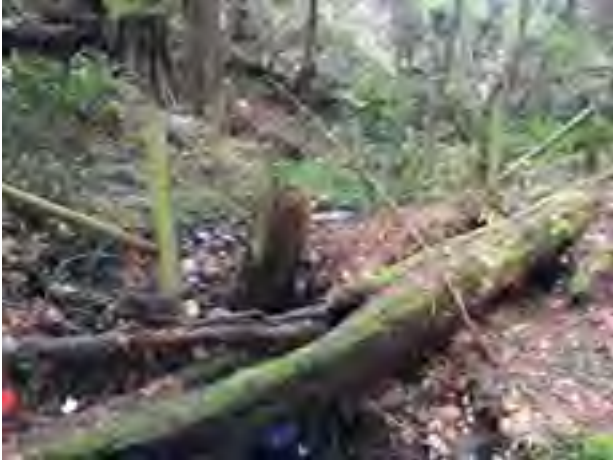
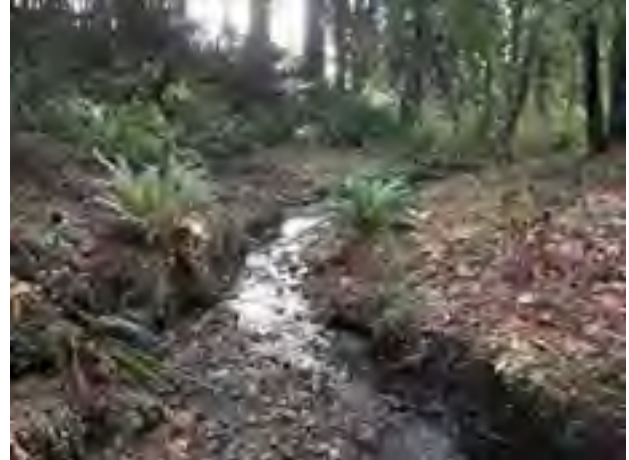
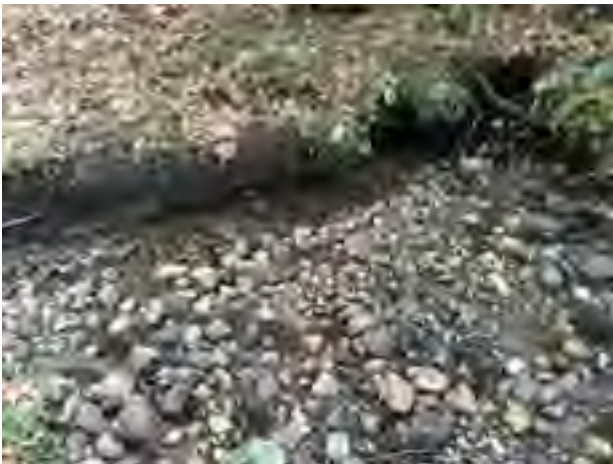
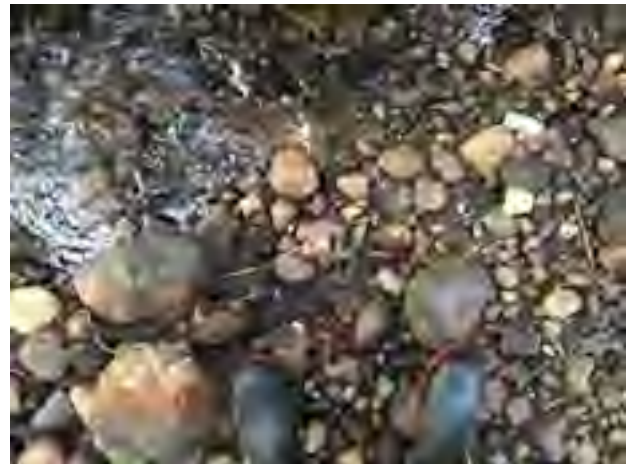
Vinson Creek East Segment: VIE-1.2

February 25, 2016 Upstream of Mathers Ave

Photo A-161: Looking Upstream

Photo A-162: Looking Downstream

Photo A-163: Typical Riffle

Photo A-164: Typical Substrate Conditions

Wetted width:	1 m	Instream cover:	10%	Spawning gravel:	Extensive
Bankfull width:	2 m	LWD:	Few	Rearing habitat:	Little
General comments:	Poor to moderate fish habitat. Shallow, with little cover. Good canopy cover but little riparian vegetation. Substrate dominated by gravel and cobble. Basically no wood. Much of understory not well vegetated.
