SYKES/LESLIE RESIDENCES

5616 Westport Pl, West Vancouver, BC

OCTOBER, 2015 (RE-PRINTED APRIL 2016)

LETTER OF RATIONALE
DAVID + CHRISTY'S LETTER TO COUNCIL
DRC LIST OF DESIGN CHANGES
SYNTHESIS DESIGN REVISED DEVELOPMENT PACKAGE
DRC DESIGN CHANGES C/W GHOST OUTLINE
NEIGHBORHOOD CONTEXT
URBAN NICHE LANDSCAPE PLAN
DIAMOND HEAD ARBORIST REPORT
GVH CONSULTING GEOTECHNICAL REPORT

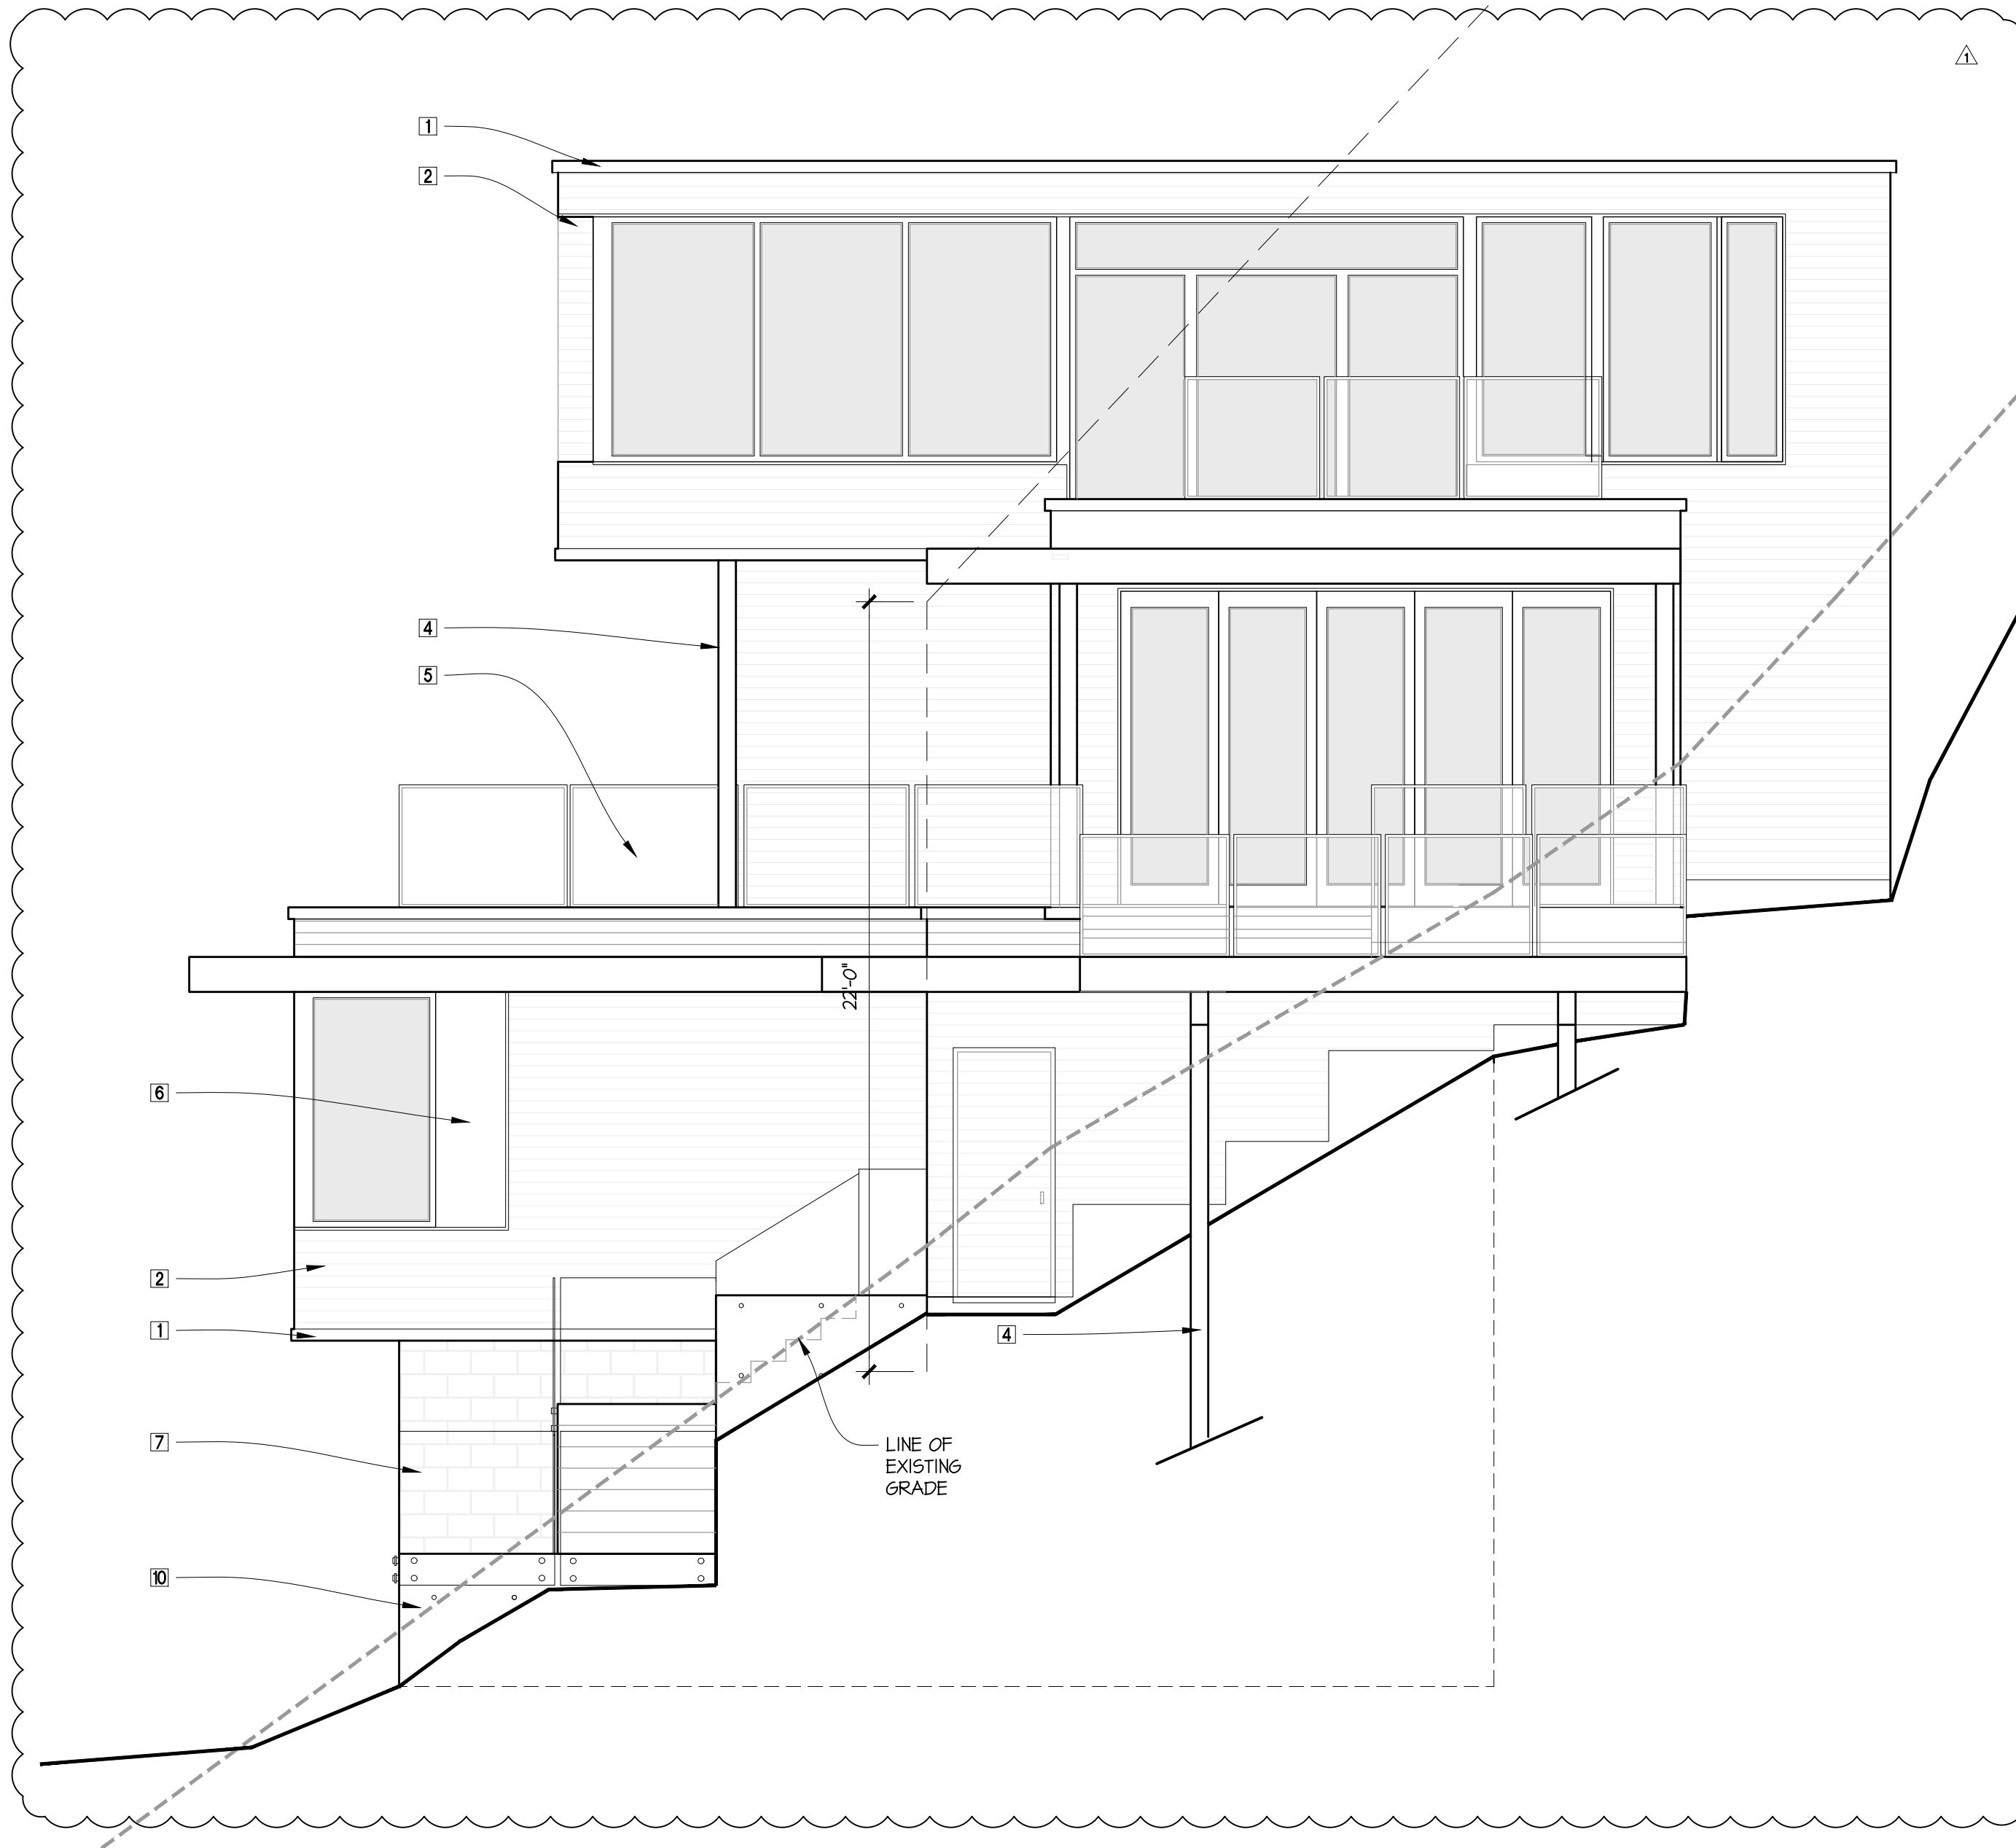
RIGHT ELEVATION

ROOF PEAK	324.8'
ROOF PEAK	316.6'
UPPER FLOOR	313.7'
UPPER FLOOR	306.4'
MAIN FLOOR	302.5'
MAIN FLOOR	295.3'
AVERAGE FINISHED GRADE	288.5'
BASEMENT	288.3'
BASEMENT	284.1'
GARAGE	273.0'

- MATERIALS LEGEND**
- 1) HEAVY GAUGE ANODIZED ALUMINUM FLASHING
 - 2) 1x4 T&G TIGHT JOINT TRESPA CEMENTITIOUS HORIZONTAL SIDING C/W 4" EXPOSURE
 - 3) 1" ANODIZED ALUMINUM TRIM AROUND ALL OPENINGS AS PER DOOR AND WINDOW MANUFACTURER AND SUPPLIER
 - 4) ROUND STEEL POST PAINTED AS PER SPECIFICATIONS
 - 5) FRAMELESS GLASS RAILING C/W ALUMINUM SHOE WEDGE
 - 6) HEAVY GAUGE ANODIZED ALUMINUM PANEL, FINISH TO MATCH WINDOWS
 - 7) FINISH (BRICK / CONCRETE / CMU / OTHER) T.B.D.
 - 8) FRAME LESS TEMPERED GLASS RAILING C/W METAL BUTTON CONNECTORS
 - 9) 1" ANODIZED ALUMINUM TRIM (BETWEEN CHANGE IN GLADDING MATERIALS)
 - 10) CONG. PLANTER & RETAINING WALL (SNAP TIE CONE IMPRESSIONS TO REMAIN)
 - 11) CONCRETE LINTEL

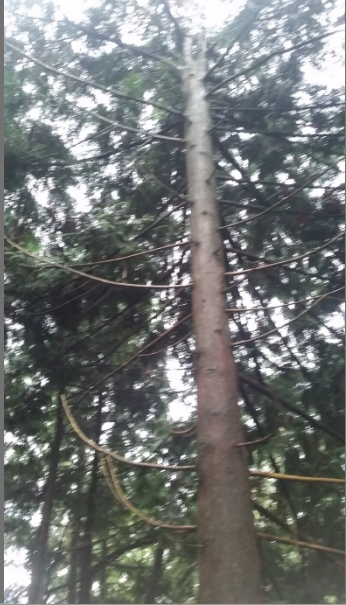
Photo 1. The majority of trees located within the proposed development area have been previously topped for views..

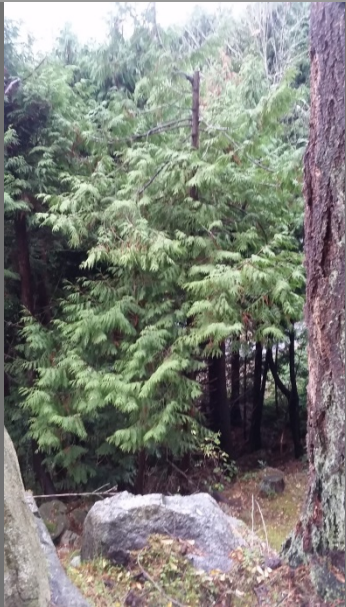
Photo 3. The majority of trees located within the proposed development area have been previously topped for views.

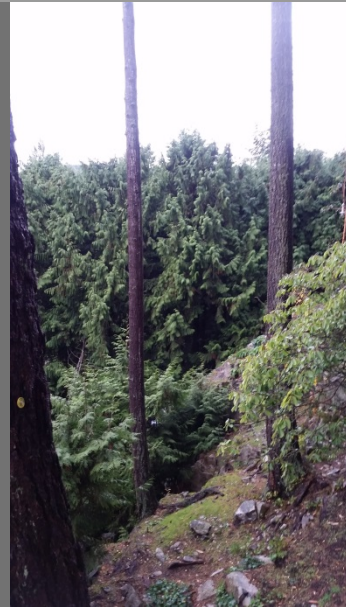
Photo 4. The majority of trees located within the proposed development area have been previously topped for views.
