Stormwater Infrastructure Asset Management Plan District of West Vancouver

Stormwater Infrastructure Asset Management Plan

FINAL REPORT

AECOM Canada Ltd.

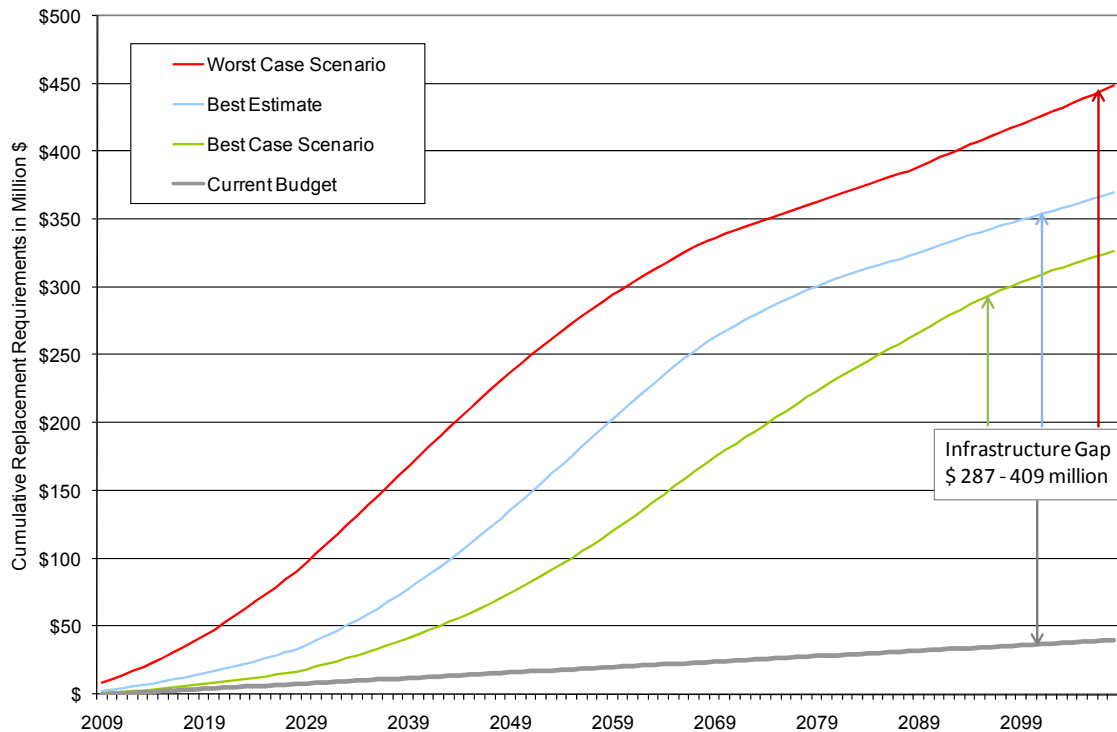
Figure ES.2 Projected Infrastructure Gap – Three Scenarios

Under all three scenarios there is an anticipated infrastructure gap ranging from \$287 to \$409 million over the next 100 years. Under the best case scenario West Vancouver has 10 years to begin preparing for an infrastructure gap, but under the worst case scenario West Vancouver needs to begin addressing its infrastructure gap immediately.

It is important to note that there were many data gaps with regard to the condition of West Vancouver’s storm sewers and creeks. The financial projection in Figure ES.1 is based on assumptions where there was no data and on typical asset lifespan estimates. Changing these estimates will impact the capital renewal forecast as demonstrated in Figure ES.2.

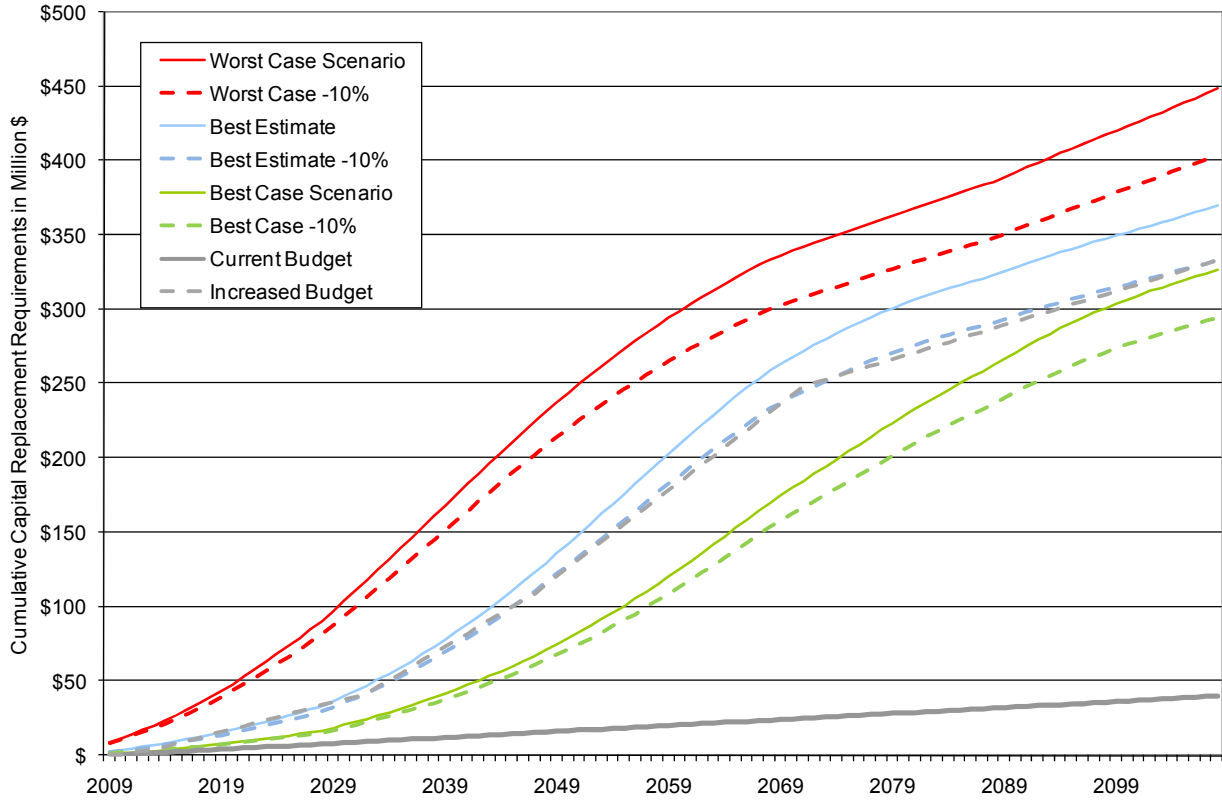
Figure ES.3 Addressing the Infrastructure Gap

The relationships shown in Figure ES.3 illustrate the benefit of reducing lifecycle costs by 10% for each scenario, and provides a potential funding strategy that satisfies theoretical asset replacement requirements. This solution reflects one possible way that resources could be implemented throughout their lifecycle, not necessarily how those resources would be provided. Consideration has not been given to factors that might either accelerate renewal efforts (e.g. elevation of risk or criticality, resource levelling, opportunistic cost sharing), or decelerate renewal efforts (e.g. short term affordability). Additional factors, including future reserve policies, remain a subject for continued public debate. Ultimately, a “budget-based” approach to asset management will govern the extent to which West Vancouver will manage assets in a sustainable fashion over the short and long term.

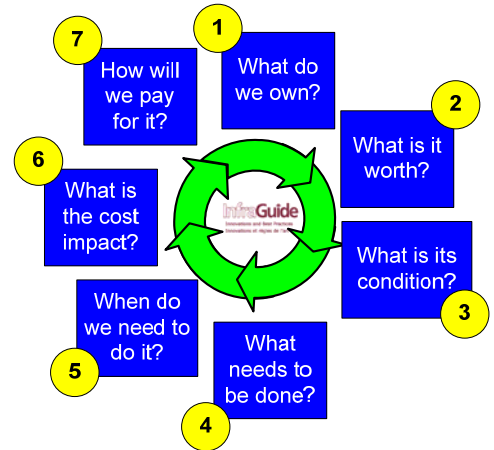
Figure 1.1 Seven Questions of Asset Management

To help West Vancouver meet its objectives, AECOM developed this Asset Management Plan using the “Seven Questions of Asset Management” approach that is recommended by InfraGuide’s “Best Practice for Managing Infrastructure Assets”. The results of each of the seven steps shown in Figure 1.1 are outlined in this report.

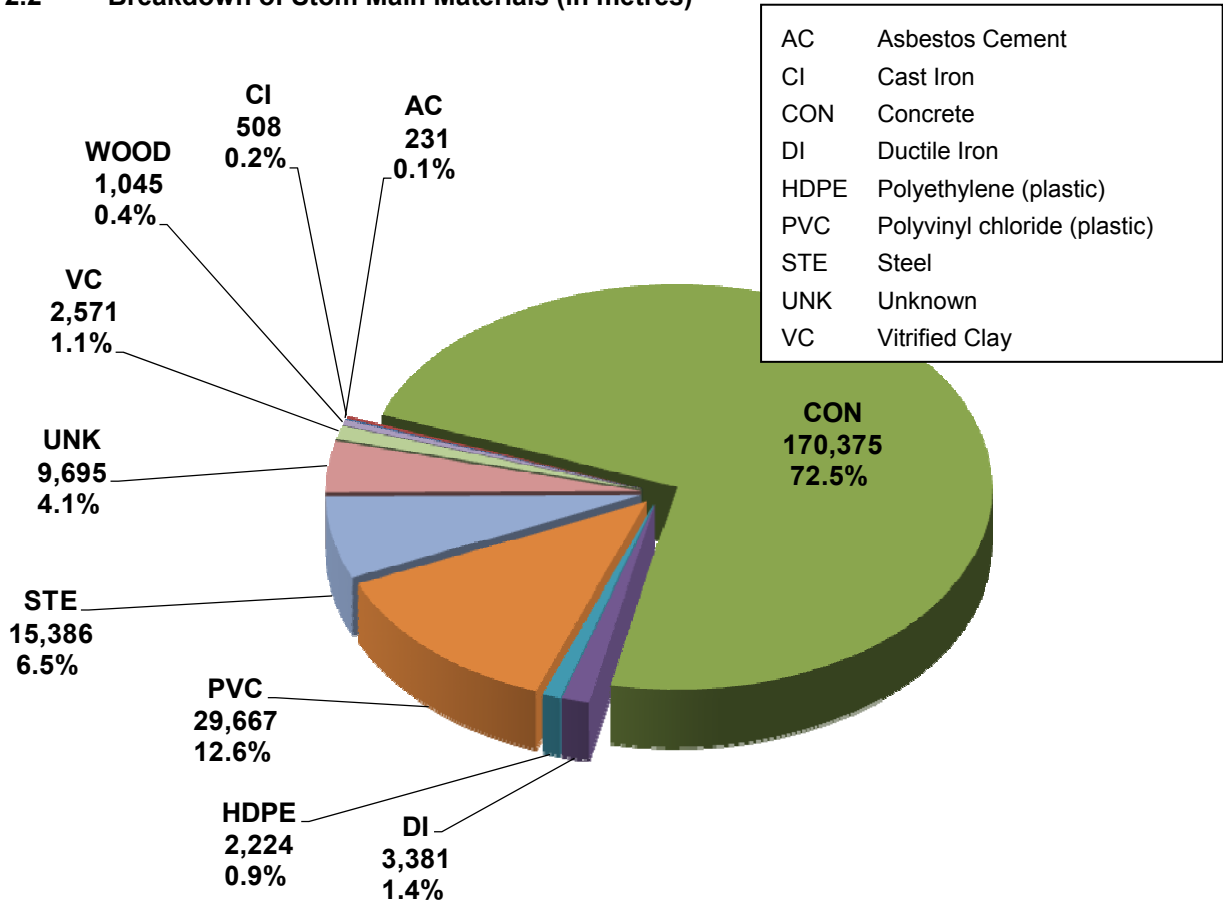
Figure 2.2 Breakdown of Stom Main Materials (in metres)

The pipe material is known for only 35% of the storm mains, which means assumptions had to be made about the majority of the inventory's material type. Figure 2.2 shows the breakdown of pipe material used for this study following the application of assumptions described in Section 2.1.

Following the application of pipe material assumptions, 80% of the mains are assumed to be made of concrete, 11% of PVC with the remaining 9% being made of a variety of pipe materials.

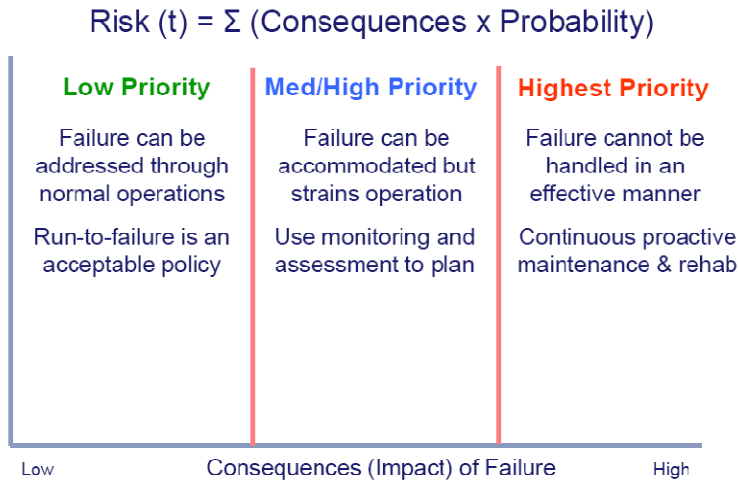
Figure 6.1 Risk-based Approach to Asset Renewal Planning

Additionally, once West Vancouver determines the criticality of different assets within its stormwater system it could use a risk based approach to determine the most cost-effective strategy for maintaining an asset based on the consequences of failure as depicted in Figure 6.1.

This risk-based approach is similar to that which was developed for West Vancouver’s *Storm Sewer Condition Assessment Program* by UMA in 2006. The objective of the Storm Sewer Condition Assessment Program was to prioritize storm sewers for inspection and identify condition assessment requirements. As the objective of this study is to develop long term financial forecasts for renewing West Vancouver’s sanitary system and not to prioritize the replacement of specific assets, the condition assessment risk model was not adopted for this study. However, we recommend that the risk model be used for prioritizing sewers for inspection and for a bottom-up renewal plan, as discussed in Section 6.4.

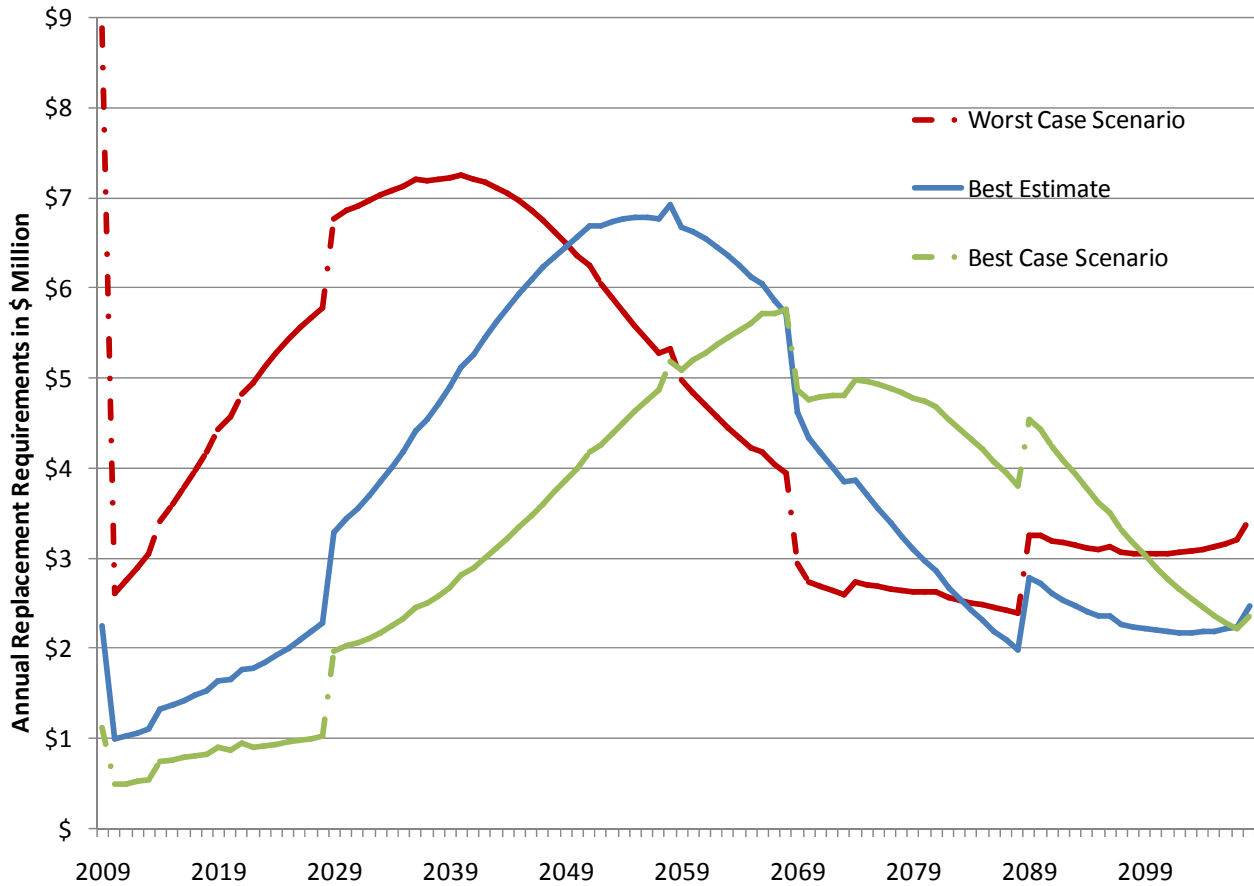
Figure 7.3 Total Annual Replacement Requirements Using a Range of Estimated Service Lives

As described in Section 6.4, a range of estimated service lives for concrete pipe and a range of estimated creek rehabilitation costs were used to determine the sensitivity of key assumptions. The total capital

renewal forecast using the original estimate of service lives as well as the worst and best case scenarios are presented in Figure 7.3 below.

If the assets last longer than predicted (e.g. best case scenario) then the “hump” of renewal requirements is pushed further into the future and spread out over more years. If the assets don’t last as long as predicted (e.g. worst case scenario) then West Vancouver will start to experience an immediate dramatic increase in renewal requirements.

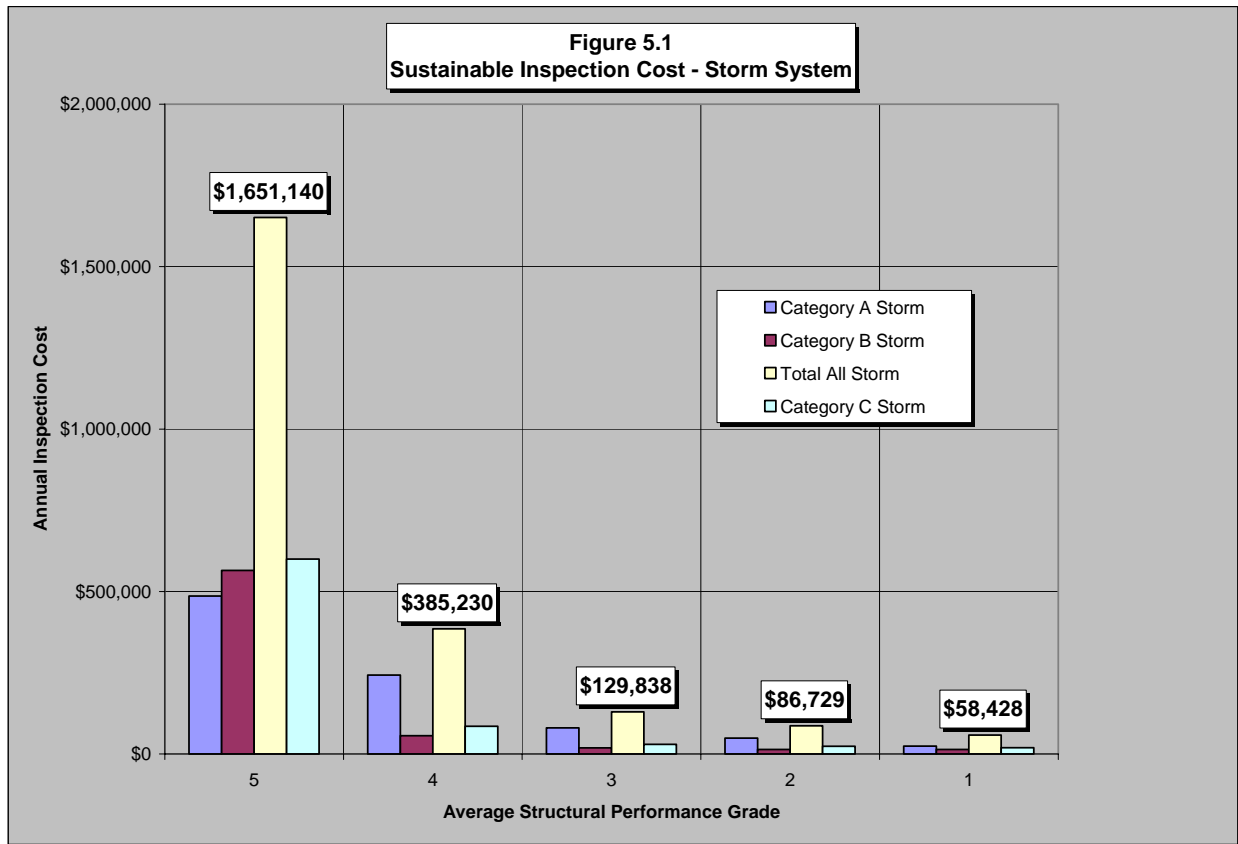
The sustainable annual cost was then calculated by multiplying the sewer length in each category by the average inspection cost (\$5/m), and dividing by the corresponding re-inspection frequency. For illustrative purposes, sewers with a SPG of 5 are assumed to have a required re-inspection frequency of 0.5 years. Figure 5.1 summarizes the calculated sustainable cost for annual sewer inspection as a function of average SPG for all storm sewer inventory.

Figure 2.1: Storm Sewer Segmentation 2
 Figure 2.2: Storm Sewer Spatial Segmentation 3
 Figure 2.3: Storm Sewer Segment ID 4
 Figure 5.1: Sustainable Inspection Cost – Storm System 20

Using this model the rate of inspection priorities in the long-term would largely be driven by the observed physical condition of the inspected sewer network. While it does provide a reasonable framework for rationalizing the annual program size based on the inspected physical condition and observed deterioration patterns, it would be prudent to rationalize what level of deterioration may be present based upon the lack of an annual capital upgrading program to date and the rates of deterioration observed by others.
