**Heritage Revitalization Agreement Bylaw No. 4951, 2017
(1195 12th Street)**

RUSH HOUSE

1195 12TH STREET, WEST VANCOUVER, BC

RUSH HOUSE: 1195 12TH STREET, WEST VANCOUVER, BC
CONSERVATION PLAN | APRIL 2017

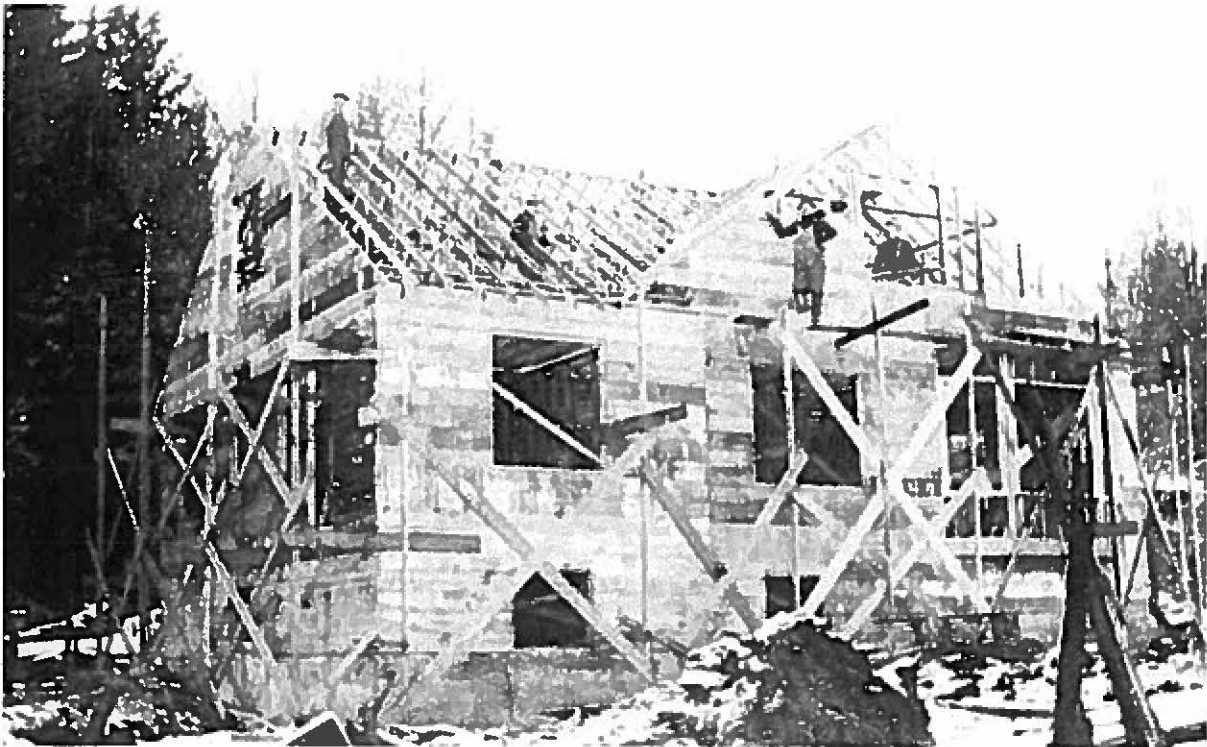
Rush House under construction, 1923. (3267.WVA.PHO)

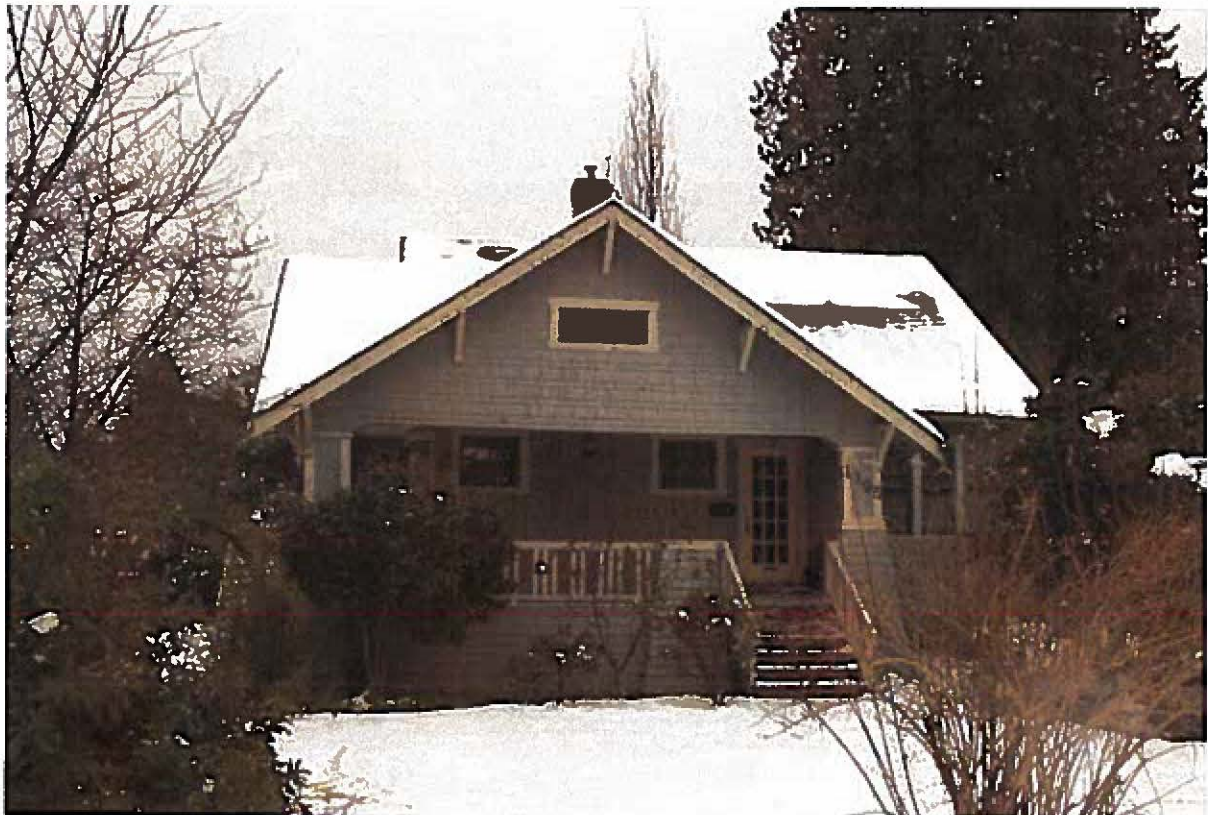
Historic front facade of the Rush House along 12th Street.

- Preserve the overall form, scale and massing of the building.
- The historic street façades along Jefferson Avenue & 12th Street should be retained.

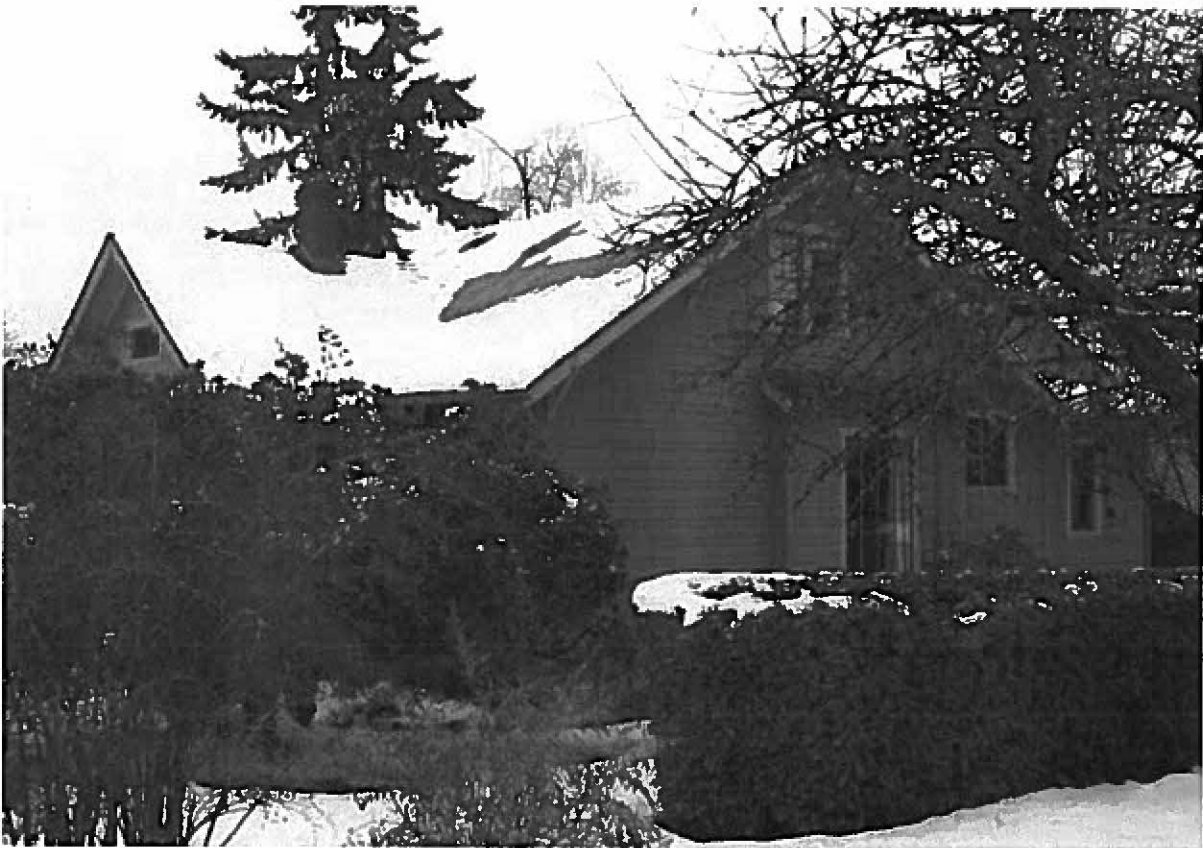
side elevation of the Rush House, at corner of 12th Street and Jefferson Avenue.

- As new foundations are proposed, concrete is a suitable material. New material should match original in appearance, as viewed from the exterior.
- Foundations should be reviewed by a Structural Engineer. Once condition is assessed, conservation recommendations can be finalized.
- To ensure the prolonged preservation of the new foundations, all landscaping should be separated from the foundations at grade by a course of gravel or decorative stones, which help prevent splash back and assist drainage. New vegetation may assist in concealing the newly exposed foundations, if desired.

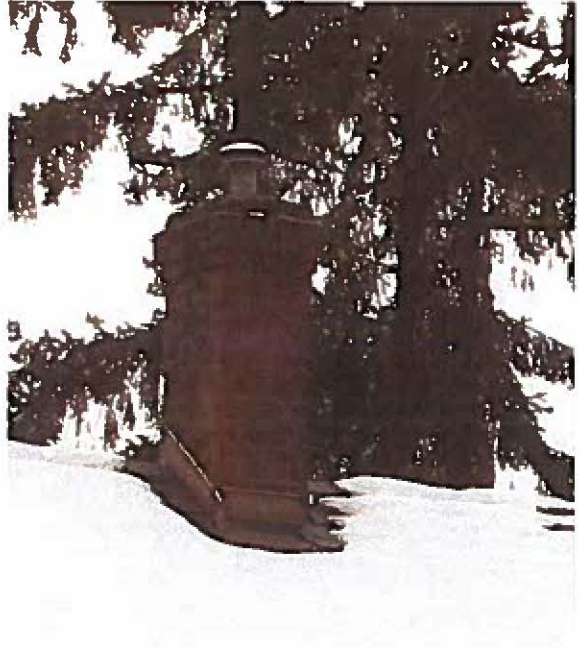
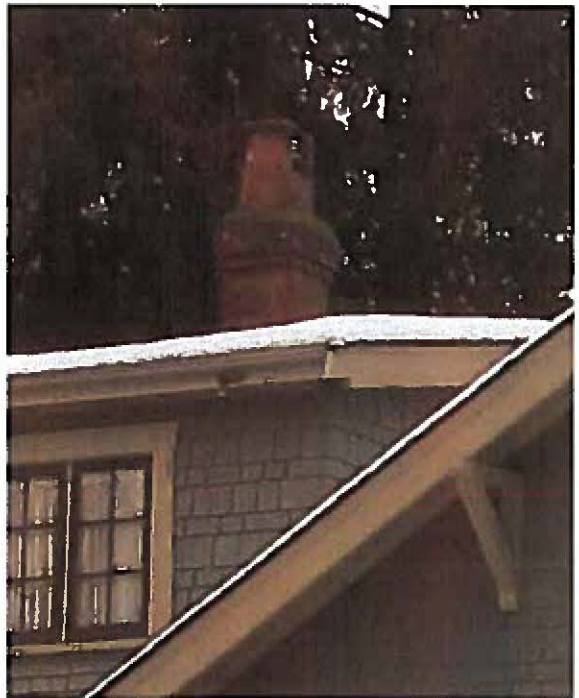
Interior brick chimneys of the Rush House.

- Preserve the chimneys in their original configuration, if possible.
- Chimneys may require structural stabilization.
- Investigate condition of brickwork. If required, brickwork may be repointed and cleaned using a natural bristle brush and mild rinse detergent.

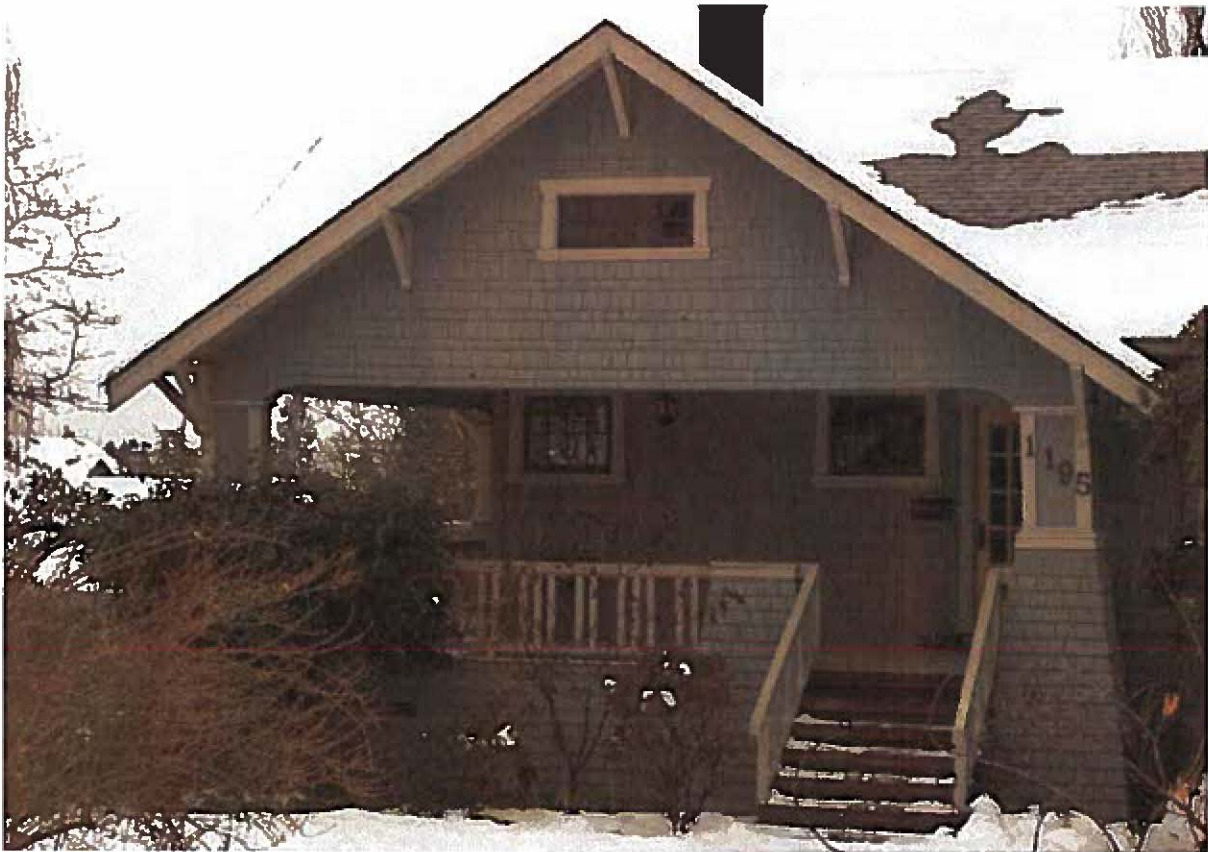
Wrap-around verandah of the Rush House, facing 12th Street.

- Original lower height of the balustrade should be restored, with alternate compliance methods utilized to achieve the required 42" height.
- Top of restored wood balustrade should be 24".
- New possible alternative materials may be glass panels, metal pipe rails or a combination of both.

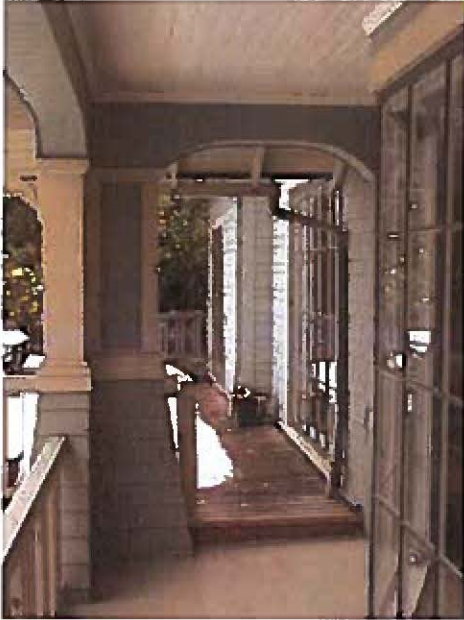
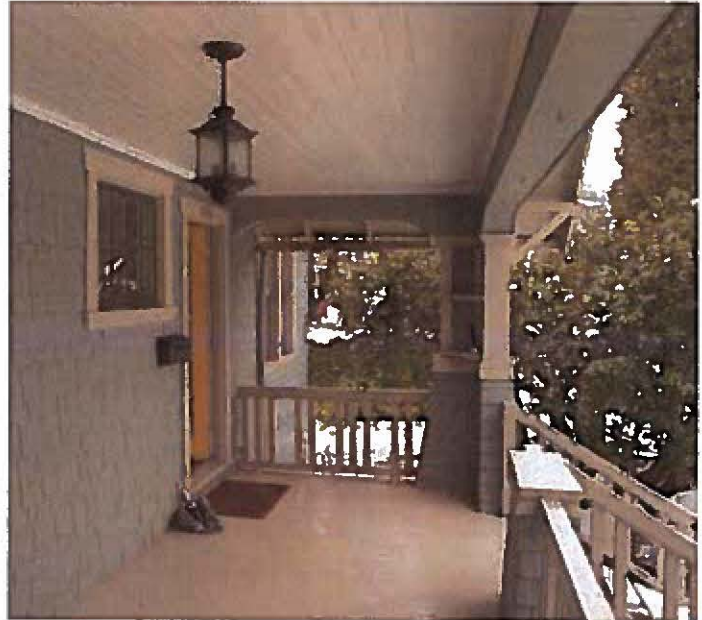
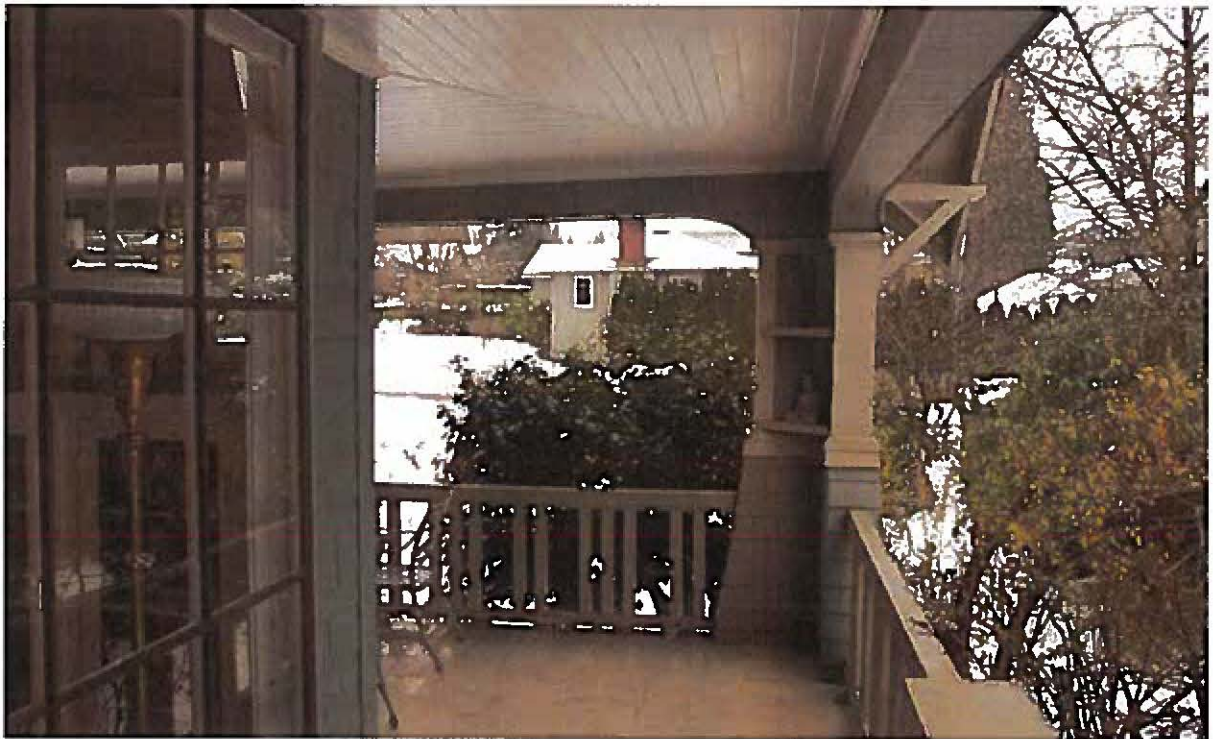
Photos showing existing condition of wrap-around verandah. Note the later porch-deck extension to the verandah (top, left)

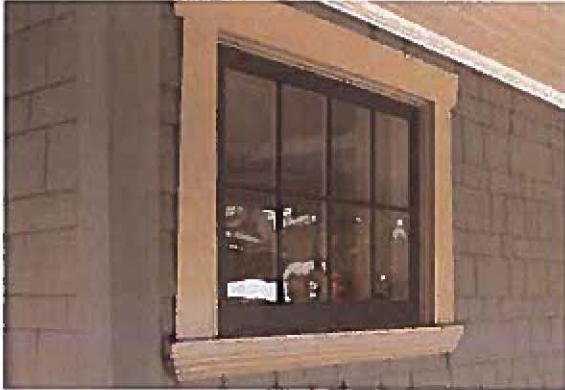
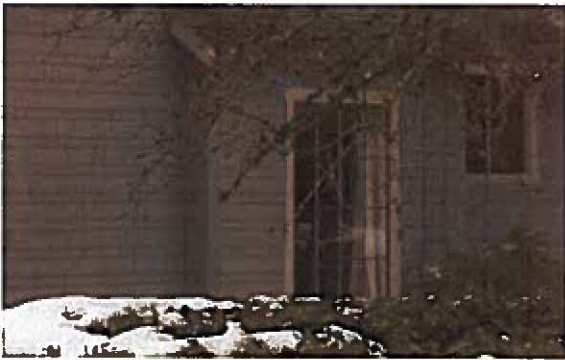
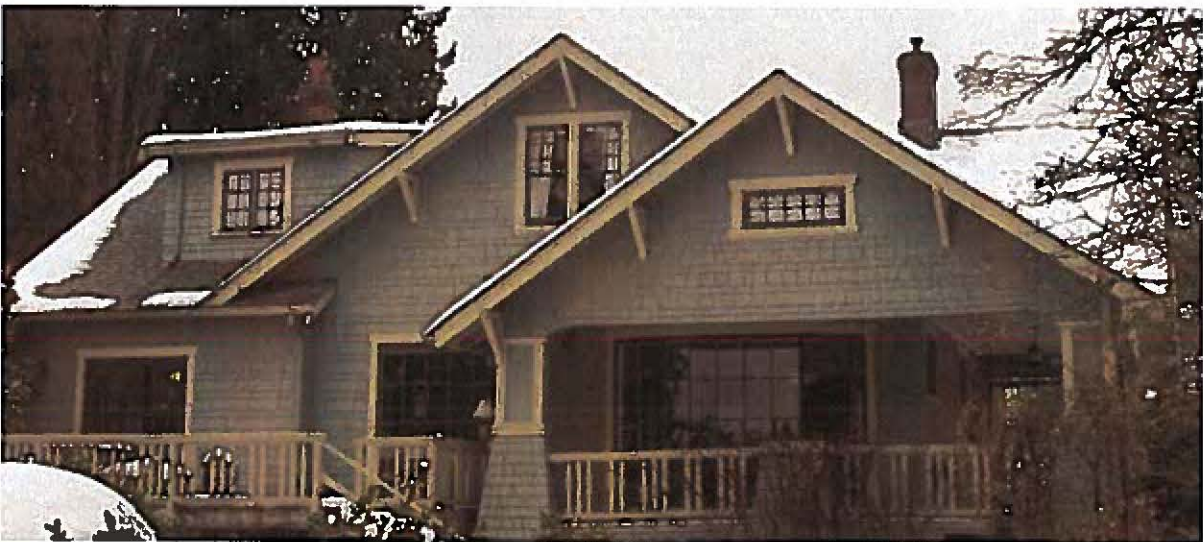
Photos showing original windows of the Rush House.

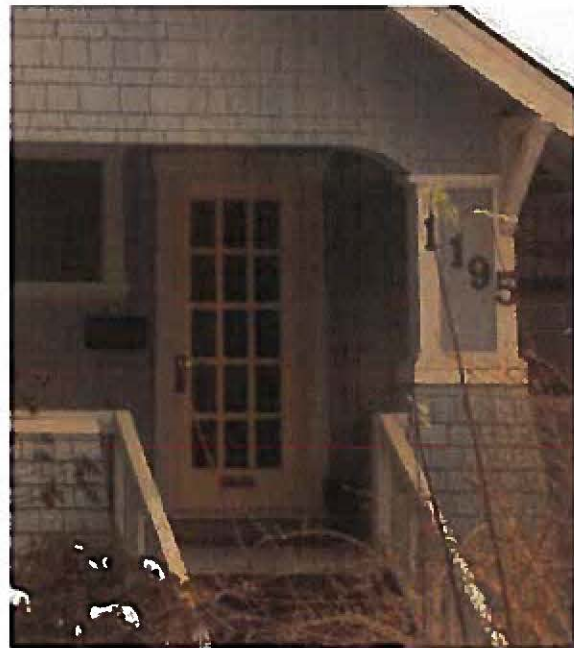
Main entrance door of the Rush House.

- Retain the door openings in their original locations, and preserve and repair all original door.
- New doors should be visually compatible with the historic character of the building.

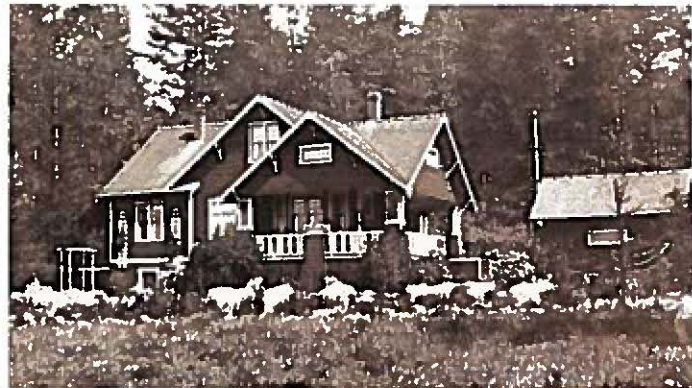
With its strong but simple roof lines and dormers, large porches and framed windows Rush House offers wonderful design inspiration for the balance of the development

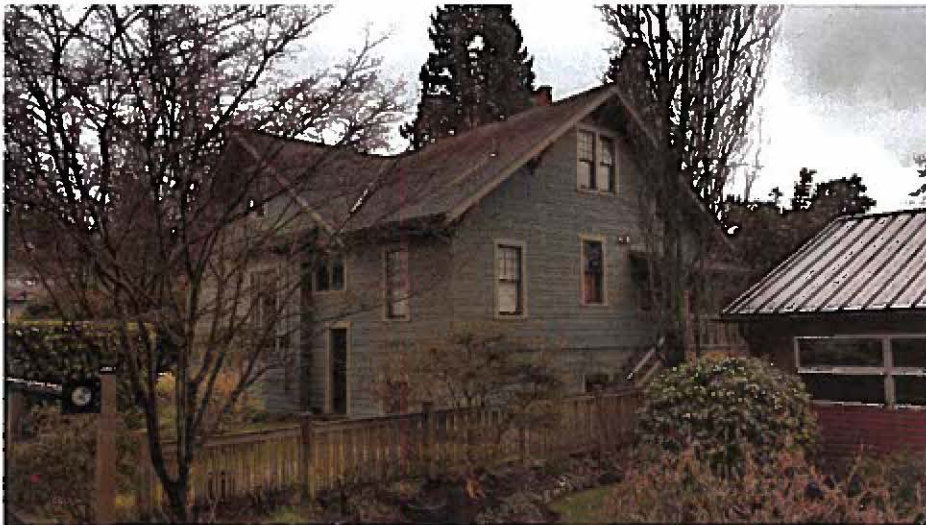
View of Rush House from the front of the house to the west. The proposal is to move Rush House 30 feet to the east to accommodate a new garage which will be at the same elevation as the neighbouring garage.

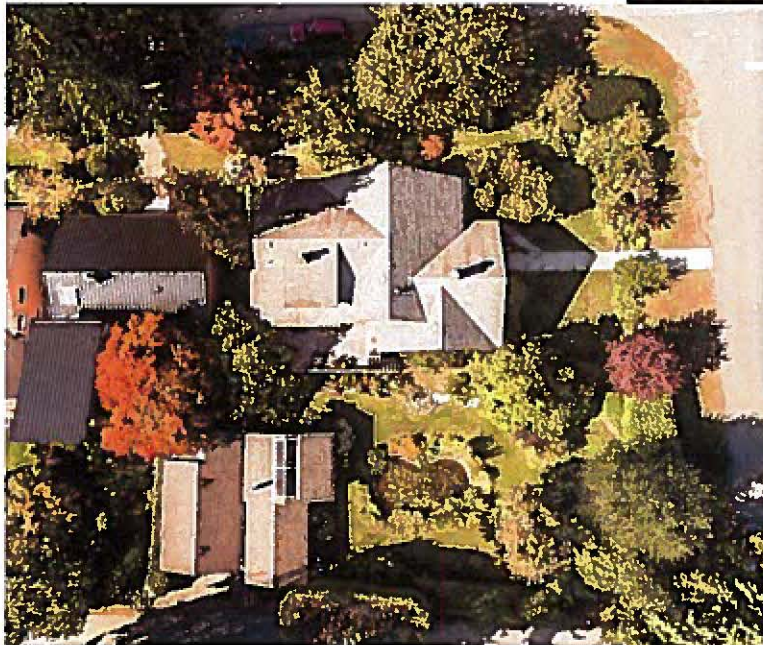
Aerial view of existing Rush House showing relationship to neighbouring house to the west, existing art studio and garage to the south abutting neighbour's garage, and extensive open space.

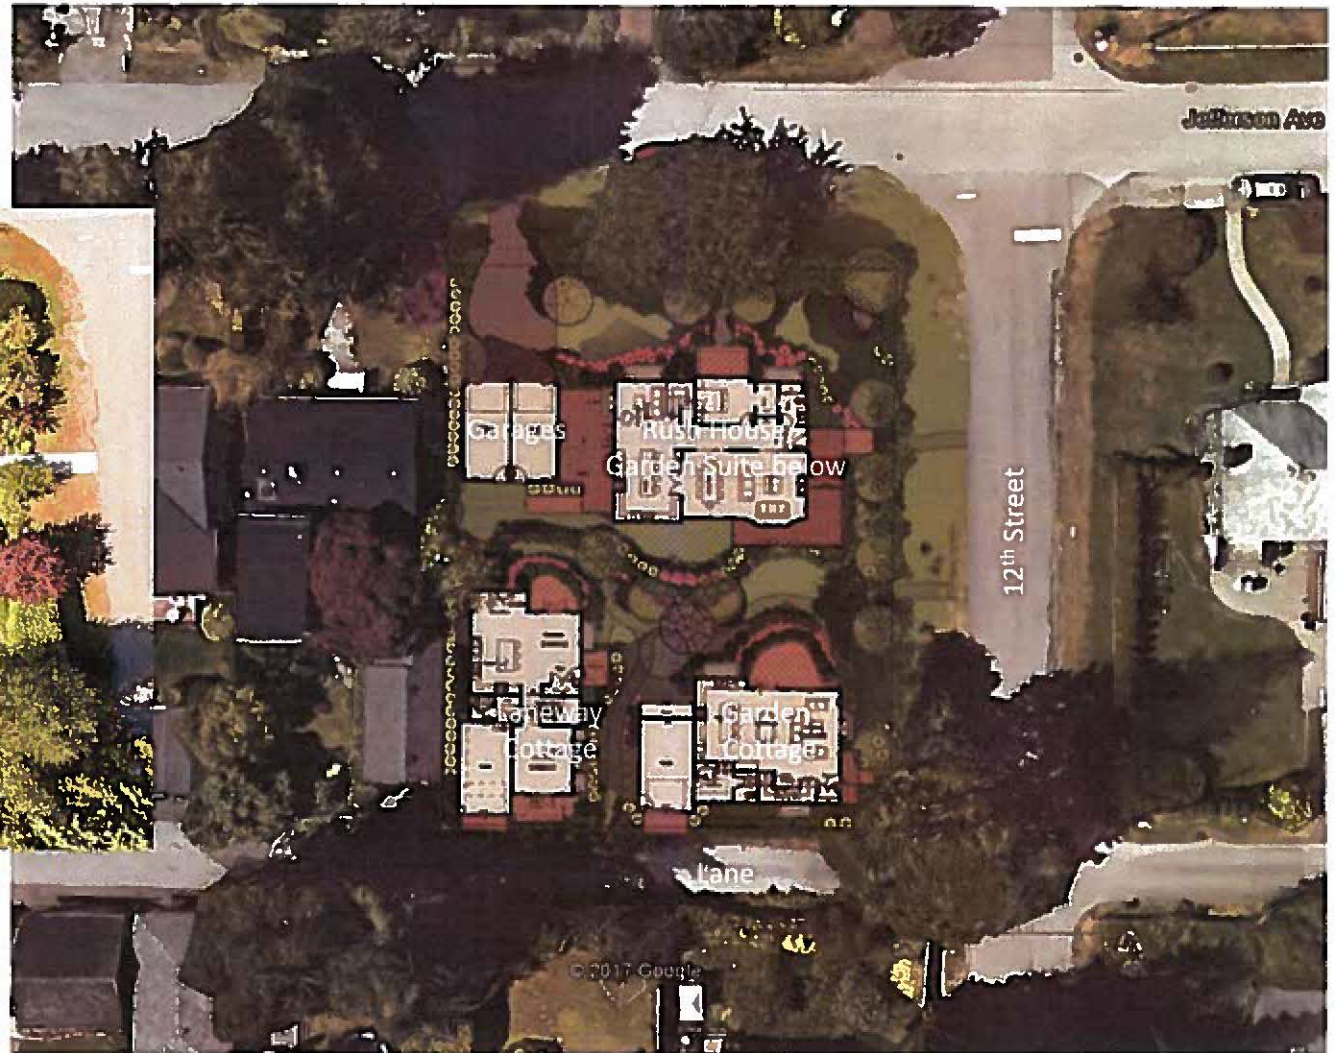
Site plan showing the relocated Rush House, and new infill cottages. The front setback for Rush House along Jefferson Avenue remains the same as present. The setback along 12th Street matches that of the houses along the north side of Jefferson Avenue and south across the lane.

As illustrated, Rush House will be moved approximately 30 feet towards 12th Street to make room for a new two car garage serving Rush House and the Garden Suite below.

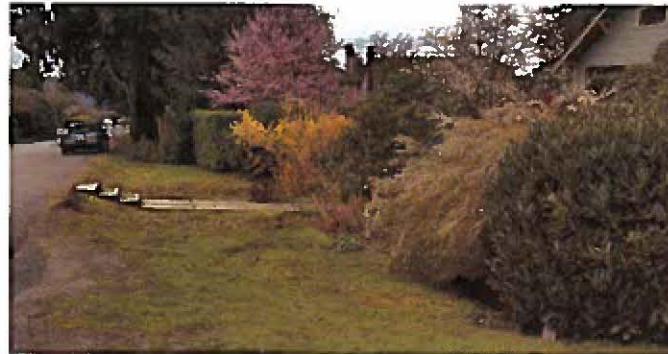
Stairs from 12th Street lead awkwardly down into the garden. It is proposed that this be improved by raising the grade and house by approximately 3 feet.

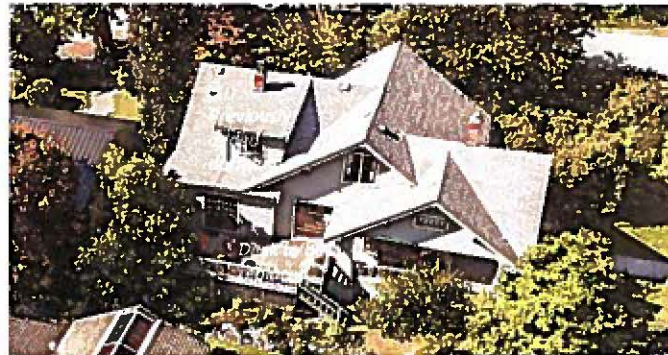
The 1970s deck along the south side of the house will be removed along with the French doors and large windows and replace with more traditional windows.

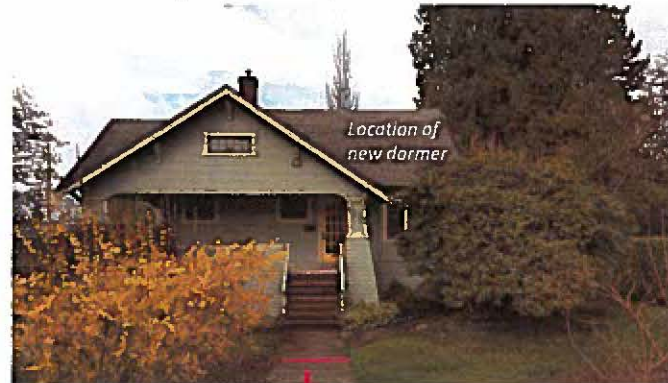
A new dormer is proposed for the 12th Street façade, similar to the dormer that was added along the south façade (see middle photo)

- *The 1970s French doors and large windows will be replaced with windows more in keeping with the original design.*
- *A new dormer window will be added along the Jefferson Avenue façade, similar to a dormer that was previously added to the south façade.*

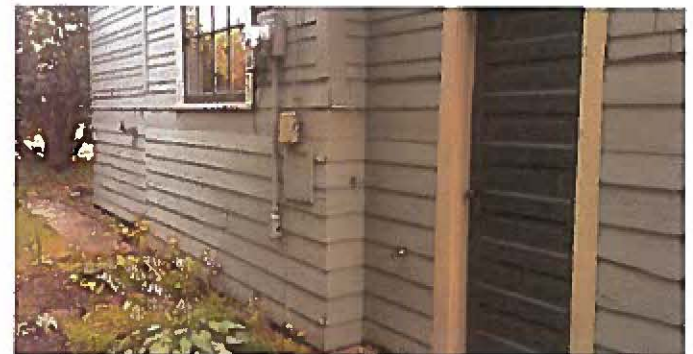
The pattern of cedar shakes and horizontal siding will be retained and replicated on the new Laneway and Garden Cottages

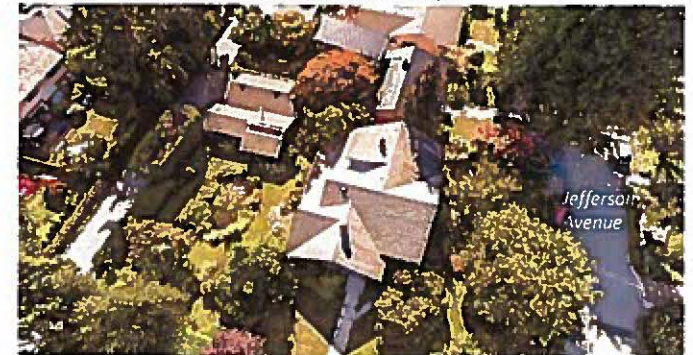
The front setback along Jefferson Avenue will be maintained. The Laneway Cottage will replace the existing art studio and garage.

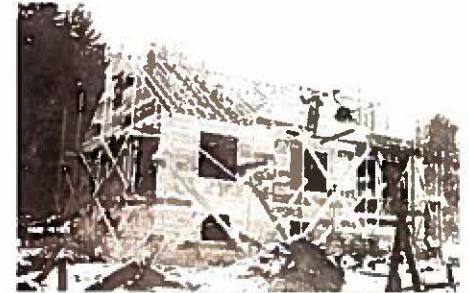
Rush House under construction, 1923, West Vancouver Archives 1267 WVA.PND

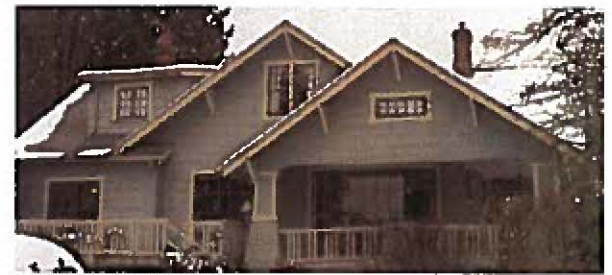
The Rush House features surviving, original wood windows, including a number of multi-pane casement and multi-pane double-hung assemblies with true-divided lights. Based on initial visual review of the original wood window assemblies, the window sashes appear to be operable and in good, repairable condition.

House showing original windows of the Rush House.

Over the years, most of the original windows have been replaced. However, it is intended that the remaining original windows be retained and some of the newer windows be replaced with more original type windows. New wood windows will be fabricated to replicate the original windows.

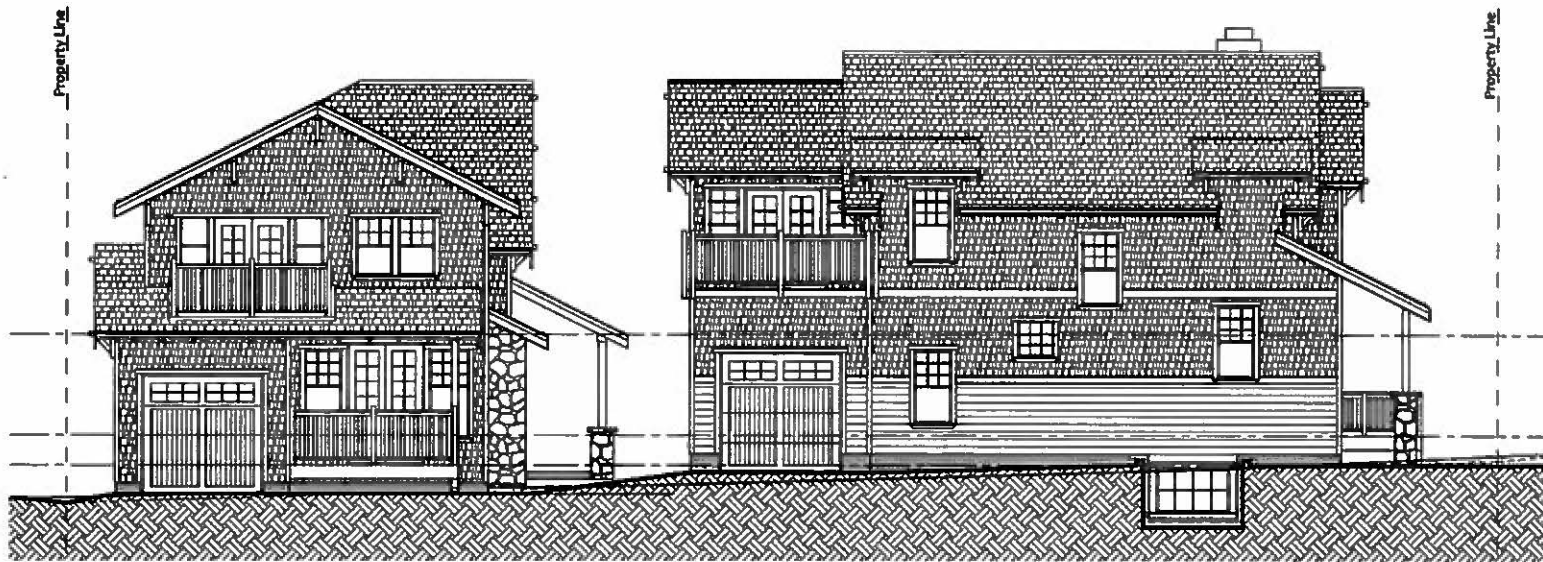
LANE ELEVATION SHOWING LANEWAY COTTAGE (LEFT) AND GARDEN COTTAGE (RIGHT)

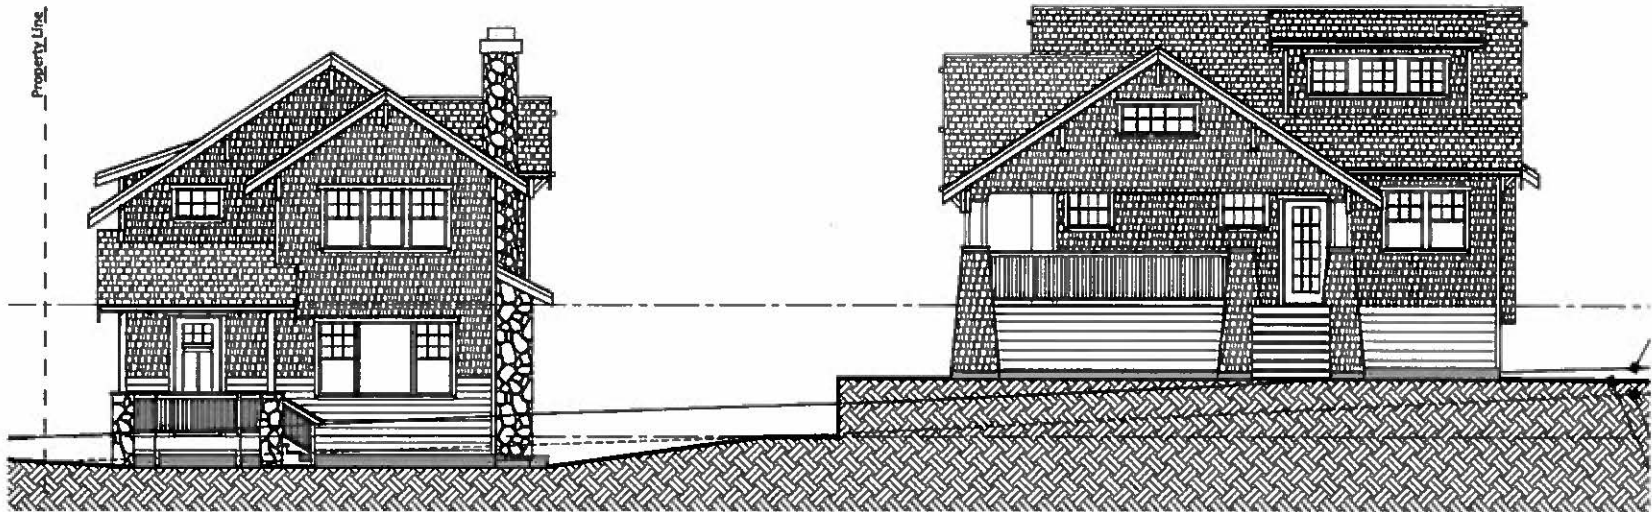
12TH STREET ELEVATION SHOWING RUSH HOUSE (LEFT) AND GARDEN COTTAGE (RIGHT)

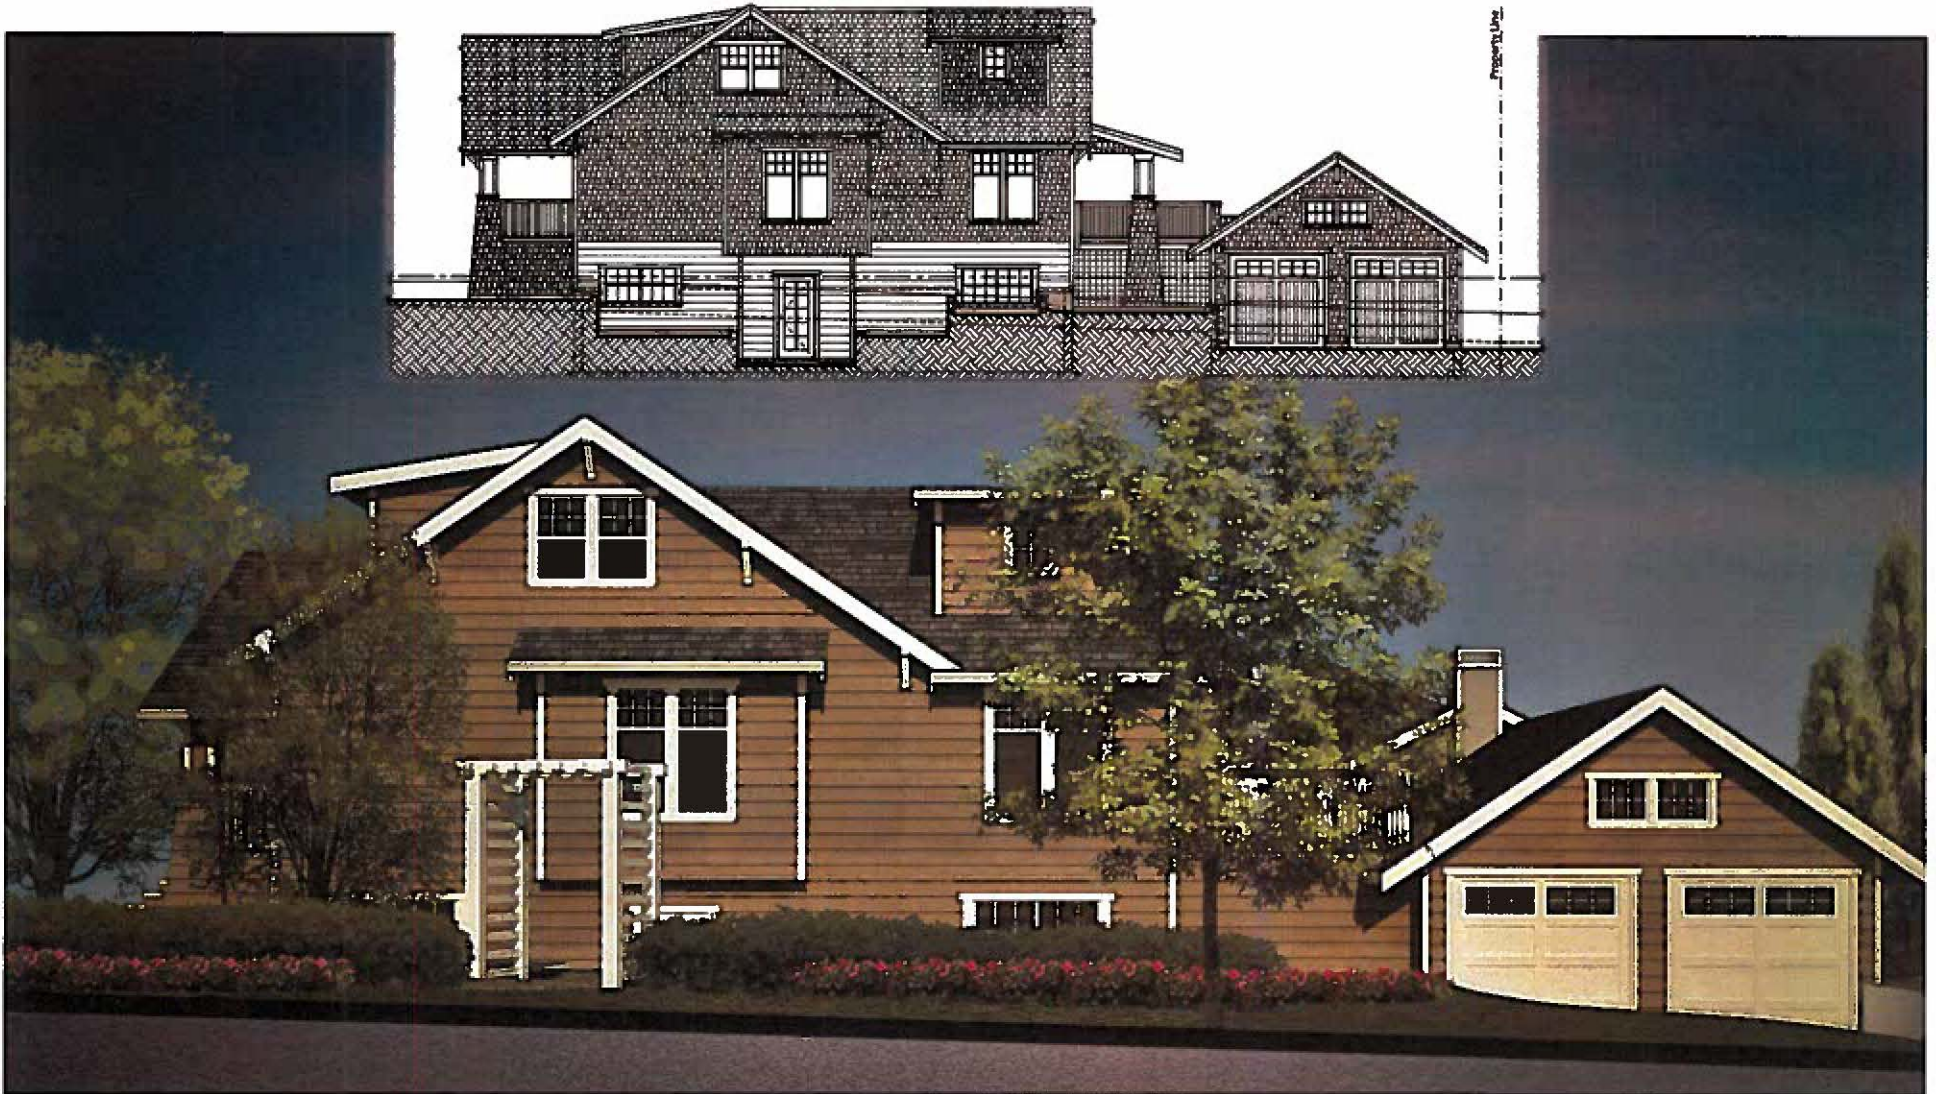
VIEW ALONG JEFFERSON AVENUE (INSERT SHOWS REVISION TO BACK PORCH DESIGN IN RESPONSE TO DESIGN REVIEW COMMITTEE RECOMMENDATION)

Earlier elevation showing Rush House and the new garage structure. A dormer has been added, as suggested by the architect and heritage consultant, to give Rush House a more impressive appearance from the street.

The insert drawing shows the new porch that has been added, similar to that found in the original plans. It also incorporates the DRC recommendation to create a more distinct break between Rush House and the garages.

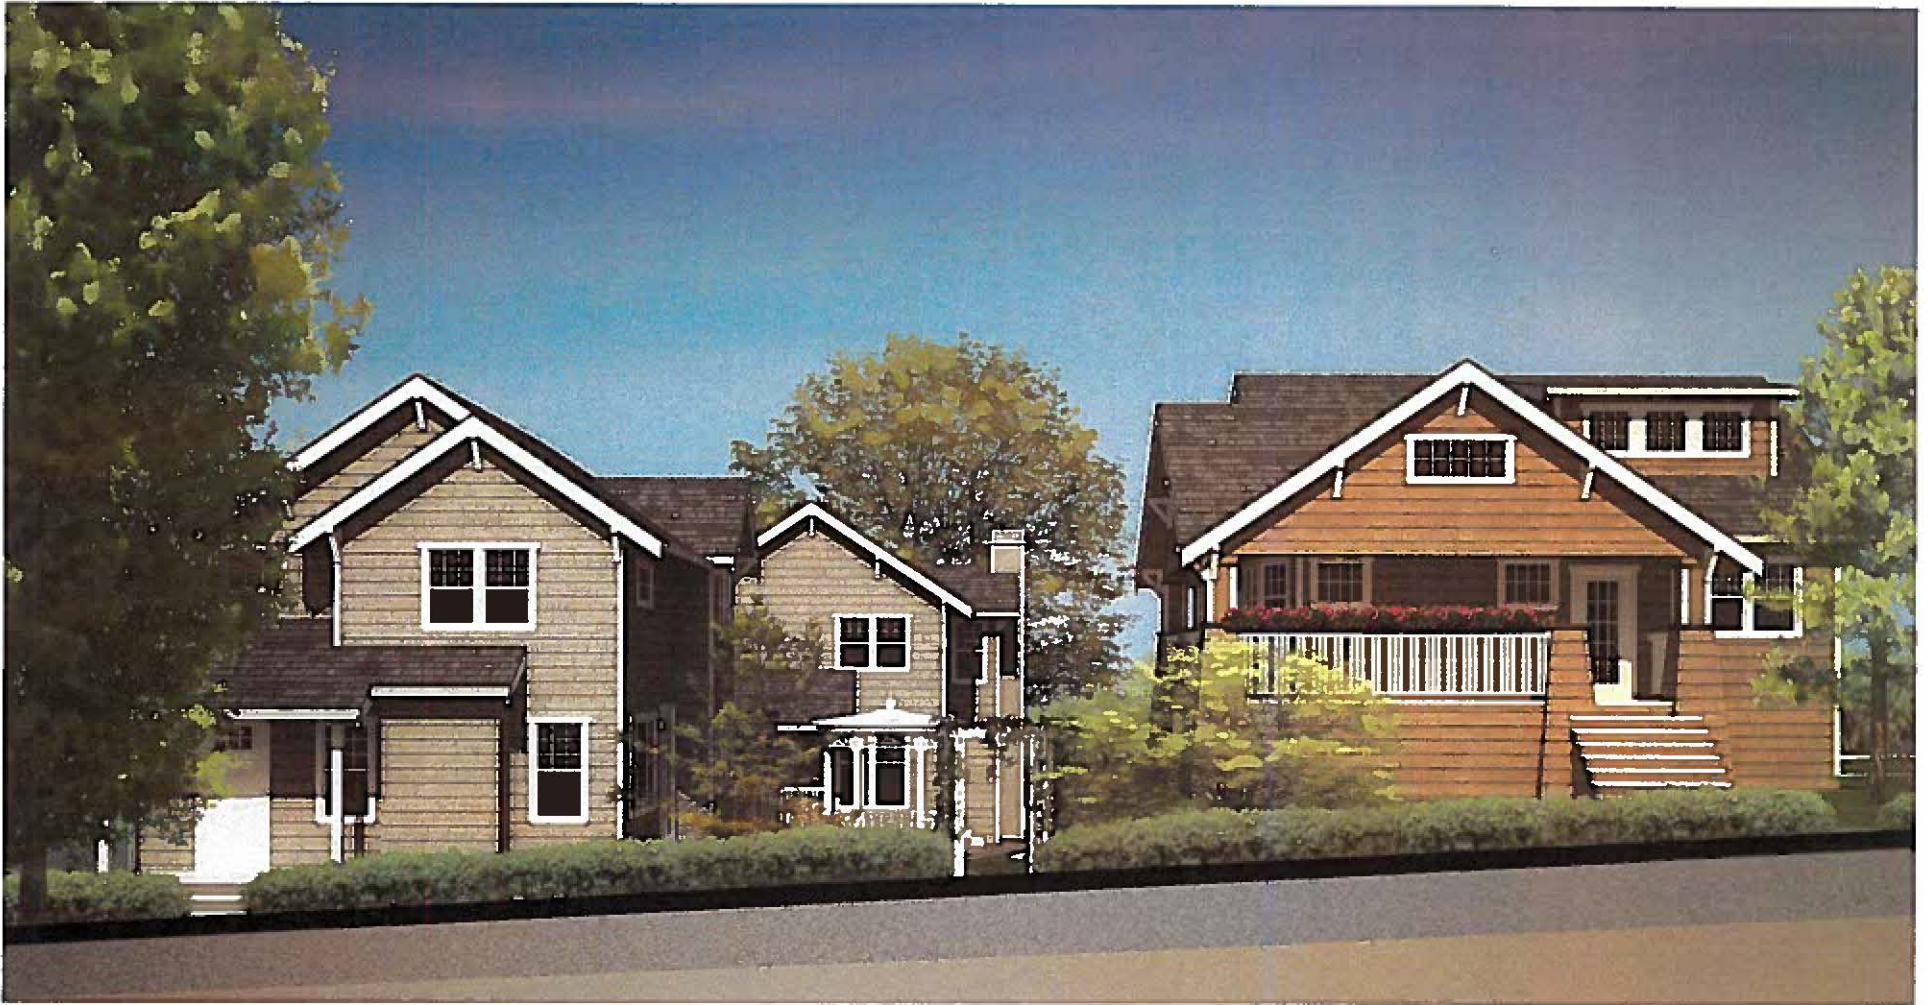
VIEW ALONG 12TH STREET

The view along 12th Street illustrating the earlier proposal to use the same colour for the Laneway and Garden Cottages. However, as a result of the Design Review Committee recommendations, different but complementary heritage colours are now proposed for the two infill cottages, along with a mix of shingles and horizontal siding similar to the existing Rush House

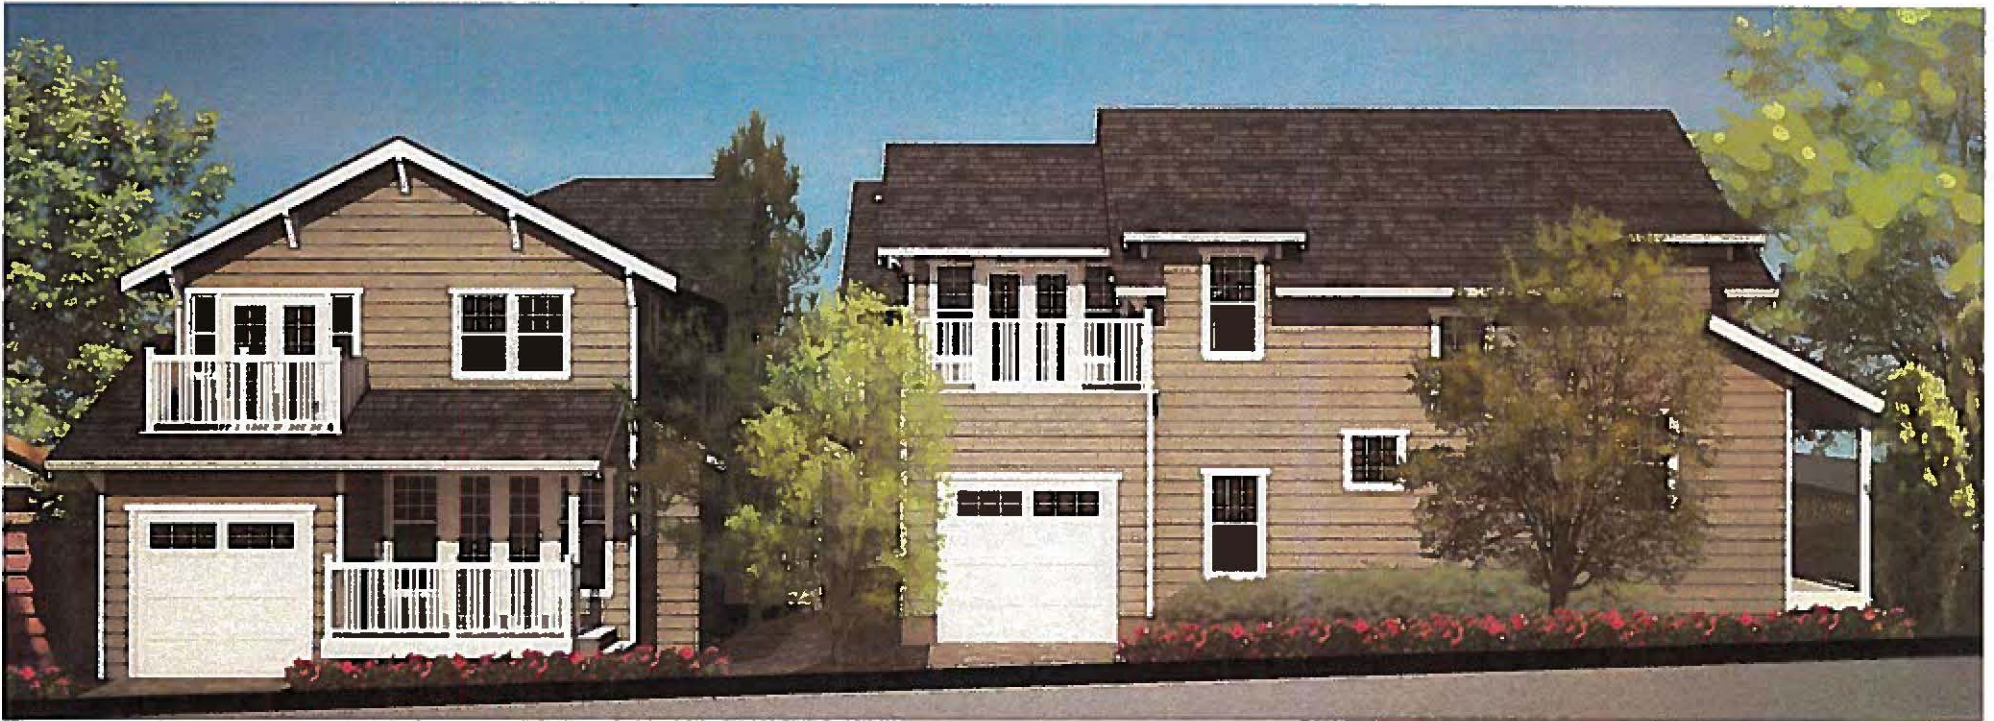
VIEW ALONG THE EAST-WEST LANE ILLUSTRATING THE LANEWAY COTTAGE (LEFT) AND GARDEN SUITE

Note the colours of these two cottages are being revised to add greater variety while not competing with the heritage Rush House

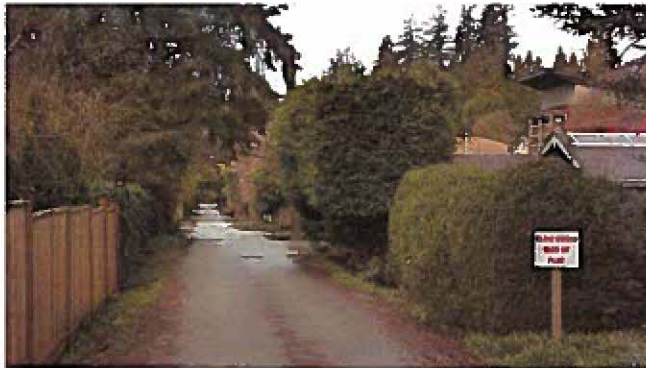
Looking west (above) . Note the lane is less than the standard 18 foot in width.

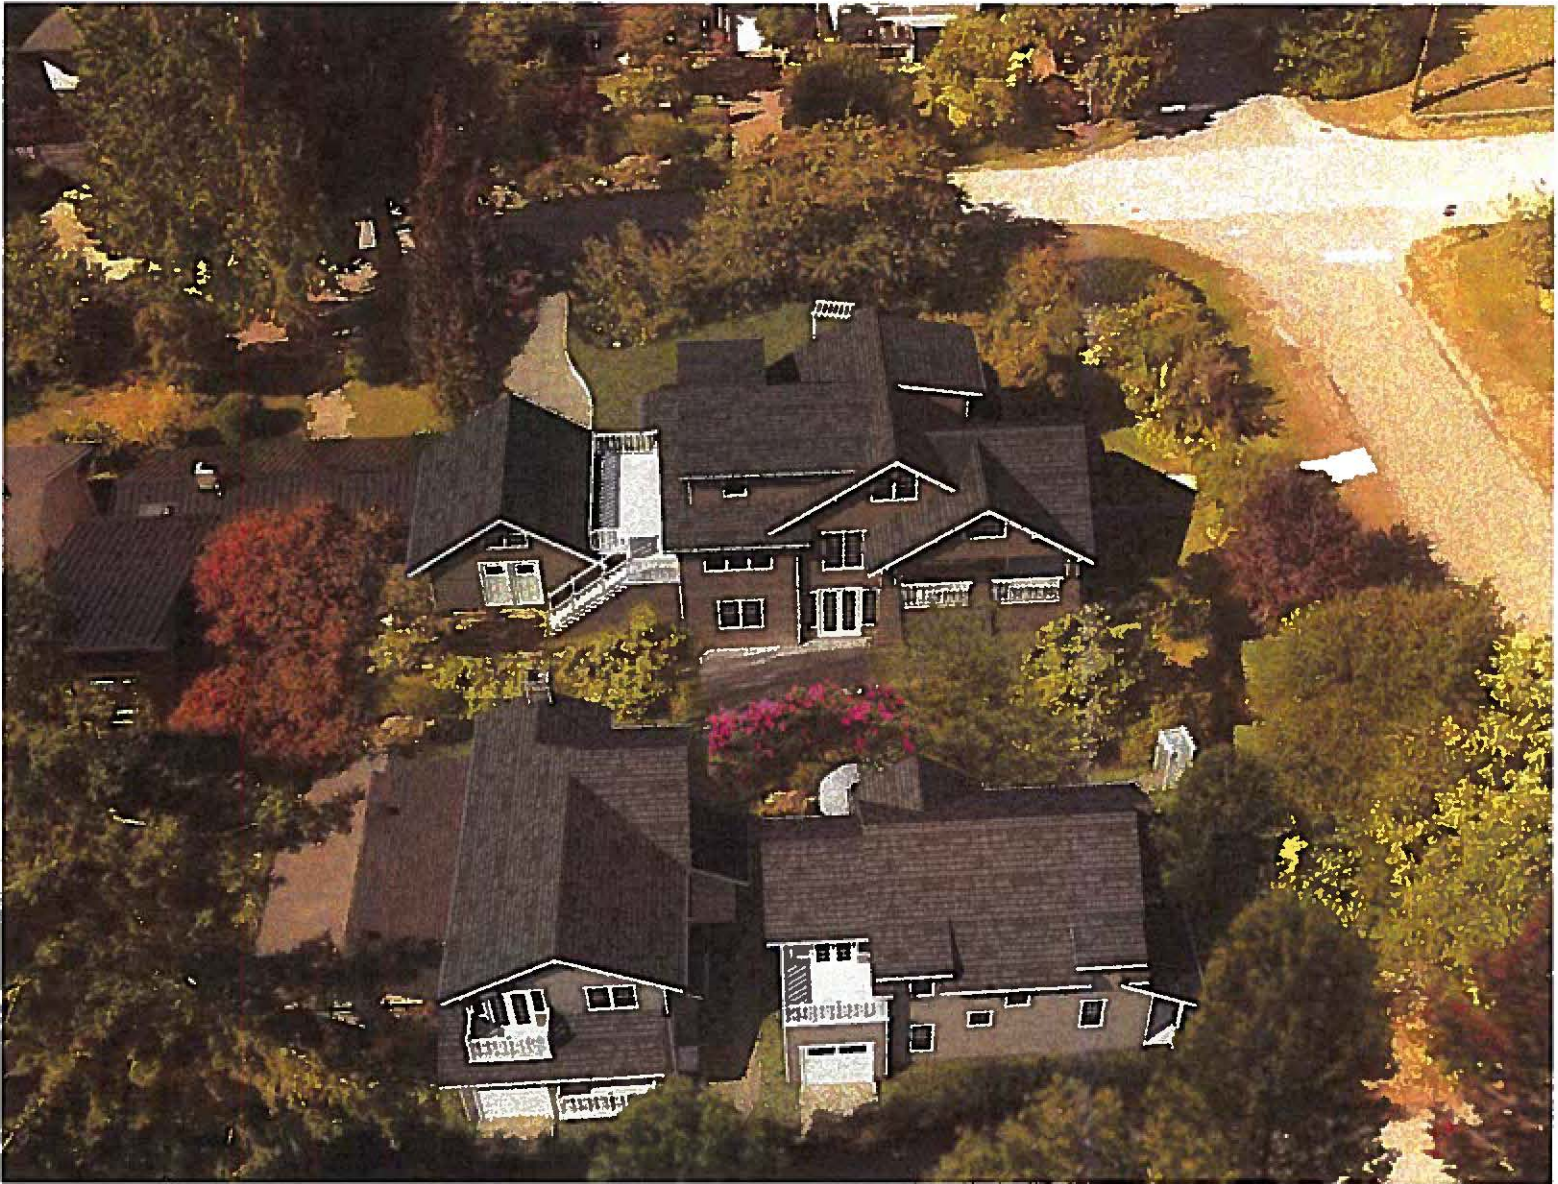
An earlier Bird's eye view looking north (Note: the rear deck between Rush House and the garage structure has subsequently been revised in response to the DRC comments
