**Heritage Revitalization Agreement Bylaw No. 4951, 2017
(1195 12th Street)**

RUSH HOUSE

1195 12TH STREET, WEST VANCOUVER, BC

RUSH HOUSE: 1195 12TH STREET, WEST VANCOUVER, BC
CONSERVATION PLAN | APRIL 2017

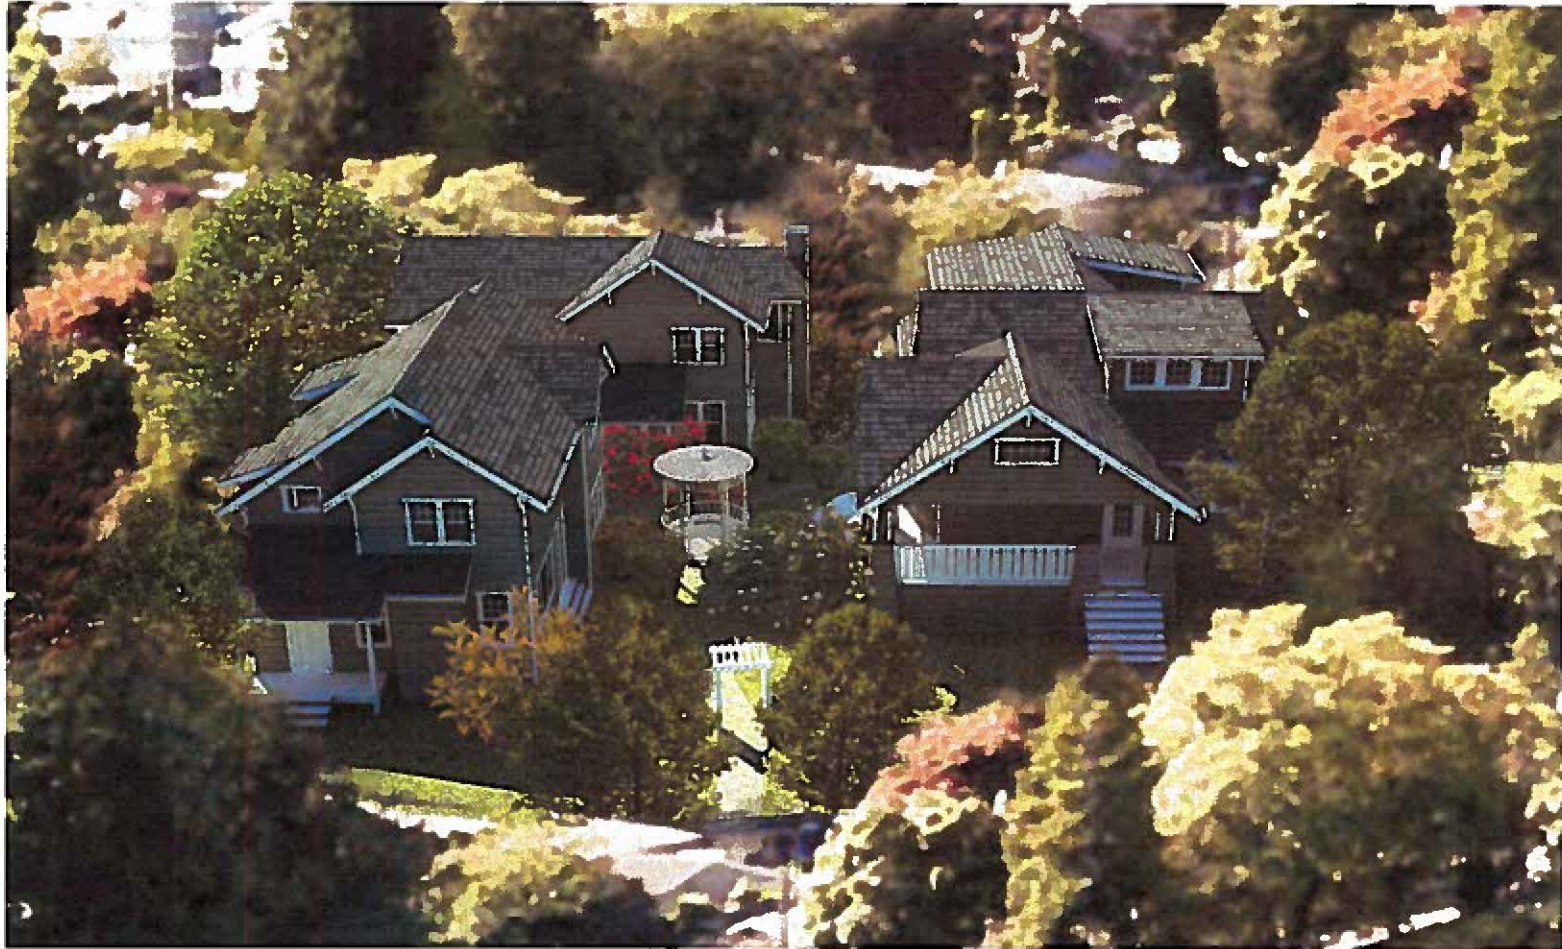
An earlier Bird's eye view looking north (Note: the rear deck between Rush House and the garage structure has subsequently been revised in response to the DRC comments

The insert drawing shows the new porch that has been added, similar to that found in the original plans. It also incorporates the DRC recommendation to create a more distinct break between Rush House and the garages.

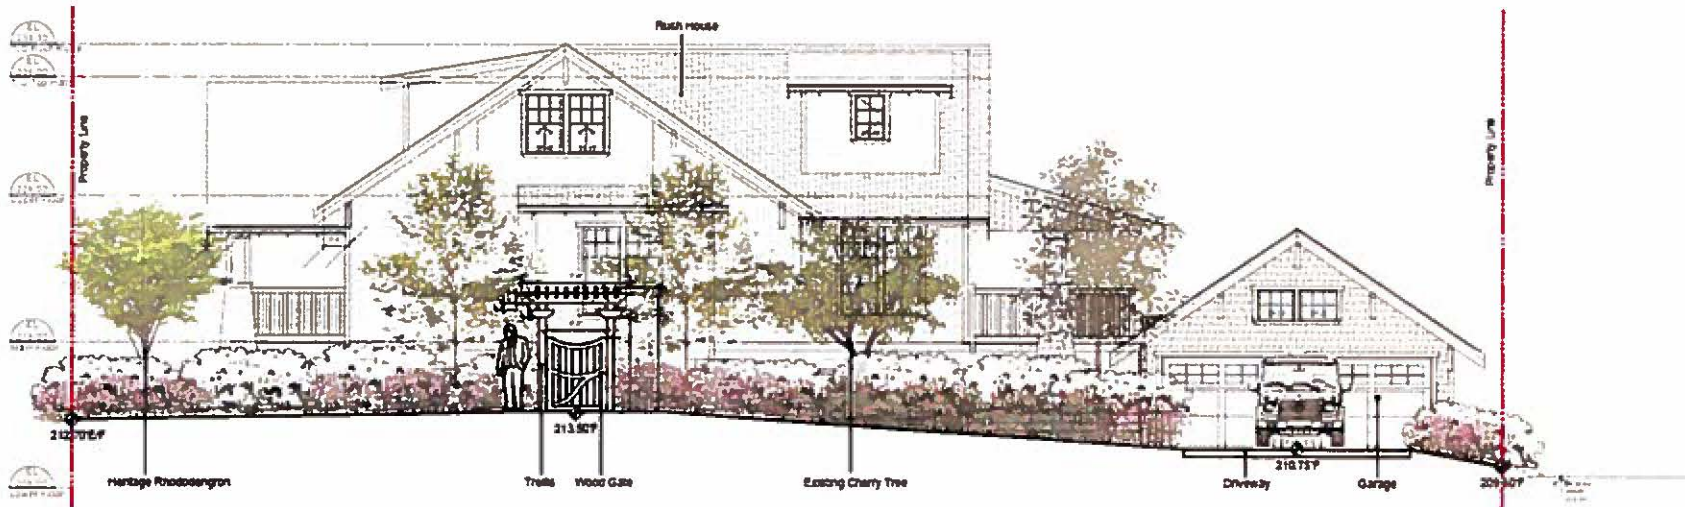
(JEFFERSON AVENUE) ○ NORTH PROPERTY LINE ELEVATION
SCALE: 3/16" = 1'-0"

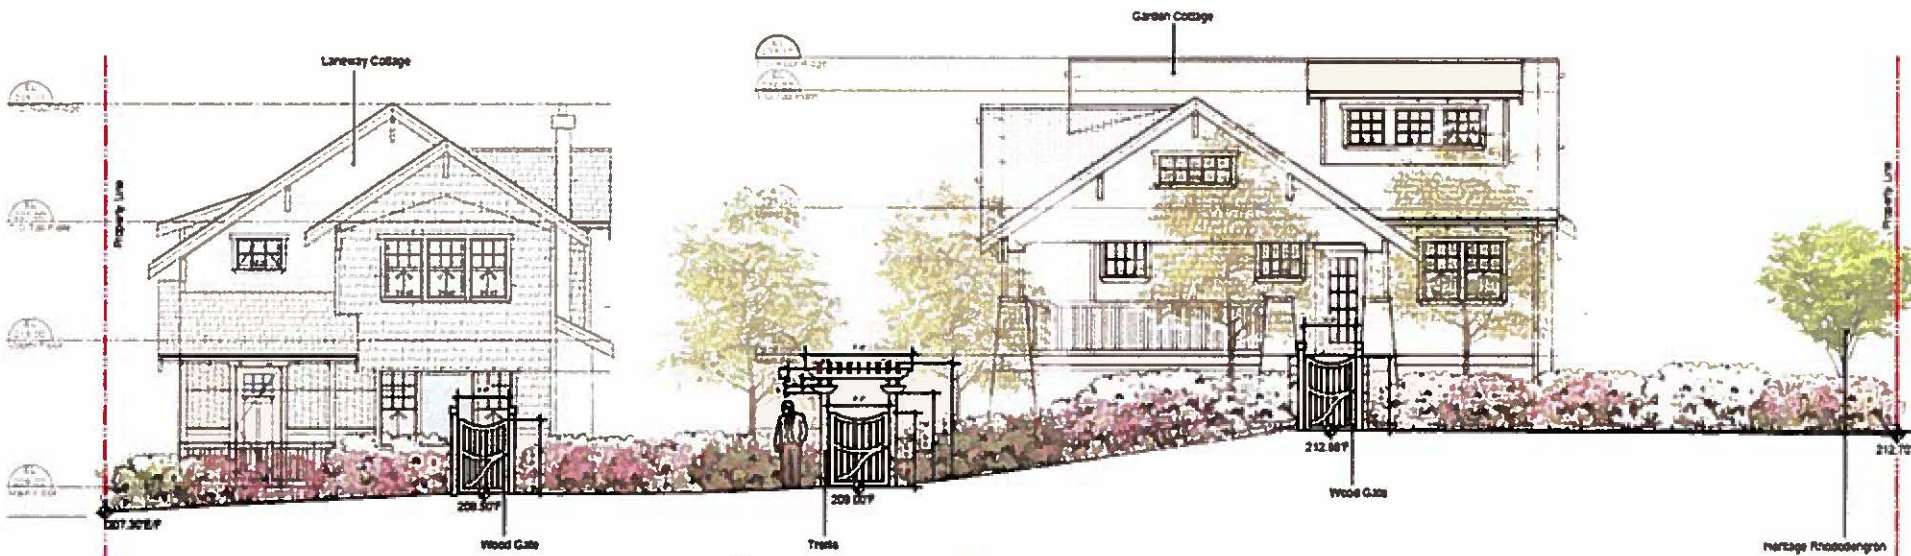
(12TH STREET) ○ EAST PROPERTY LINE ELEVATION
SCALE: 3/16" = 1'-0"

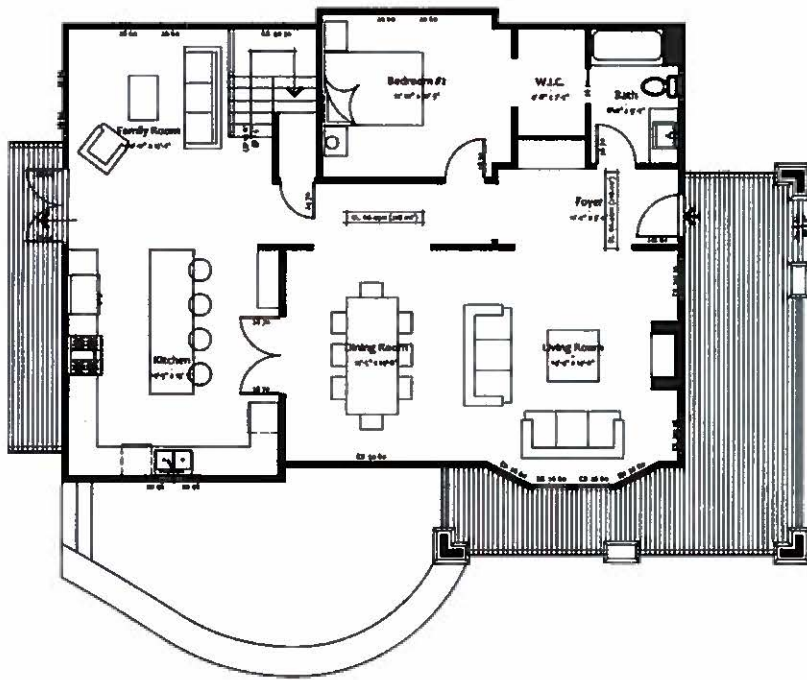
Main level Rush House

The planning of Rush House has been guided by the Heritage Conservation Plan prepared by Donald Luxton Associates Inc. The main floor plan retains some of the existing layout with a couple of exceptions. The existing bathroom has been eliminated in order to expand the small kitchen and connect it to a new family room. The existing dining room is being converted to a master bedroom, and the ensuite bath will also serve as a powder room. While the flooring will be replaced, efforts will be made to retain some of the existing heritage features as recommended in the conservation plan.

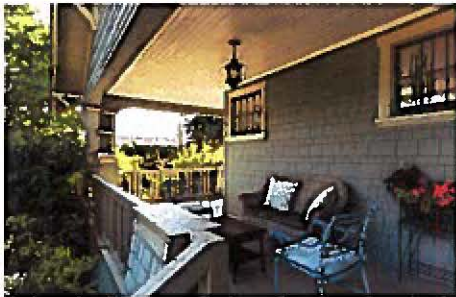
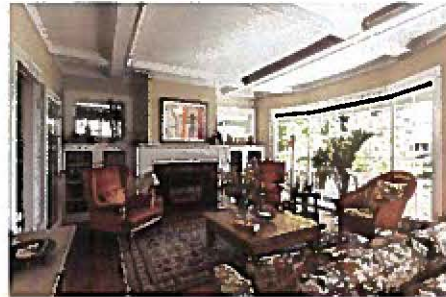
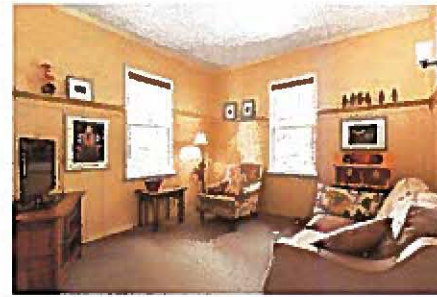
Photos of Rush House as it appears today

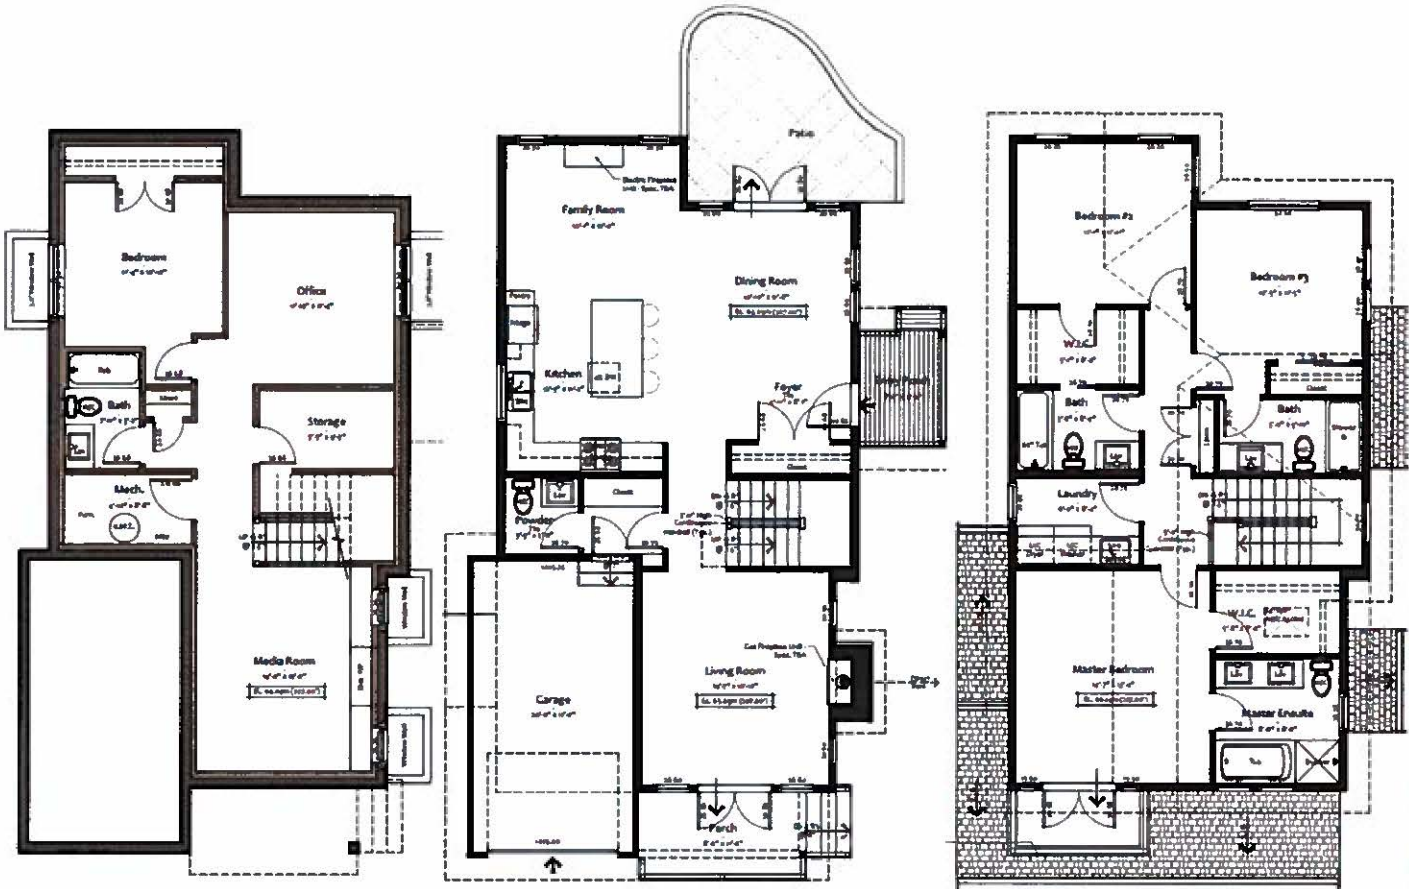
The exterior materials are hardie board shingles in a warm grey, so as not to conflict with the richer colour proposed for the heritage house. Careful attention has been given to the roof shapes to complement the main house. The roofing material will be similar in appearance.

The area of the laneway cottage is approximately 1859 square feet plus basement.

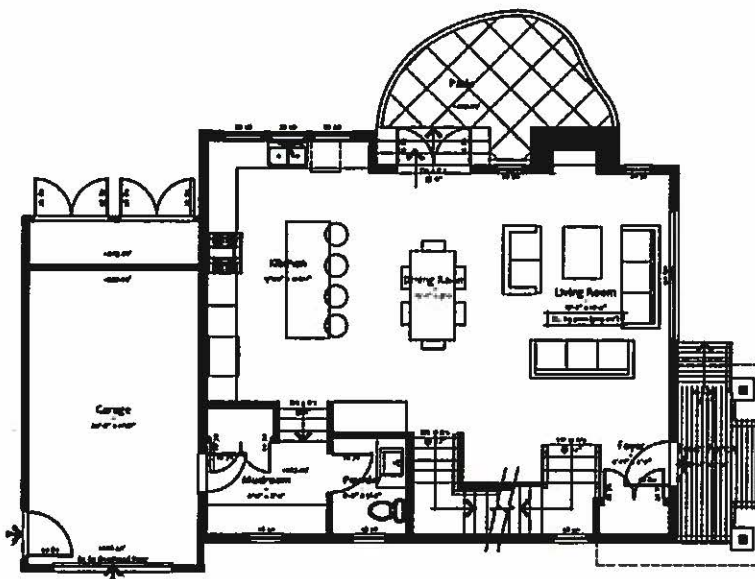
Main floor

GARDEN COTTAGE FLOOR PLANS

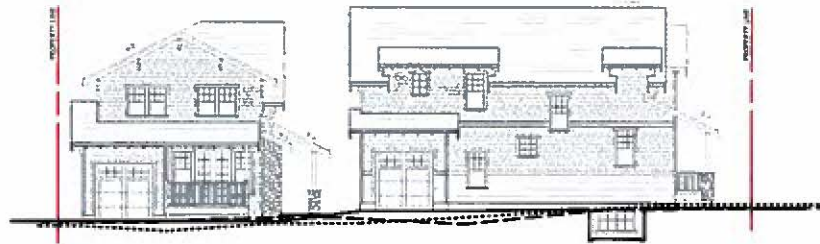
- - - - - STREET GRADE
 - - - - - FINISHED GRADE
 - - - - - FORMER GRADE

1 STREETScape - LANE
A04

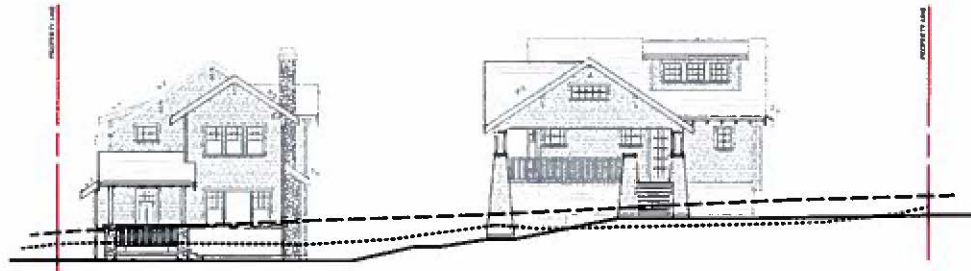
2 STREETScape - 12TH STREET
A04

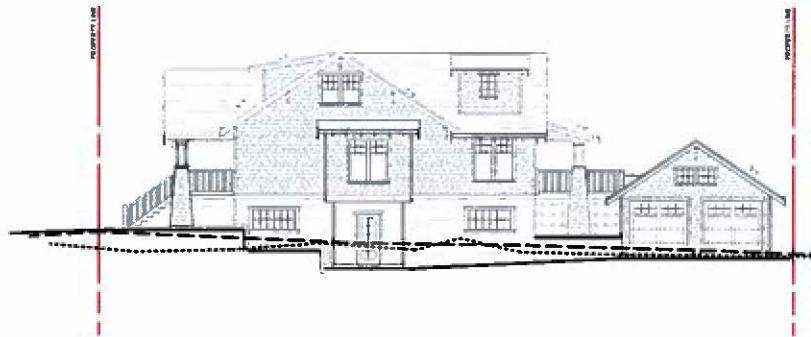
3 STREETScape - JEFFERSON AVENUE
A04
