Project:
 Inglewood Campus Care Facility

Location:
 725 Inglewood Ave,
 West Vancouver, BC,
 V7T 1X5

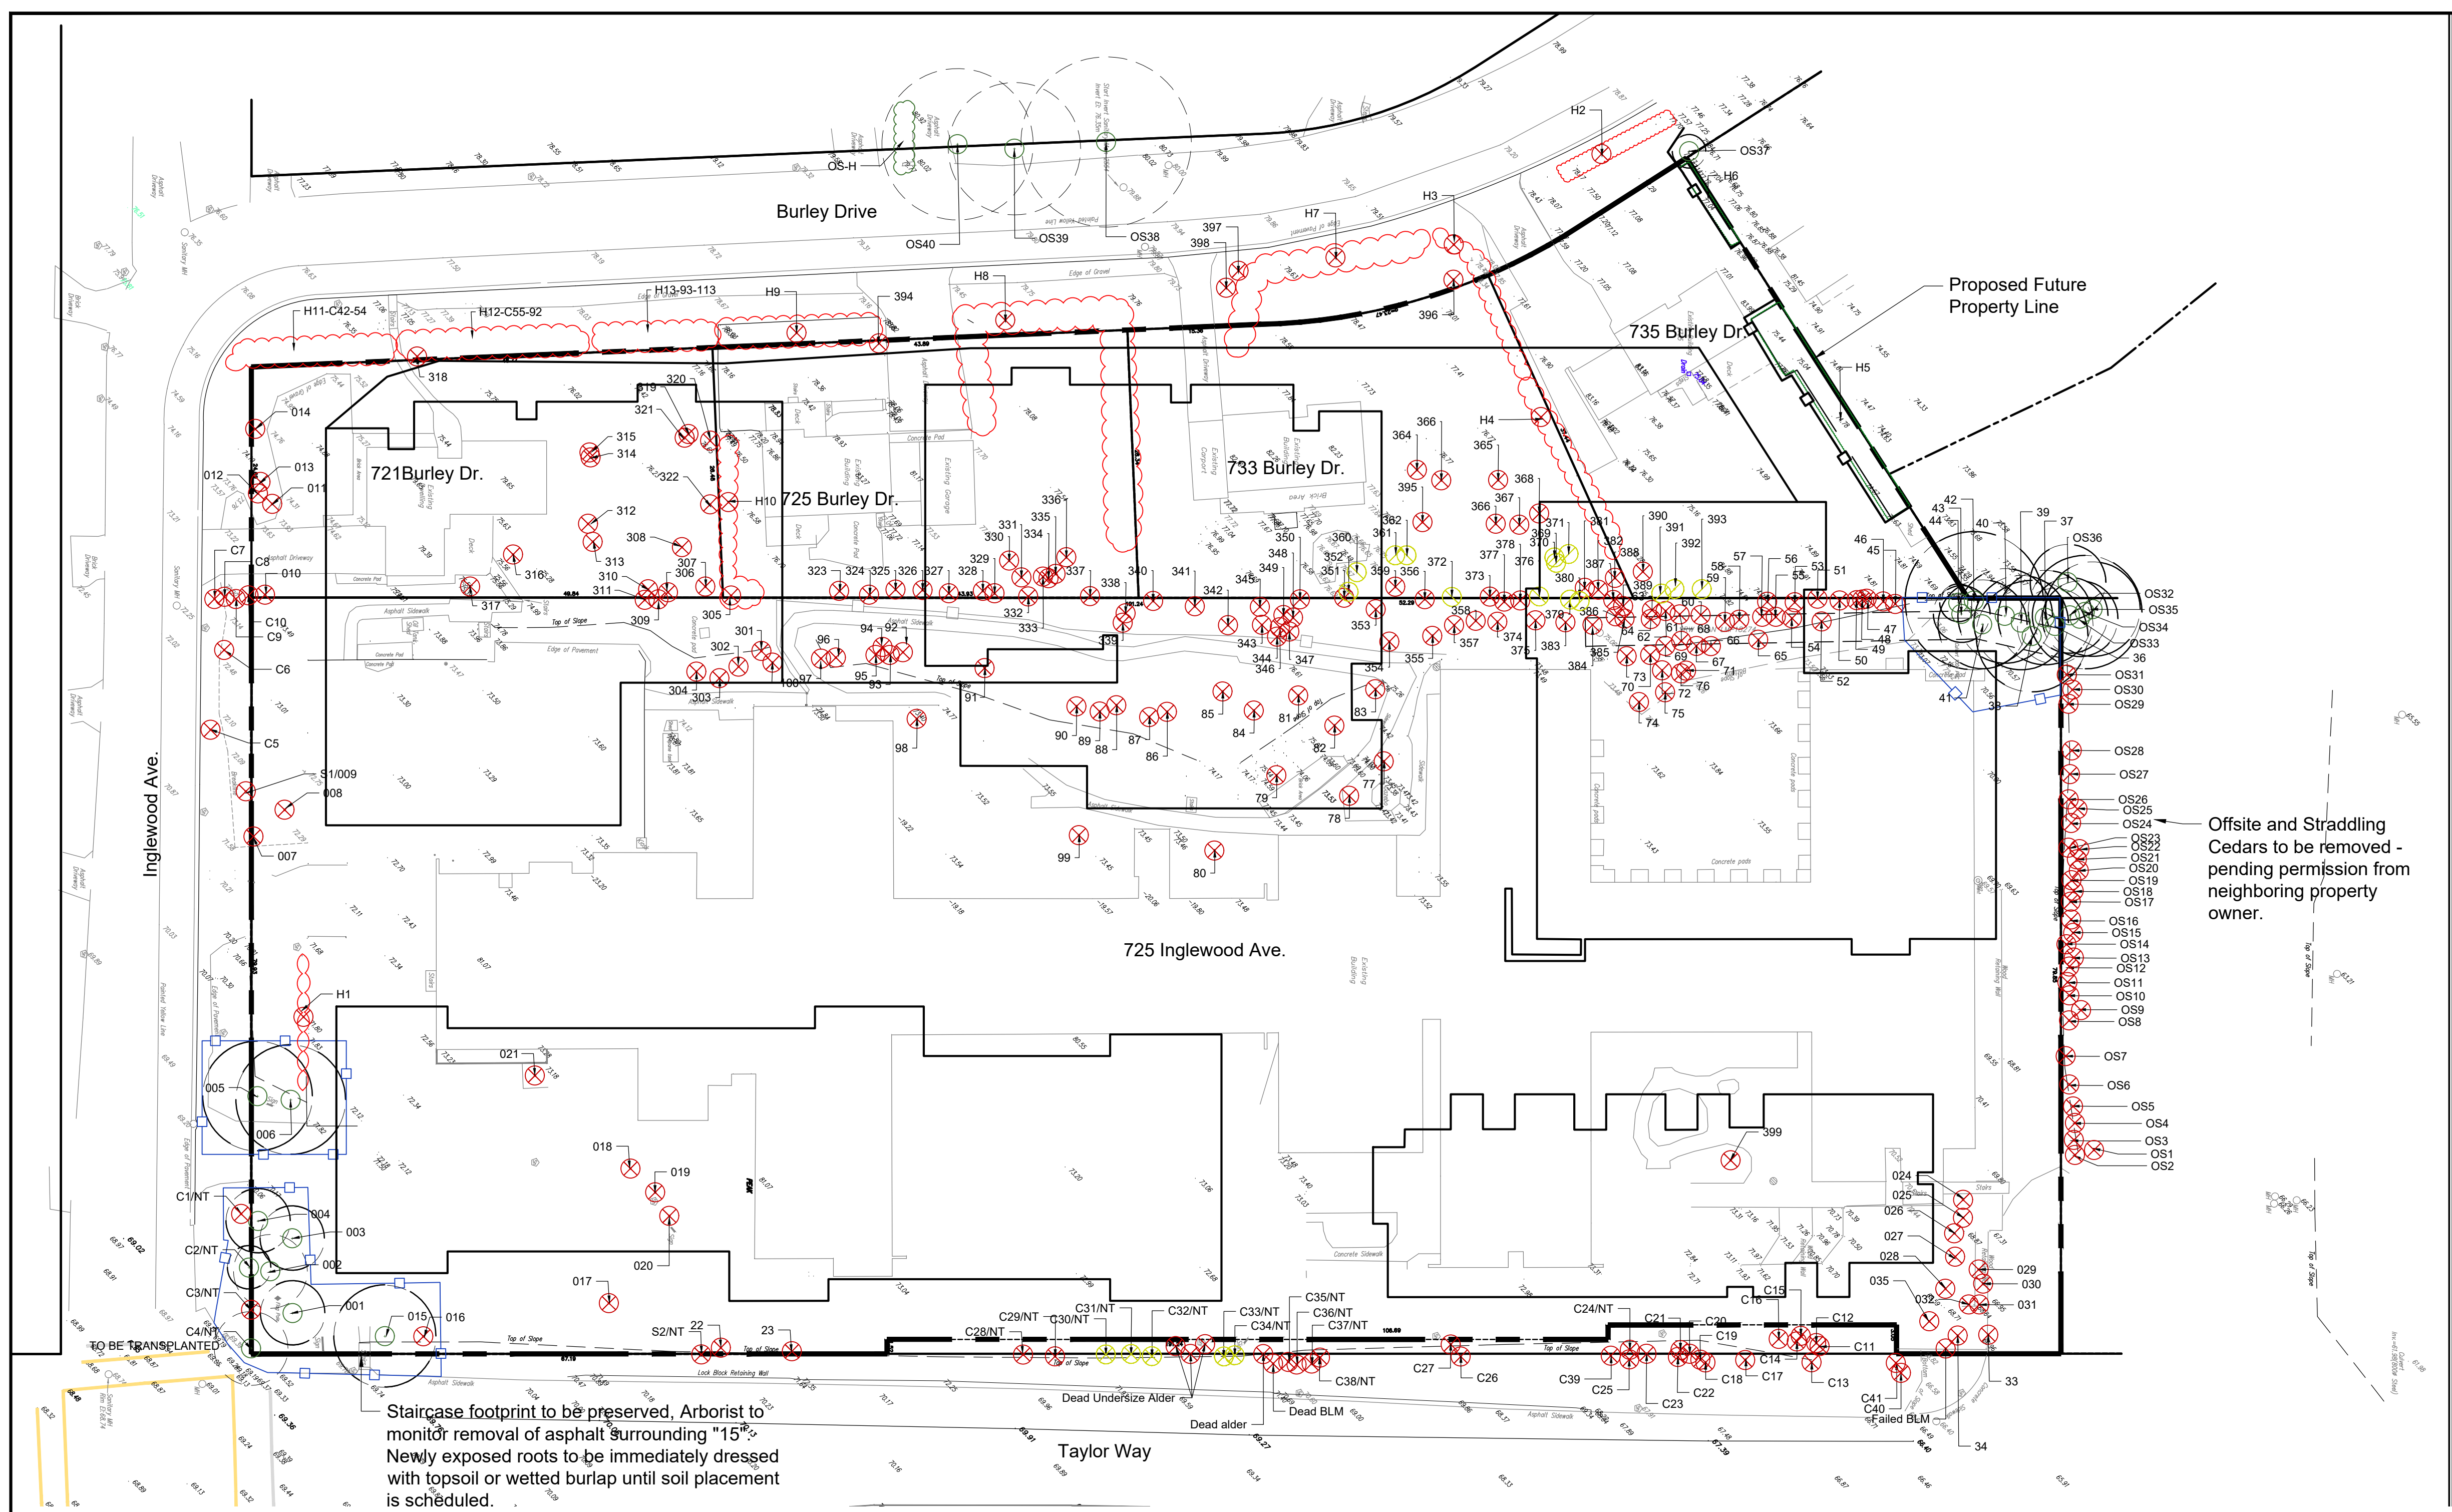
Offsite and Straddling Cedars to be removed - pending permission from neighboring property owner.

Staircase footprint to be preserved, Arborist to monitor removal of asphalt surrounding "15". Newly exposed roots to be immediately dressed with topsoil or wetted burlap until soil placement is scheduled.

- f. Tree #15 requires preservation of curb running through Critical Root zone.
